# Research Notes

**Project Title:** Midwest Roadside Safety Pooled Fund Program TPF-5(533) (FY25-FY29)

## Midwest Roadside Safety Pooled Fund Program TPF-5(533) (FY25-FY29)

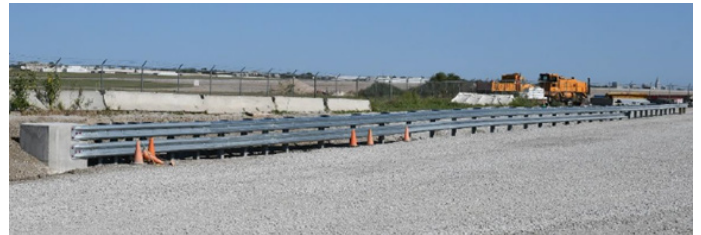
Image 1: Test Article Prior to Testing.

MWRSF recently performed crash testing to evaluate crashworthiness of the Hawaii DOT Flared Buried-in-Backslope End Terminal to Test Level 3 (TL-3) criteria of the Association of State Highway and Transportation Official (AASHTO) Manual for Assessing Safety Hardware, Second Edition (MASH 2016). The system consisted of Midwest Guardrail System (MGS) W-beam railing supported by W6x8.5 steel posts and 8-in. deep recycled plastic blockouts, with a lower W-beam rubrail attached to the post.

A single-flare and dual-flare system were tested. Only the dual flare was deemed acceptable to MASH 2016 TL-3 safety performance criteria. A photo of the test article prior to testing and one photo of a crash test are shown below. The testing was broken up into two final reports: one with standard direction impact tests and the other with reverse direction impact tests. The final reports can be found here:

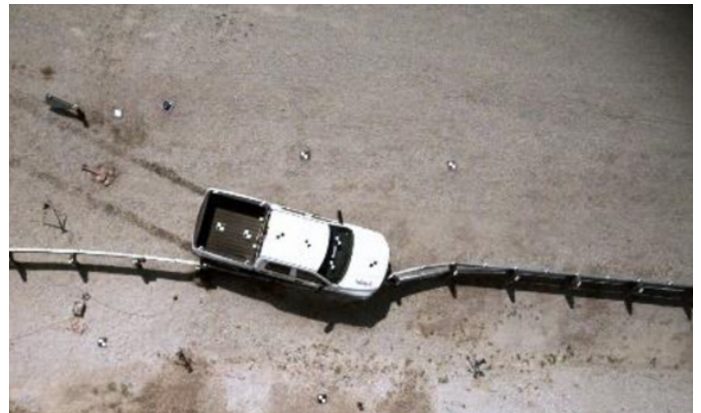
Image 2: MASH Crash Test 3-37a.
