Deployment Support and Caltrans' Implementation of the Sealzall Machine

## Implementing Automated Machinery for Sealing Pavement Cracks

*Sealzall machine increases productivity and safety when repairing longitudinal highway cracks*

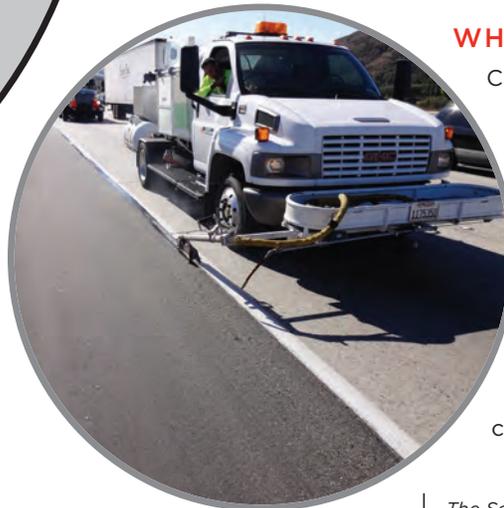
*The Sealzall longitudinal sealing operation produces a uniform and smooth seal, shown here on Interstate 15 in Escondido.*

The Sealzall is much more productive and efficient than the manual method of longitudinal crack sealing. Maintenance operators inside the cab of the Sealzall truck can seal 5-8 linear miles in one day, compared to only one linear mile a day manually. Operation is continuous, with moving lane closures, thus reducing the need to coordinate with the California Highway Patrol for fixed lane closures and the resulting impact on traffic.

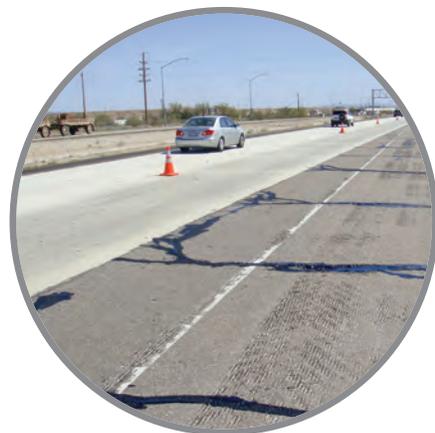
*Results of a Sealzall manual sealing operation on Interstate 8 in Winterhaven*
