MAY 2021

Evaluation of Vehicle Detection Systems Compared to Inductive Loops and Video Ground Truth Using the C1 Reader

## Sensys Detection System Evaluation for Signals and Ramp Meters

Comparing the accuracy of Sensys Networks wireless magnetometers to inductive loop detectors for traffic signal and ramp meter actuation

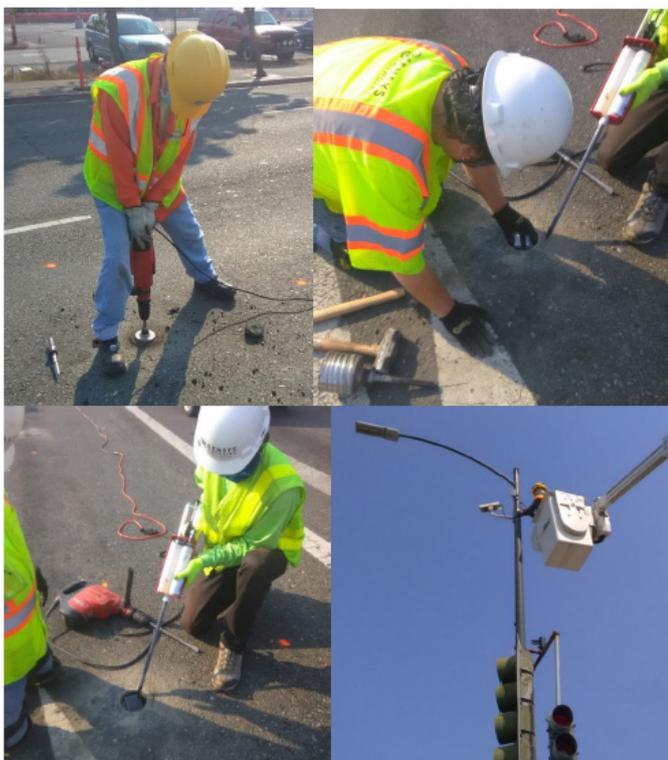
Image 1: Caltrans and Sensys installing a magnetometer and connecting it to a wireless access point

Caltrans installed the “C1/C11 Reader” device (see image 1), developed by DRISI to sample actuation logic signals from vehicle detectors, between the input files and the controllers in the equipment cabinets at both locations. Approximately one week of C1/C11 data and video were concurrently recorded at each location.
