## SPOT INSPECTION REPORT

**Building Name:** Natural Logistics

**Street Address:** 5th Street

**Inspection Date :** 11/21/2023

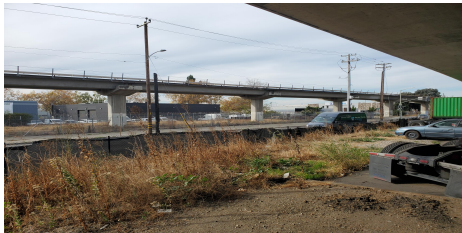
**Violation # 697395**

**Comments:** On the Southeast corner of the property, the dead vegetation needs to be completely removed.

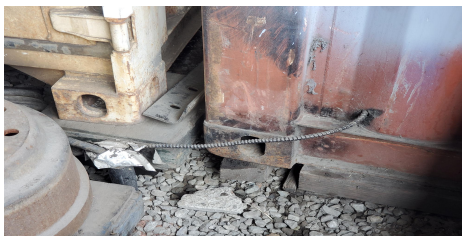
**Violation # 697397**

**Comments:** All flexible cords underground and into the conex/shipping container must removed and replaced with permanent wiring.

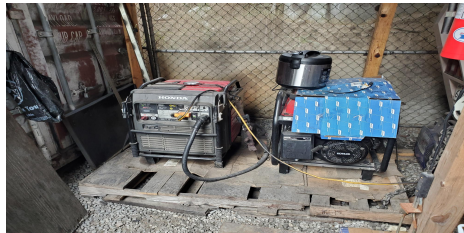
**Violation # 697399**

**Comments:** unapproved orange in color power tap being used. Please remove from service.

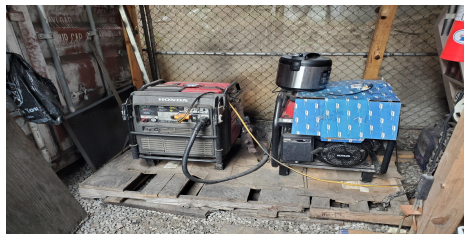
**Violation # 697400**

**Comments:** Both generators must be grounded and bonded.

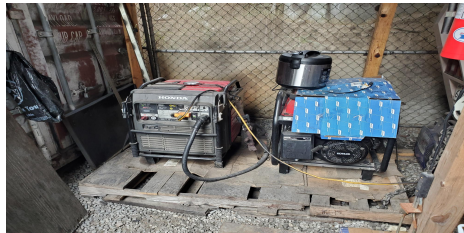
### Violation # 697400

**Comments:** Both generators must be grounded and bonded.

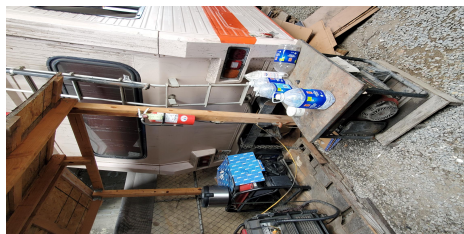
### Violation # 697405

**Comments:** The fire extinguisher near the generator is too high. Below lower it to 5 feet or below.

Fire extinguishers having a gross weight not exceeding 40 lbs (18.14kg) shall be installed so that the top of the fire extinguisher is not more than 5 ft. (1.53m) above the floor. Fire extinguishers having a gross weight greater than 40 lbs. (18.14kg) (except wheeled types) shall be so installed that the top of the fire extinguisher is not more than 3- ½ ft. (1.07 m) above the floor. In no case shall the clearance between the bottom of the extinguisher and the floor be less than 4 in. (10.2 cm).

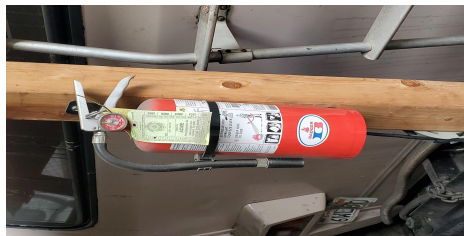
**Violation # 697402**

**Comments:** Fire extinguisher near the generator is expired and in need of an current annual servicing inspection and please provide.

Portable extinguishers shall be maintained in a fully charged and operable condition, and kept in their designated places at all times when they are not being used.
