| 4. TITLE AND SUBTITLE PPRC11 SPE 4.41.2: Laboratory and Accelerated Pavement Testing (APT) of Gap-Graded Rubberized Mixes (Hot Mix Asphalt and Warm Mix Asphalt) for the Department of Resource Recycling and Recovery (CalRecycle). Subtitle: Warm-Mix Asphalt Study - Field Test Performance Evaluation | | 5. REPORT DATE December 2013 |
| 7. AUTHOR D. Jones | | 6. PERFORMING ORGANIZATION CODE |
| 9. PERFORMING ORGANIZATION NAME AND ADDRESS California Department of Transportation Division of Research, Innovation and Systems Information, MS-83 P.O. Box 942873 Sacramento, CA 94273-0001 | | 8. PERFORMING ORGANIZATION REPORT NO. UCPRC-TM-2013-08 |

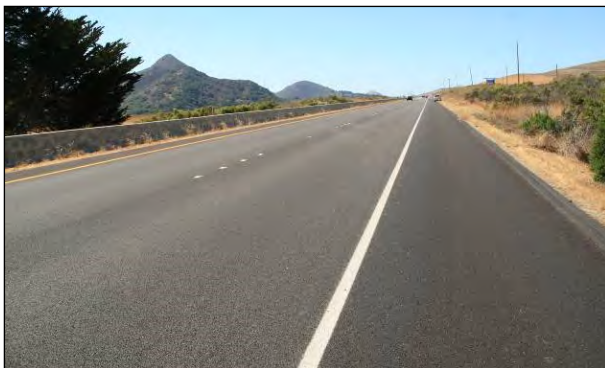
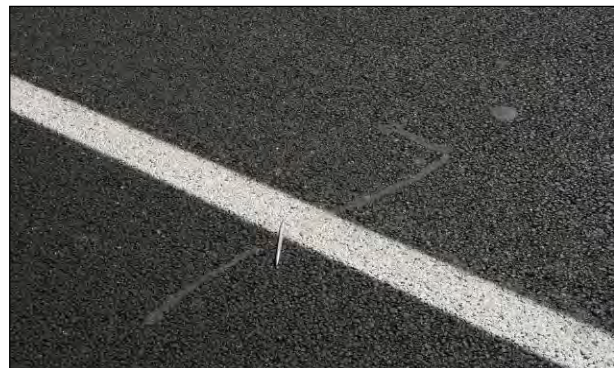
Figure 3.1: Morro Bay Control, May 2007 (0 months).

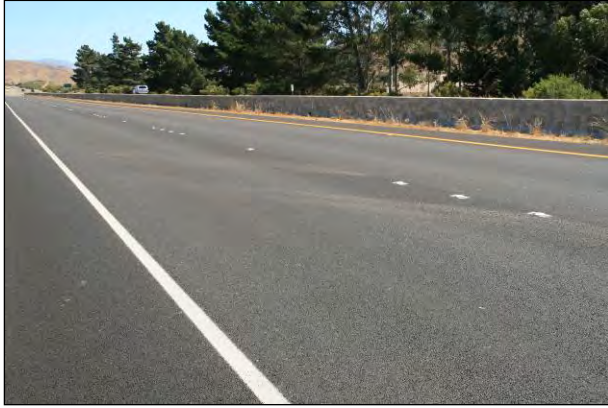
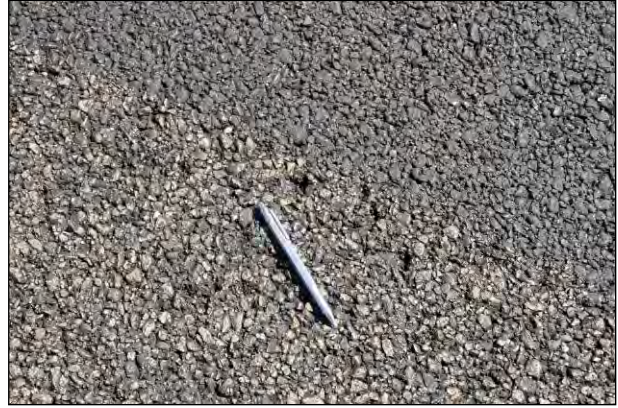
Figure 3.2: Morro Bay Control, May 2007 (0 months), track marks.

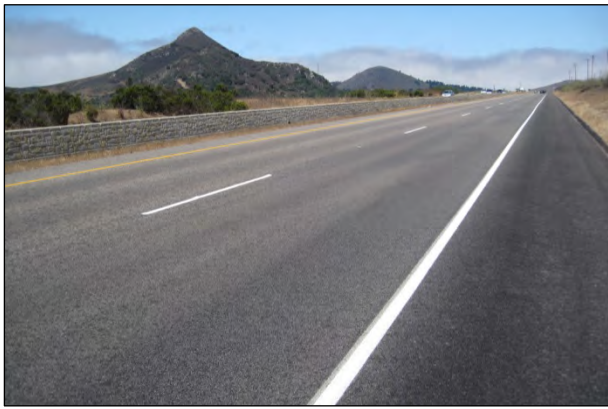
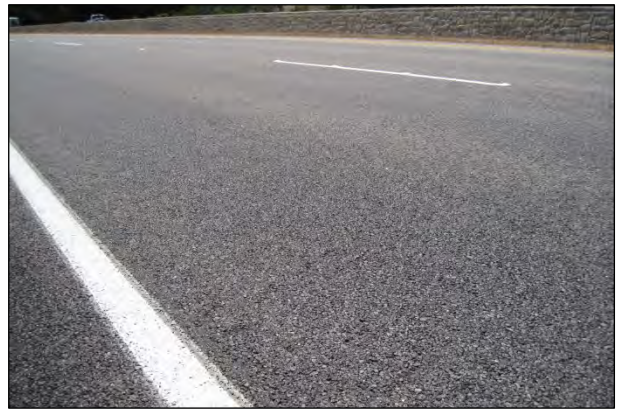
No deterioration compared to the May 2007 baseline measurements was noted on the sections after 73 months of traffic. Although the surface color of all sections was considerably lighter compared to new asphalt, the surface was still in very good condition and only minor stone loss, consistent with the age of the surface, was observed. Permeability through the open-graded friction course also remained effective on all sections (Figure 3.16).

Figure 3.4: Morro Bay Control, June 2013 (73 months).

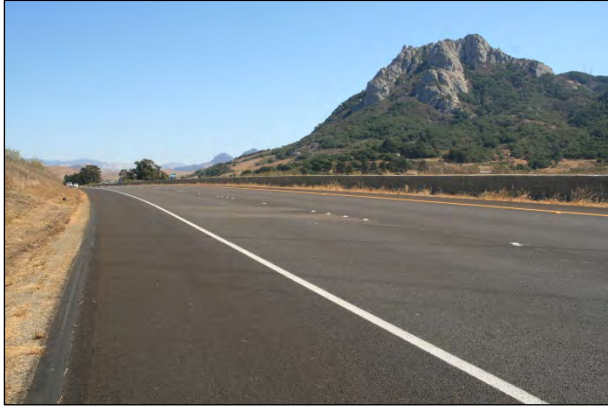
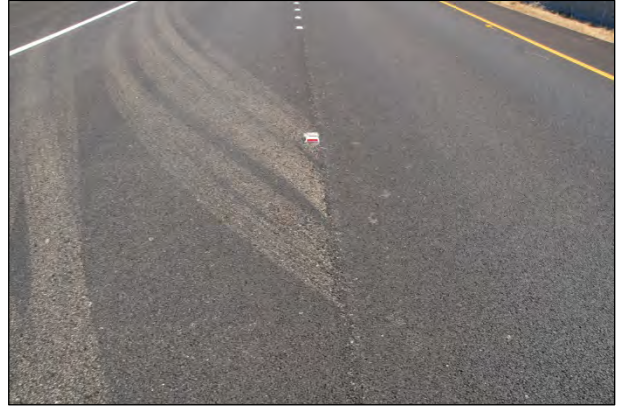
Figure 3.5: Morro Bay Advera, May 2007 (0 months).

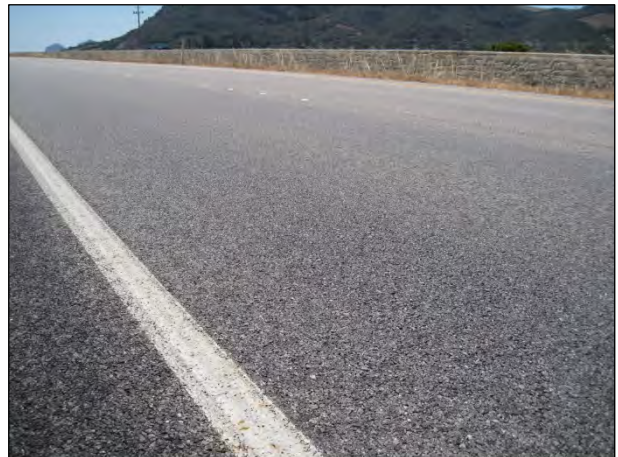
Figure 3.7: Morro Bay Advera, June 2013 (73 months).

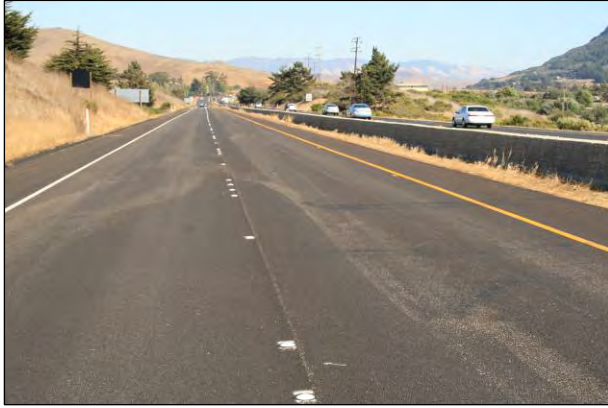
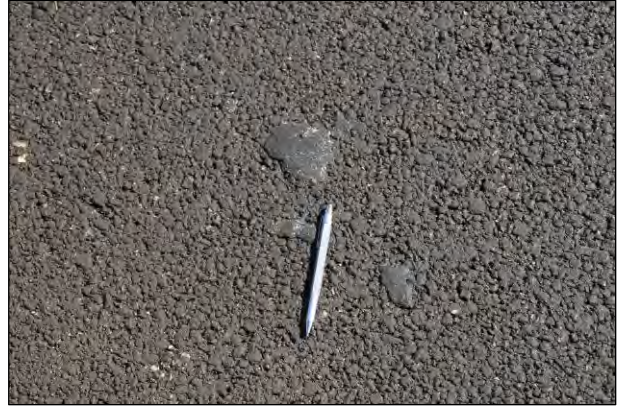
Figure 3.8: Morro Bay Evotherm, May 2007 (0 months).

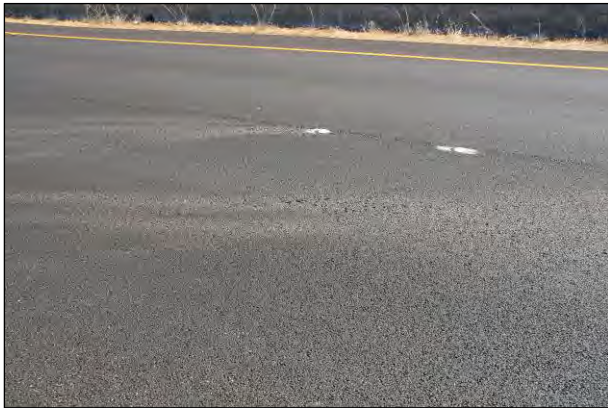
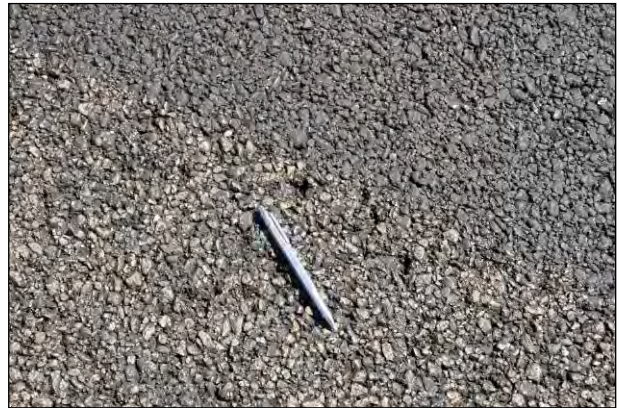
Figure 3.9: Morro Bay Evotherm, May 2007 (0 months), track marks.

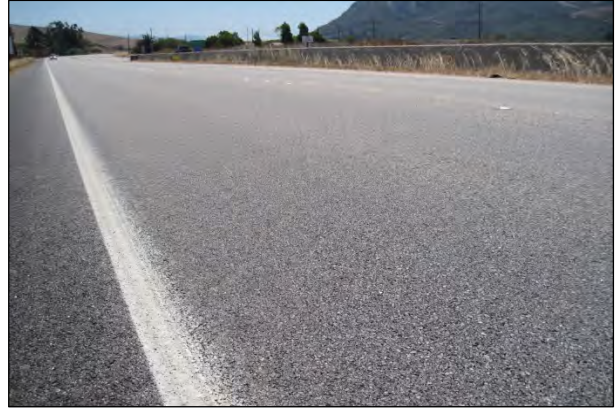
Figure 3.11: Morro Bay Evotherm, June 2013 (73 months).

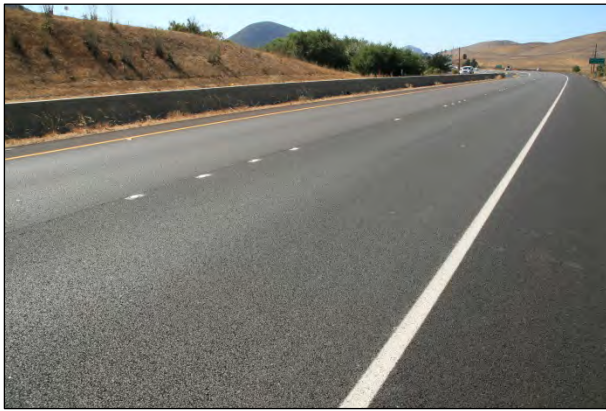
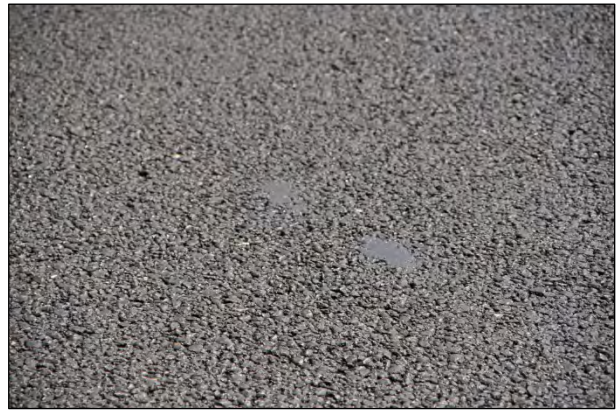
Figure 3.12: Morro Bay Sasobit, May 2007 (0 months).

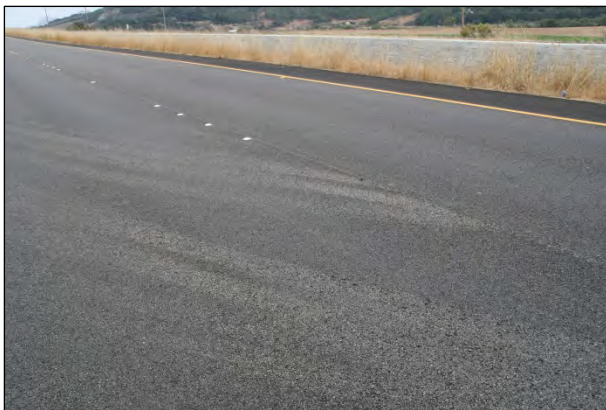
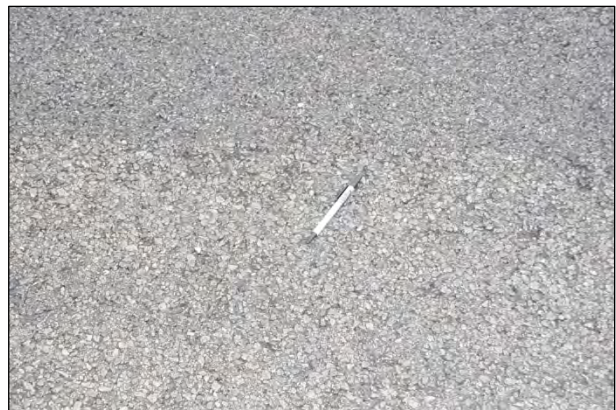
Figure 3.13: Morro Bay Sasobit, May 2007 (0 months), track marks.

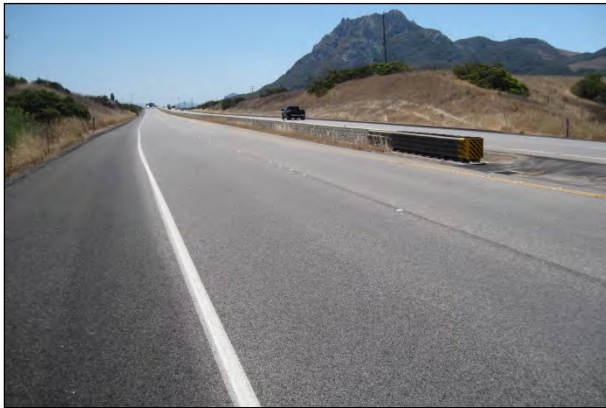
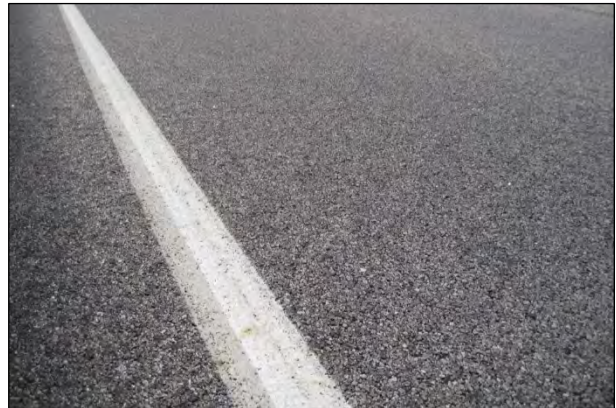
Figure 3.15: Morro Bay Sasobit, June 2013 (73 months).

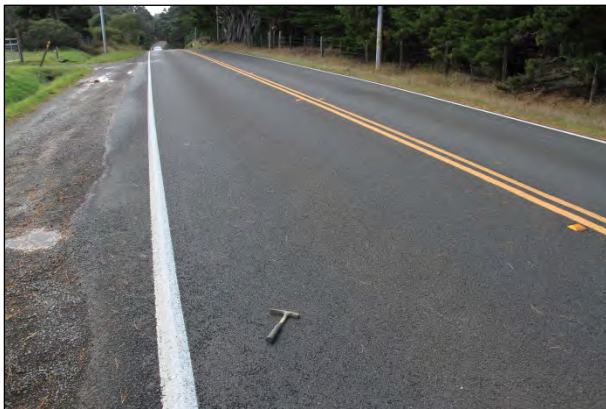
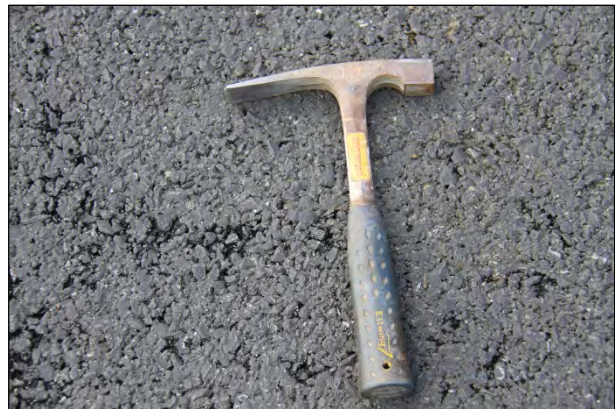
The Evotherm section resembled a typical open-graded friction course and was given an overall rating of “good.” No early stone loss was noted. Water was effectively draining through the friction course and out through the sides of the road. No other problems were observed.

Figure 4.1: Point Arena Evotherm, December 2008 (3 months).

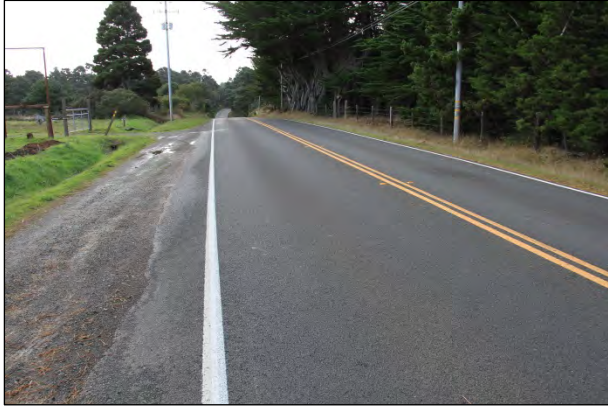
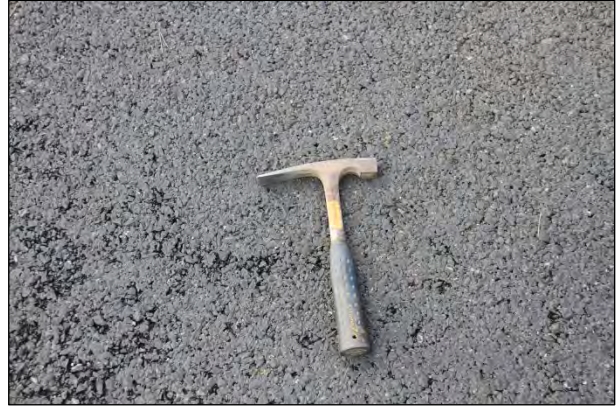
Figure 4.2: Point Arena Evotherm, November 2010 (23 months).

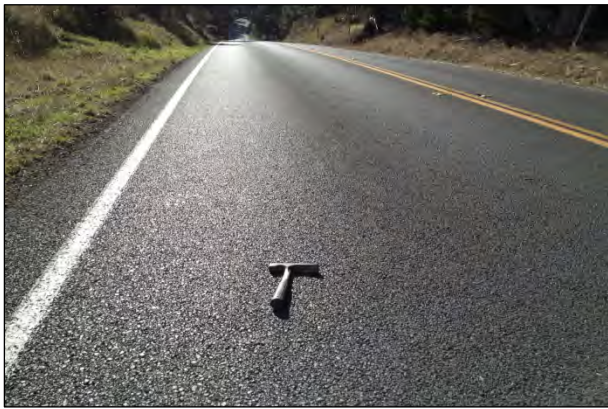
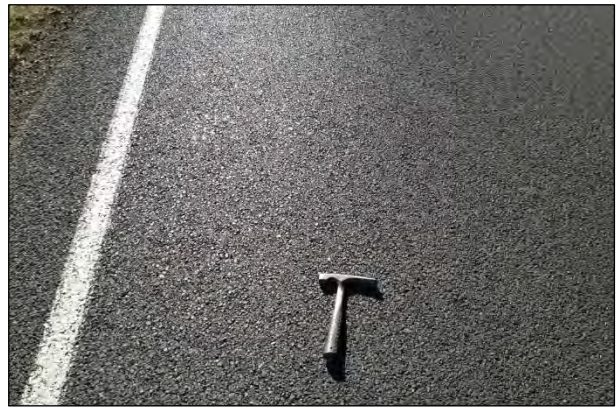
No deterioration compared to the December 2008 baseline measurements was noted on the sections after 54 months of traffic. The number and severity of the longitudinal cracks did not appear to have increased since the June 2012 visit. Drainage through the OGFC was still effective.

Figure 4.4: Point Arena Evotherm, December 2013 (54 months).

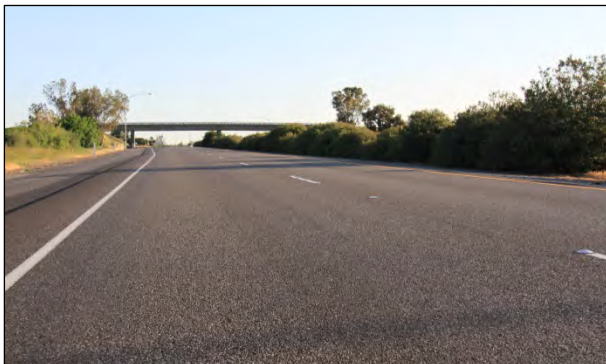
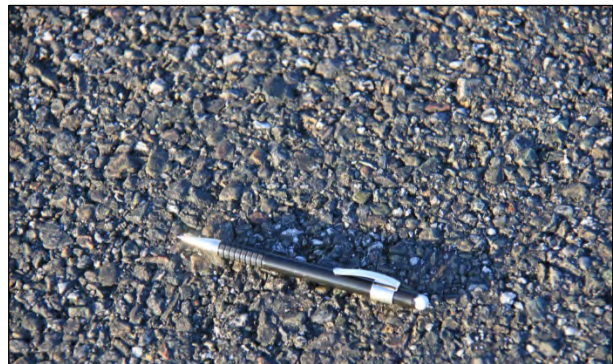
Figure 5.1: Orland Control, June 2009 (1 month).

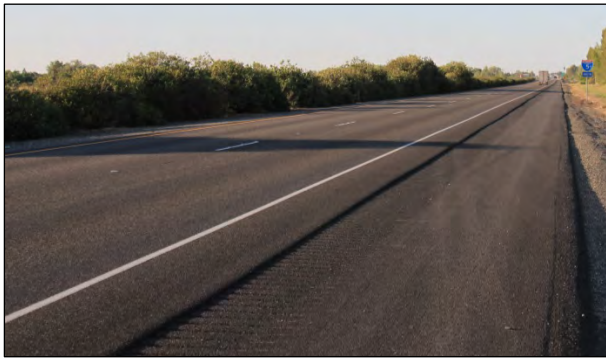
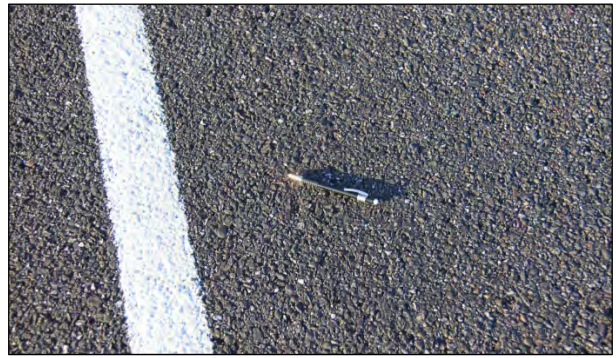
Figure 5.3: Orland Evotherm, June 2009 (1 month).

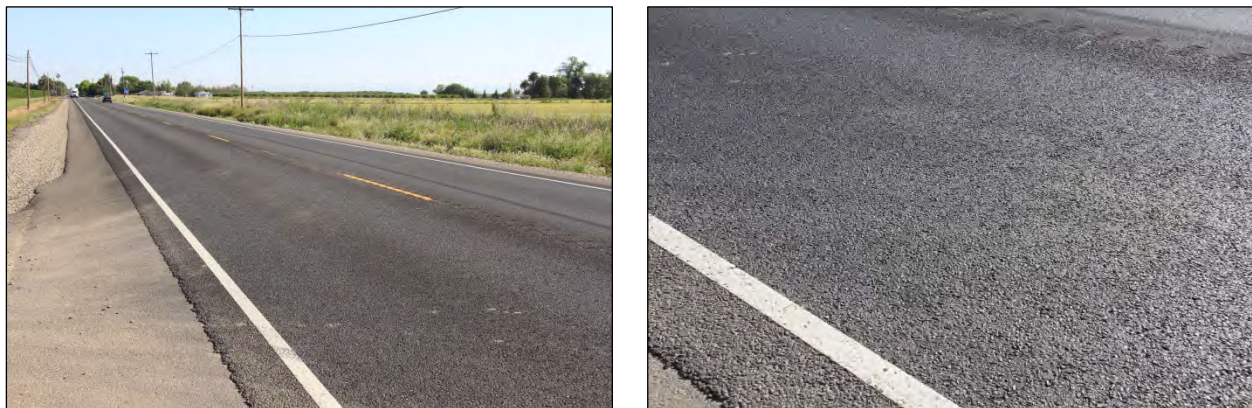
Figure 6.1: Marysville Evotherm, June 2009 (0 months).

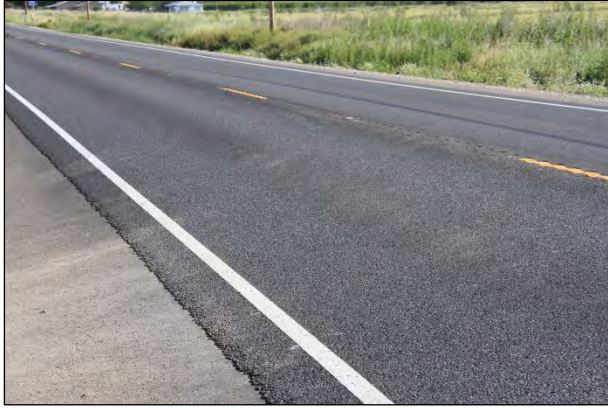
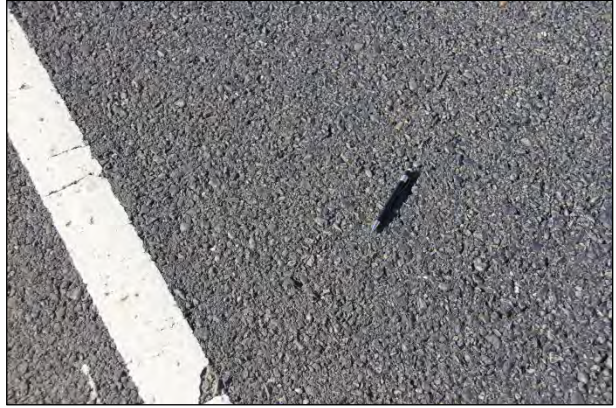
No deterioration compared to the June 2009 baseline measurements was noted on the section after 24 months of traffic, indicating that frequent and aggressive turning movements by large agricultural equipment is unlikely to negatively influence warm-mix asphalt surfacings.

Figure 6.2: Marysville Evotherm, June 2011 (24 months).

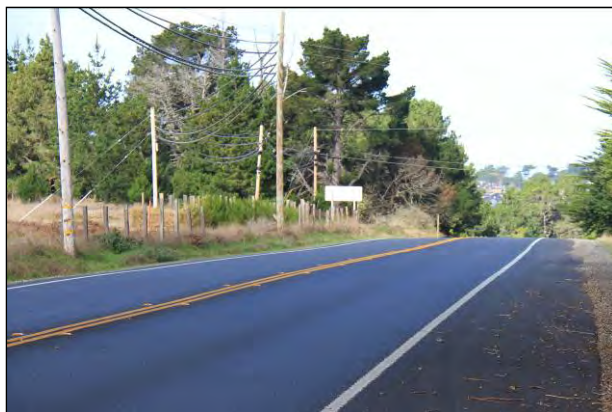
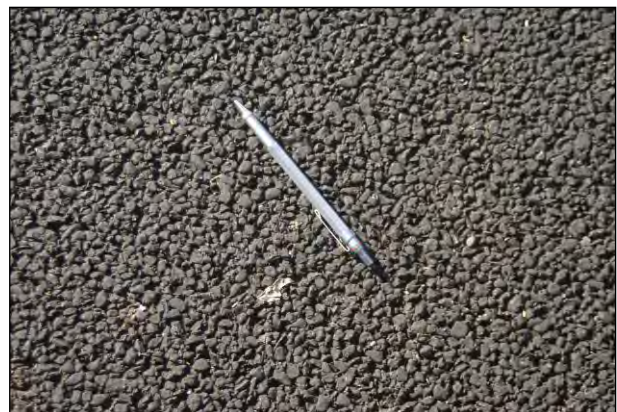
Figure 7.1: Mendocino Control, July 2010 (0 months).

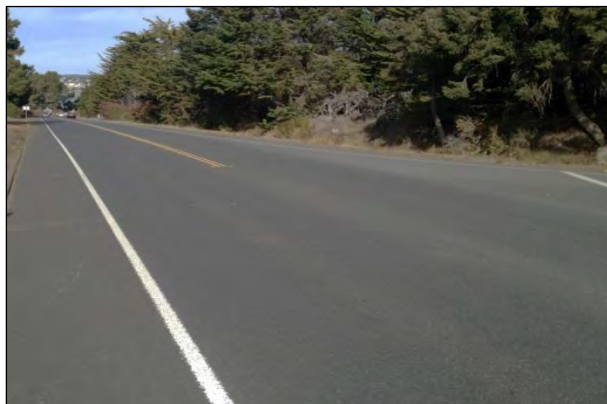
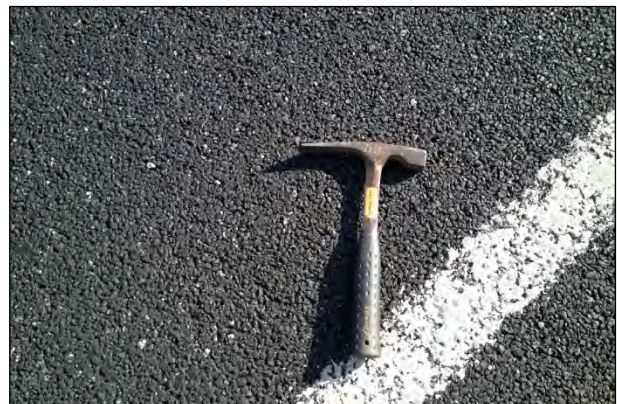
No deterioration compared to the July 2010 baseline measurements was noted on the sections after 42 months of traffic. The raveling observed on the Advera section during the December 2012 visit had not deteriorated.

Figure 7.2: Mendocino Control, December 2013 (42 months).

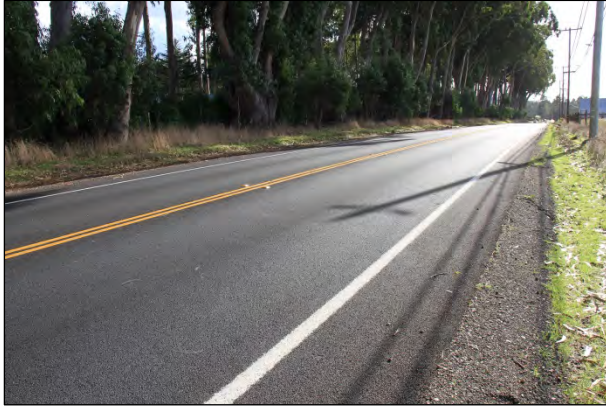
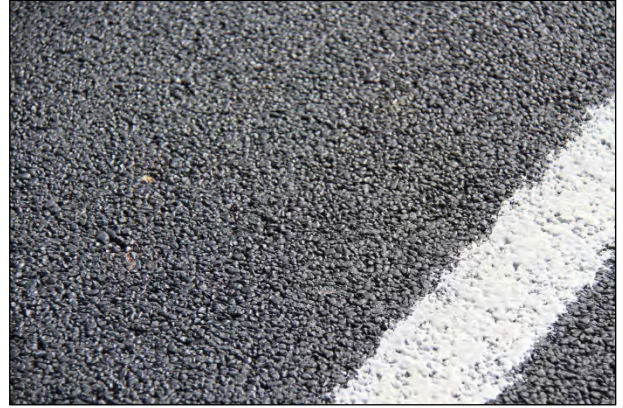
Figure 7.3: Mendocino Advera, July 2010 (0 months).

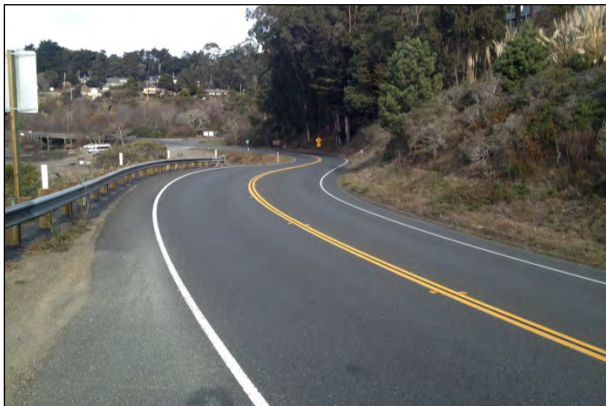
Figure 7.5: Mendocino Gencor, July 2010 (0 months).

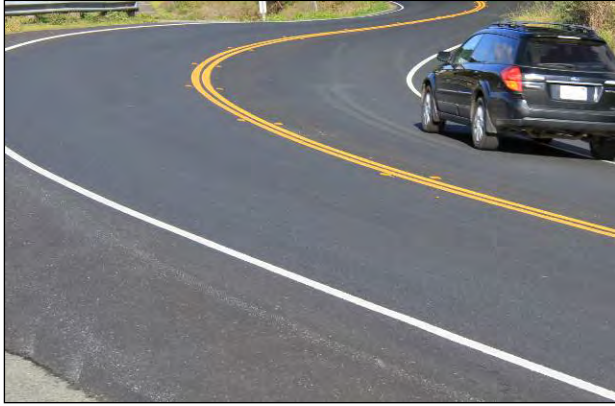
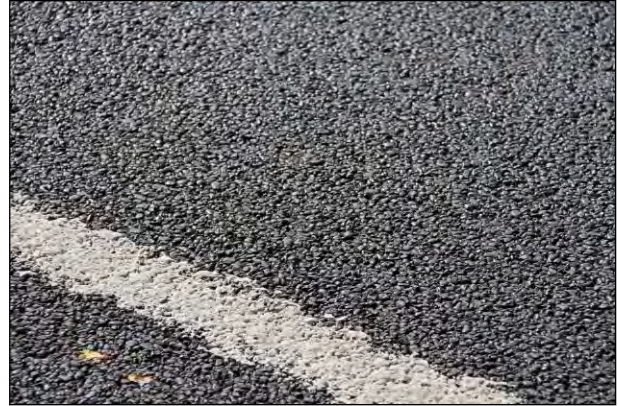
Figure 7.6: Mendocino Gencor, December 2013 (42 months).

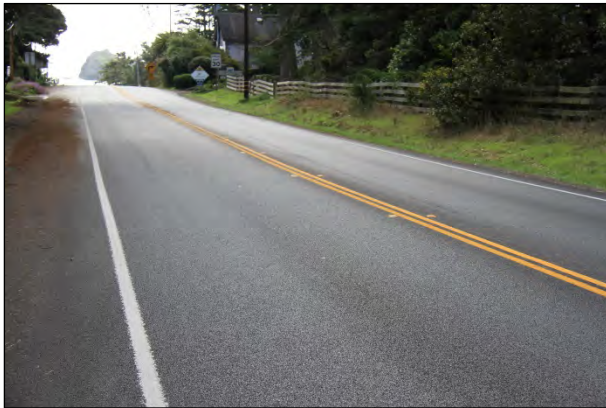
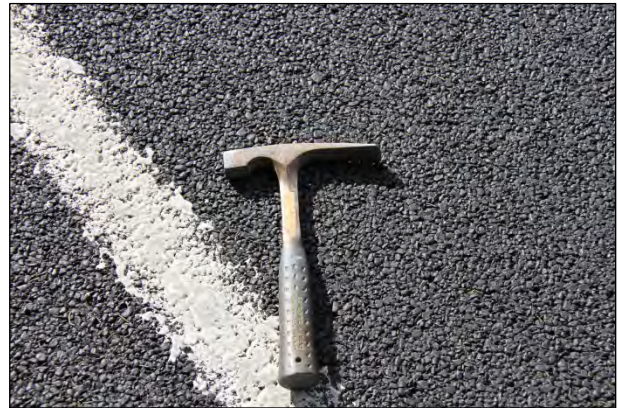
Figure 7.7: Mendocino Rediset, July 2010 (0 months).

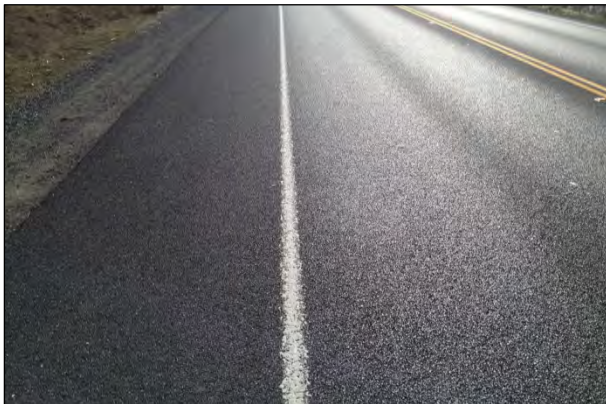
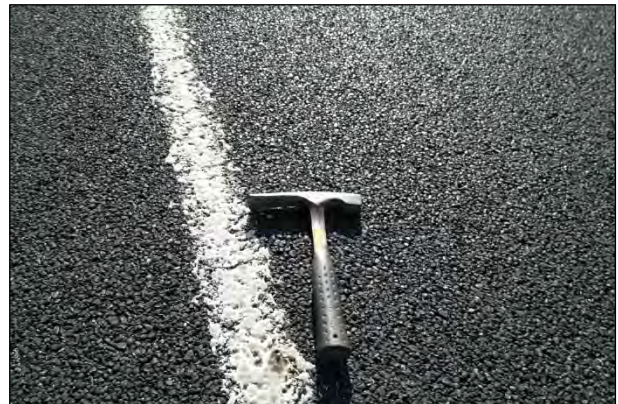
Figure 7.8: Mendocino Rediset, December 2013 (42 months).
