**Summary of SFOBB East Span Eye Bar Failure Analysis**

March 17, 2010

04-0G8404

SFOBB Emergency Eye Bar Repair

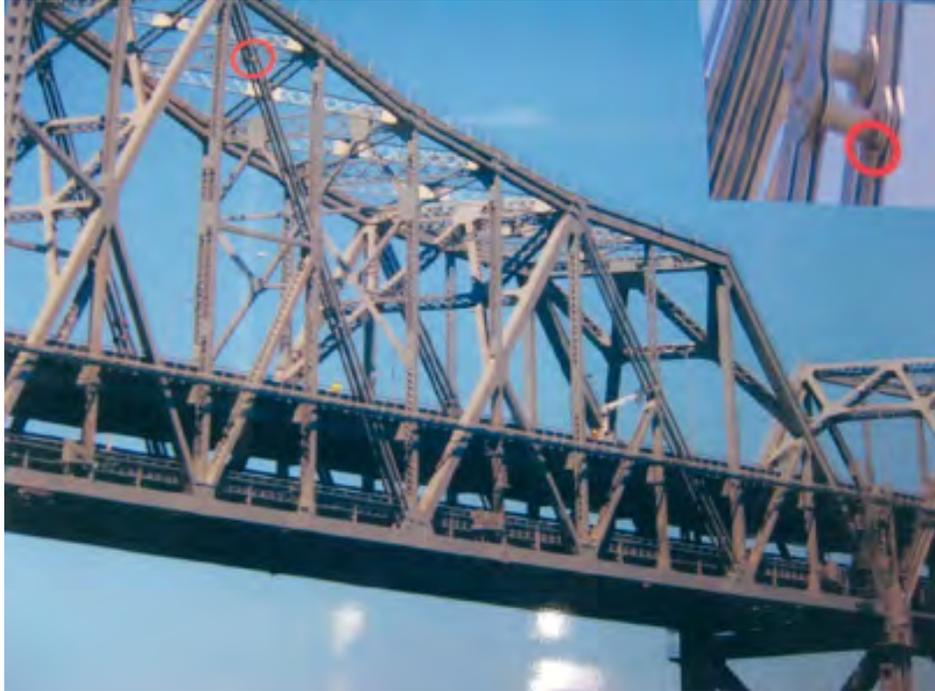
Figure 1: San Francisco-Oakland Bay Bridge East Span. Circled area is location of failed eye bar.

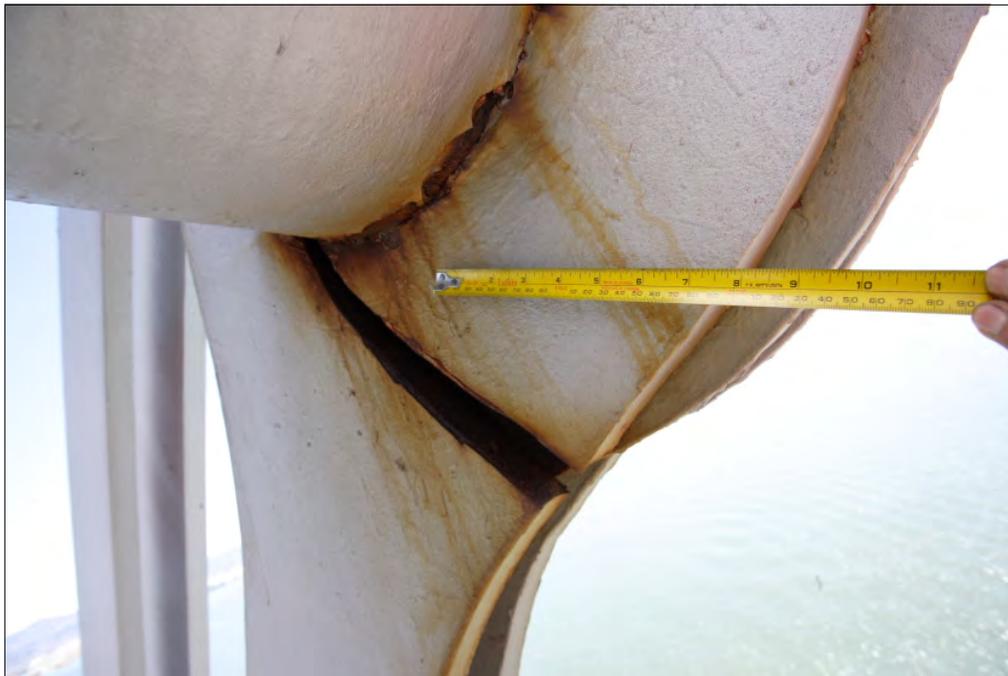
Figure 2: Eye bar showing failure location

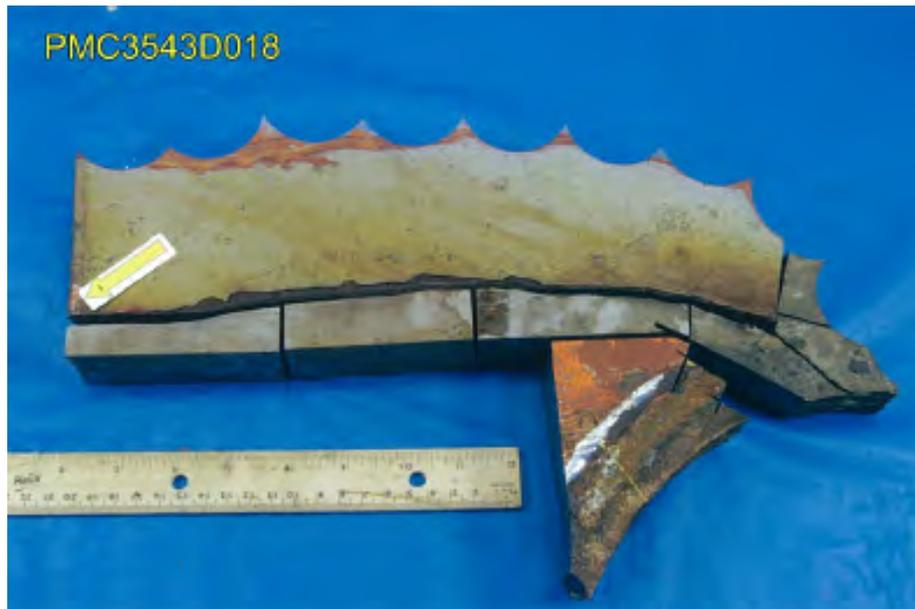
Figure 7 below also shows the layout of the fractured surfaces with the yellow arrow pointing to the outside edge of the eye bar and the fracture initiation location.

**Figure 7: Upper and lower portion of fractured eye bar. Fracture origin at arrow location.**

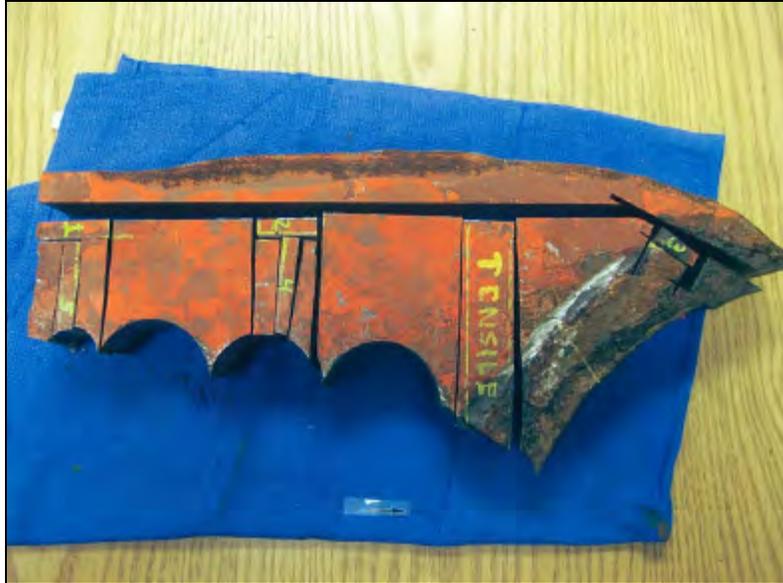
The microsections prepared by McKnight Laboratories at the locations shown in Figure 9 as No. 1 to 5, were examined for microstructure and hardness.

**Figure 9: Cut locations to remove micros.**

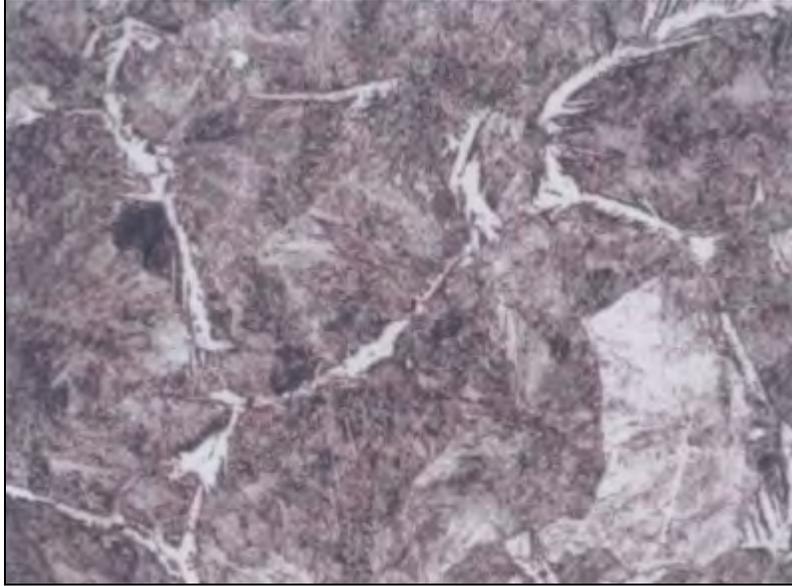
Inward toward the center from this area the core microstructure consisted of martensitic grains surrounded by ferrite. This is illustrated in Figure 11 below.

**Figure 11: Core microstructure of sample #1 in Figure 10. 500x Etched.**

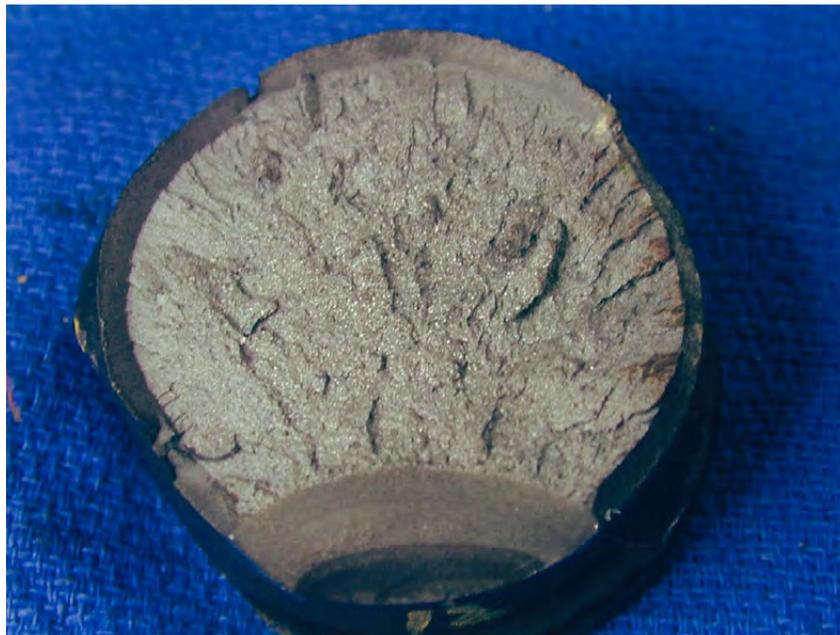
The fracture analyses of the failed rod revealed a fatigue thumbnail crack at one location on the perimeter of the cross section of the bar (See figure below). The remaining portion of the cross section of the fracture face showed a complete cleavage type fracture which is indicative of a brittle fracture over-load. The fact that there was one single fatigue thumbnail present on the fracture face indicates that the bar experienced severe unilateral bending stress. This indicates that either the bar was bent during installation or was bearing some place against the blocks or fixture to put this particular bar in bending. As a result of the unilateral bending stress and vibration on the bridge, the combination of these two factors caused the fatigue crack just below the radius of the rib on the bar where it interfaced with the fastener or nut in the assembly.

**Figure 12: Fracture surface of failed support rod.**

The failure analysis of the high strength bar used on the first emergency repair indicates that the failure was caused by a fatigue crack that resulted from unilateral bending stress and vibration on the bridge.

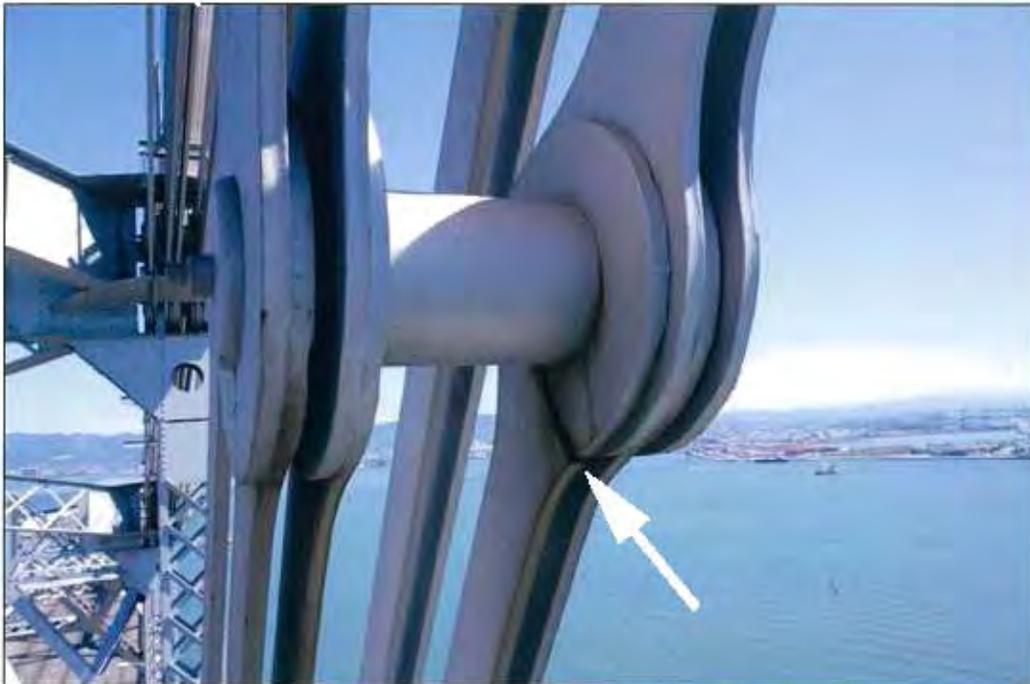
**Fig. 2 Location of cracked eye bar.  
(Looking East)**

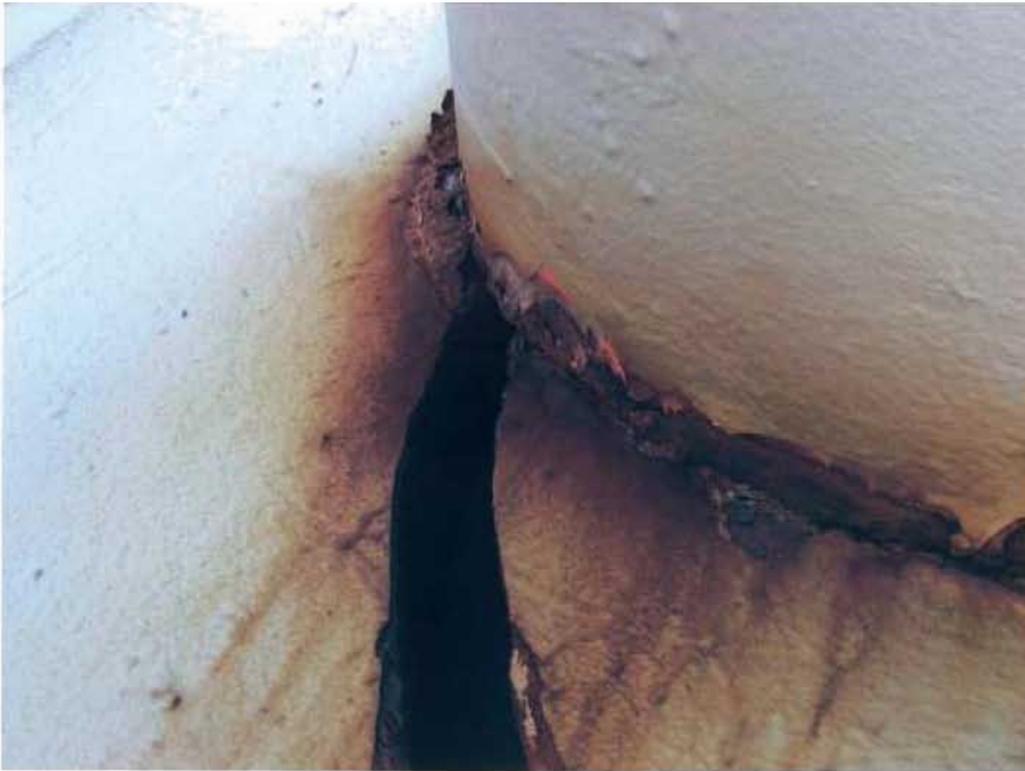
**Fig. 5 Corrosion at sleeve location at end of crack.**

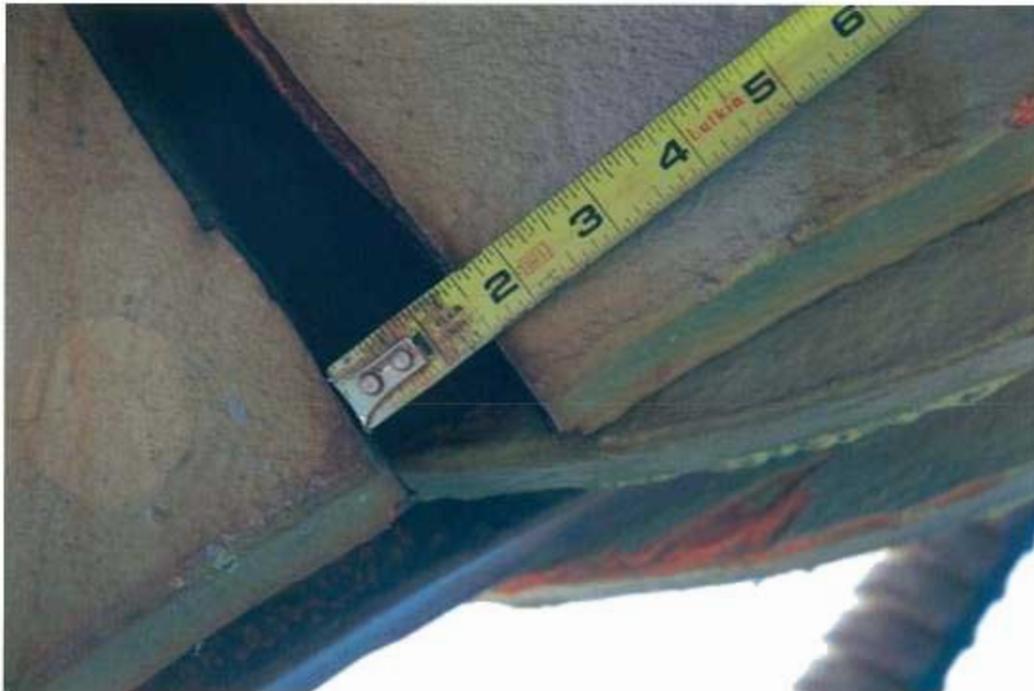
**Fig. 8 Crack opening displacement, outer edge.**

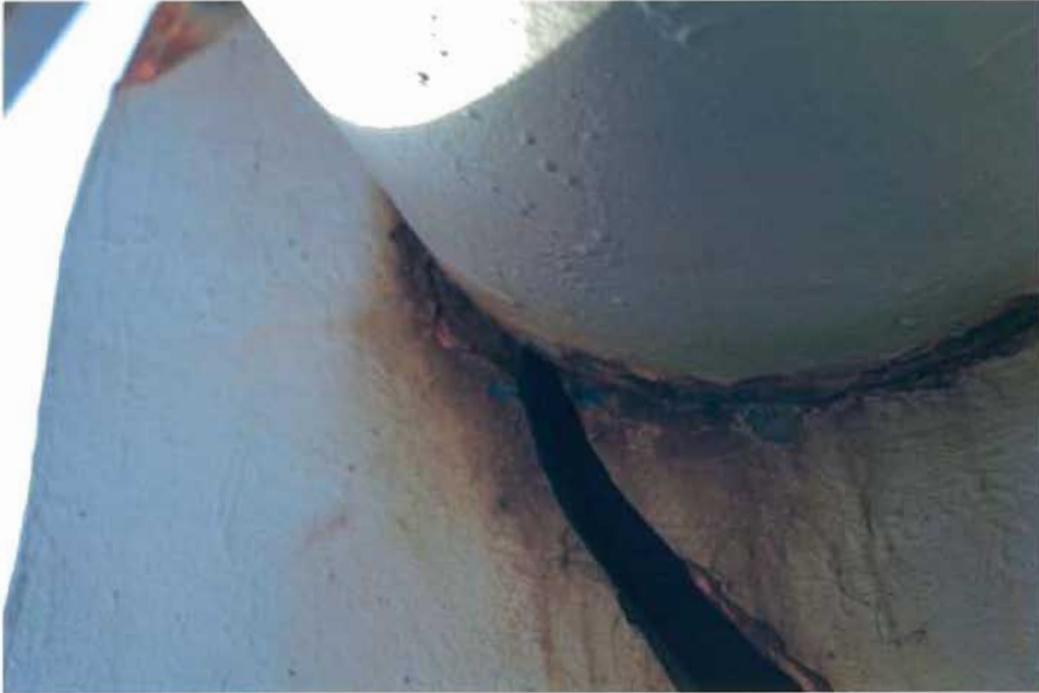
**Fig. 9 Fracture at sleeve location.**

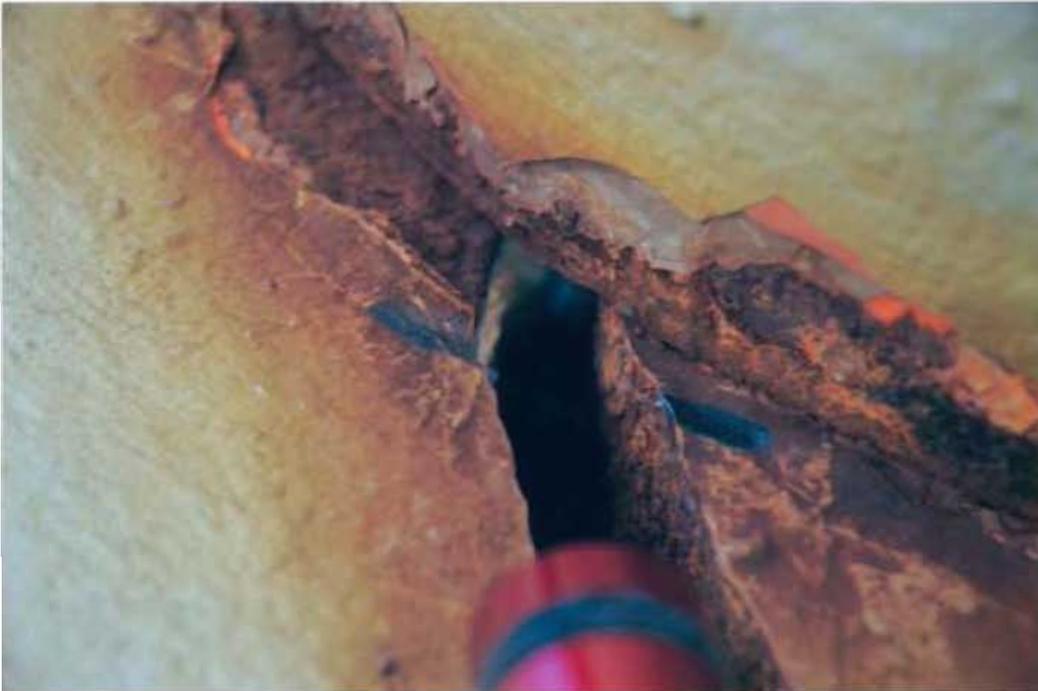
**Fig. 10 Corrosion at pin location.**

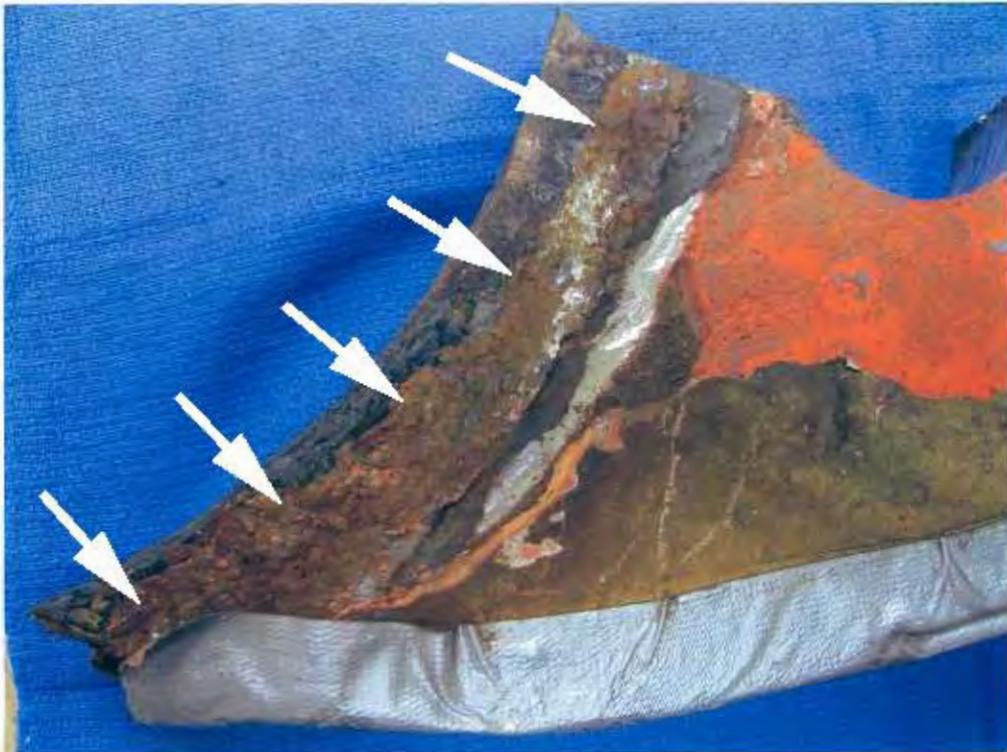
Fig. 11 illustrates the first segment of the fractured eye bar that was submitted to the laboratory with the duct tape covering the plane of fracture. Fig. 12 illustrates a close up of the oxidation and preferential wear on the surface of the eye bar where it interfaced with the end of the sleeve. Figs. 13 and 14 illustrate the oxidation and wear on the

**Fig. 12 Corrosion and wear at sleeve location.**

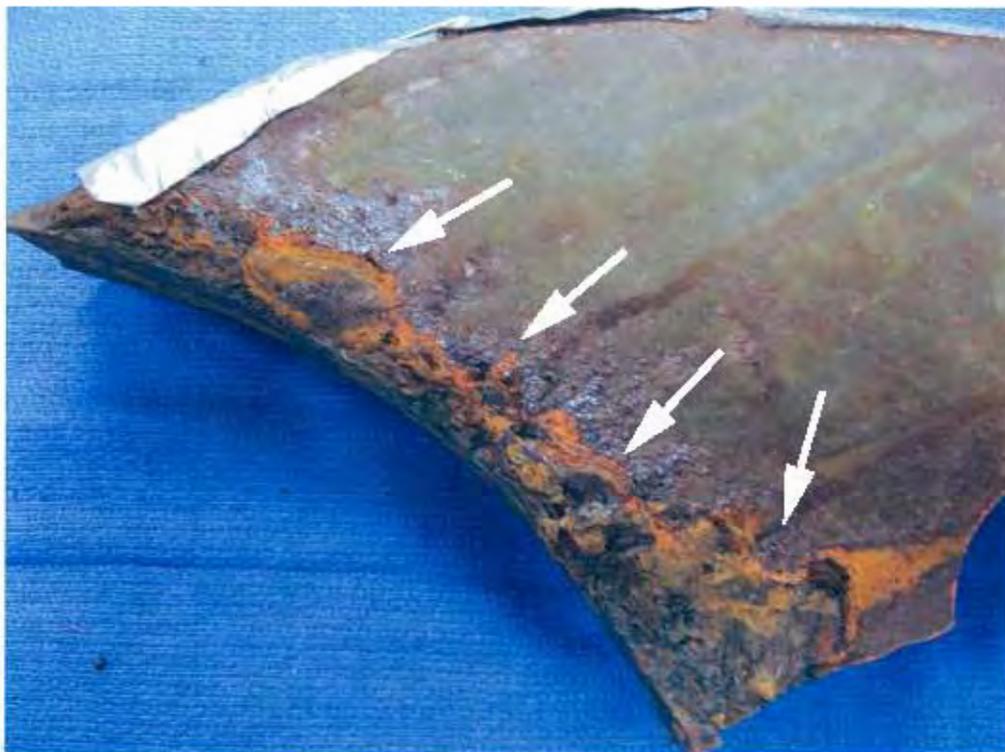
**Fig. 14** Corrosion and wear at sleeve location, opposite side.

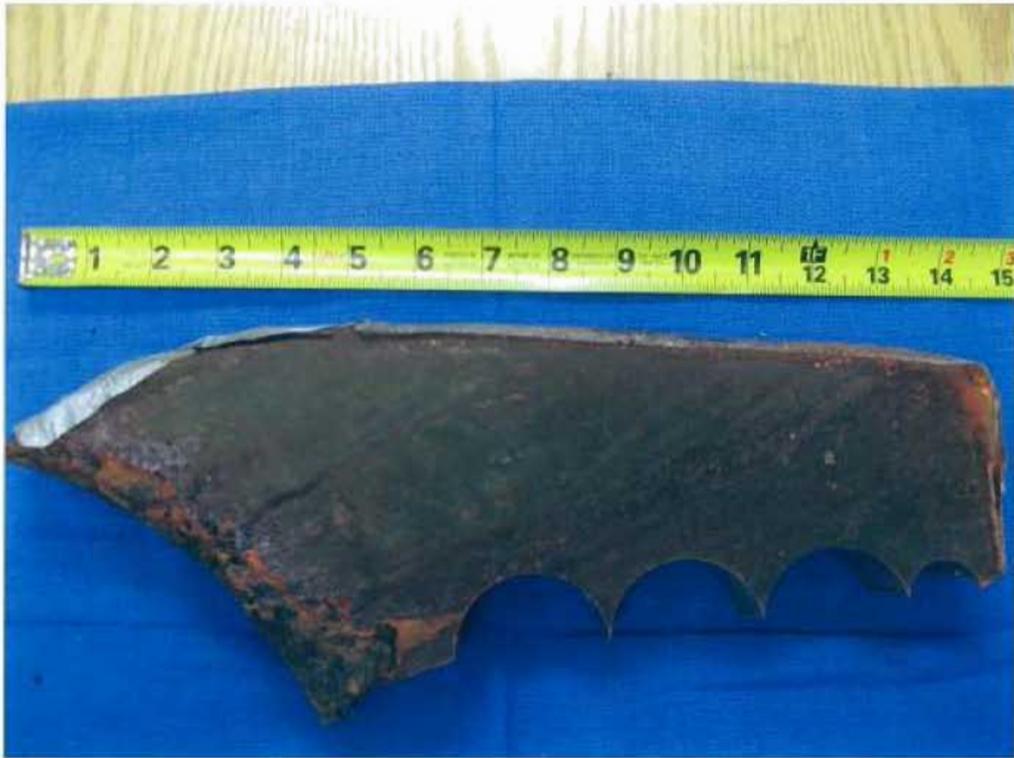
opposite side of this segment of the eye bar. Fig. 15 illustrates the upper fracture portion of the eye bar and shows the approximate length of the fracture face from the outside edge to the inside edge which measures approximately 14". Fig. 16 illustrates the location of the cut that was made below the plane of fracture to remove the fracture face on this segment of the eye bar. Fig. 17 illustrates the thickness of the eye bar. The nominal thickness of the eye bar was measured and found to be 1.8" and at the extreme inside diameter edge where it mated with the pin the thickness was 1.57" due to preferential wear. Figs. 18, 19 and 20 illustrate the specimens that were cut from the eye bar. Micro sections were prepared at locations 1, 2 and 3 parallel with the plane of fracture and additional microsections were prepared at locations 4 and 5 which were perpendicular to the plane of fracture. In addition, a tensile coupon was removed at the location labeled "Tensile" in Fig. 18 and fig. 20. At this location tensile specimens were prepared near the top surface of the eye bar, at the center of the eye bar, and at the opposite side of the eye bar. These were tested for tensile strength. In addition, a sample was removed for chemical analyses. Fig. 19 illustrates the location of micro specimens 1 and 5. The arrow in this particular photograph points to the corner outside edge where subsequent fracture analyses determined was the fracture origin. Fig. 21 illustrates the appearance of the fracture face before cleaning and Fig. 22 illustrates the appearance of the paint chip samples that were removed from the surface of the eye bar. The fracture face was cut into four different segments along the length shown in Fig. 23, then at locations 1 thru 12 Energy Dispersive X-ray analyses were conducted of the oxidized

**Fig. 15 Fracture face segment upper portion, opposite side.**

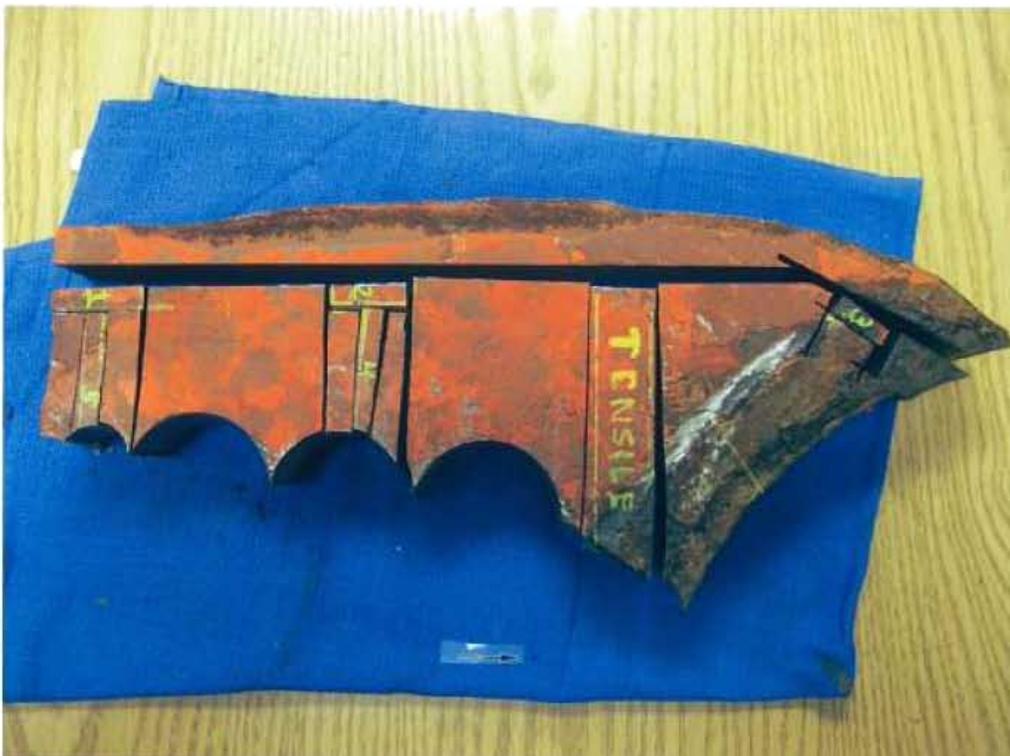
**Fig. 20 Cut locations to remove micros, tensile, and chemistry samples.**

The microsections prepared at the location indicated in Fig. 20 were examined for microstructure and hardness. Fig. 71 illustrates the microsection prepared at location 1 in Fig. 20. The outer edge of the eye bar at this location is shown to the left in the photograph. The outer edge of the eye bar has a concave configuration as is illustrated in Fig. 71. The arrow at the sharp corner at the top indicates where the fatigue fracture initiated in the eye bar. The microstructure near the top outer edge is shown in Fig. 72 and 73. The microstructure consists of highly tempered martensitic type structure. Inboard from this area the core microstructure consisted of martensitic grains surrounded by ferrite. This is illustrated in Figs. 74 and 75. Fig. 76 illustrates the microsection prepared at location 2 shown in Fig. 20. Fig. 77 illustrates the core microstructure of this specimen at 200X. Fig. 78 illustrates the microsection prepared at location 3 in Fig. 20. The area to the right represents the surface that is against the pin in the assembly. Figs. 79 and 80 illustrate the appearance of the top surface near the pin location which shows evidence of extensive oxidation and pitting. Fig. 81 illustrates the microstructure and the microsection prepared perpendicular to the plane of fracture at location 4 in Fig. 20. Examination of this specimen in the unetched condition revealed longitudinal oriented inclusions such as illustrated in Fig. 82. This identifies the principal roll direction or grain flow direction of the bar which is perpendicular to the plane of fracture and parallel to the long axes of the eye bar. Fig. 83 illustrates the microstructure near the top surface of this sample and which is tempered martensite and

Results of the tensile test conducted at the tensile location shown in Fig. 20 showed the following results: near the top the ultimate tensile strength was 97,500psi, yield strength 64,000psi, elongation 23%, reduction of area 61%. At the center or core location the tensile strength was 85,000psi, the yield strength was 51,000psi, elongation 29%, percent reduction of area 63%. On the bottom side the ultimate tensile strength was 98,00psi, yield strength 64,500psi, elongation 26% and reduction of area 61%.

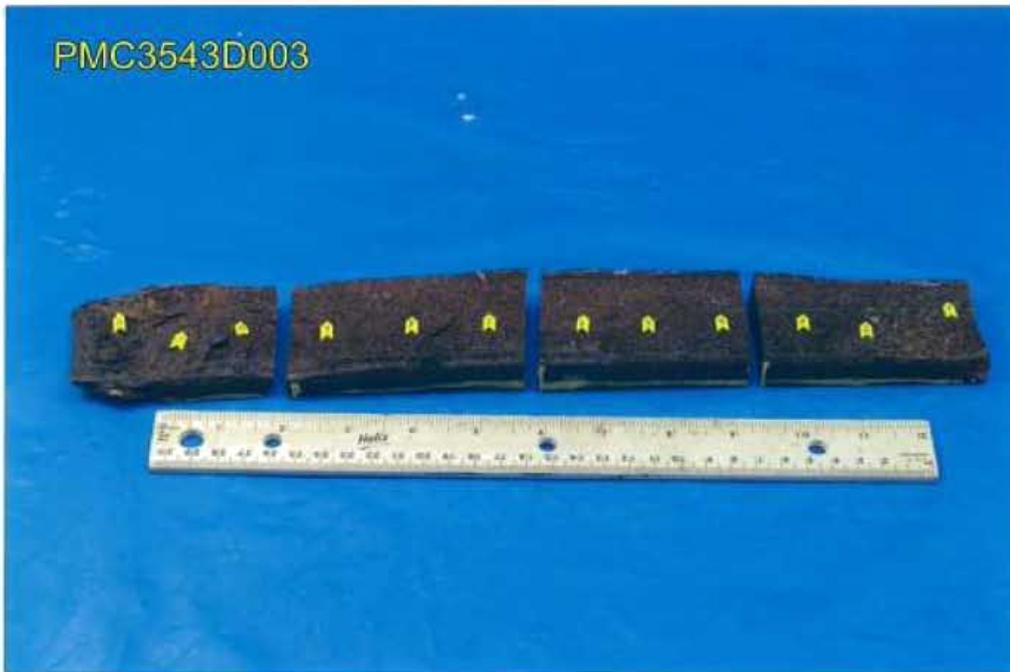
fracture face. These locations are shown in Figs. 23 thru 27 proceeding from the outer edge towards the inside edge. One can see the extensive amount of oxidation and corrosion attack along the plane of fracture. In this condition it was impossible to determine fracture mode. Fig. 28 illustrates the inside surface area of the eye bar where it interfaced with the pin. EDS analyses were also conducted of the oxide layer at this location. Fig. 29 illustrates the paint chip samples that were removed from the surface. These were labeled as 14, 15 and 16. Fig. 30 illustrates an over all view of the upper portion of the fracture face and the lower portion of the plane of fracture which was submitted on November of 2009. The results of the Energy Dispersive X-ray analyses conducted at locations 1 thru 12 on the oxidized plane of fracture are shown in spectra 1-12, and analyses of the inside diameter surface of the eye bar where it interfaced with the pin is illustrated in Spectrum No. 13. X-ray analyses of the paint chips are illustrated in Spectrums 14, 15 and 16. Results of the X-ray analyses of the oxidized layer show principally iron and oxygen with small trace amounts of other elements such as calcium, chlorine, silicon and in some cases carbon. There is also a small trace of sulfur and a very small trace of lead which is attributed to the paint on the surface of the bar. However, there was no significant presence of lead on the oxidized plane of fracture which indicates that the crack was not present at the time that the lead paint was applied. The principal elements are iron and oxygen. Spectrum No. 14 illustrates the analyses of the red colored portion of the paint chip which was the first layer of paint on the surface of the eye bar. Fig. 15 illustrates the spectrum analyses of the second coat of paint which appears to contain a significant amount of aluminum, oxygen and carbon which is

**Fig. 23 Fracture face of eye bar, upper portion. Arrows indicate E.D.S analyses locations.**

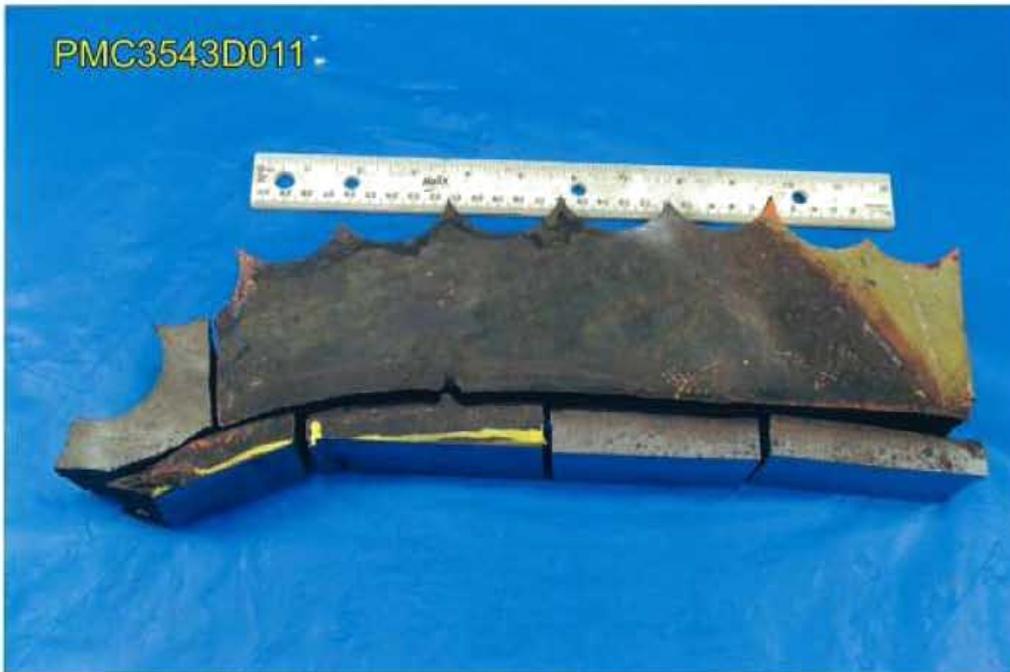
Fig. 31 illustrates the opposite side of the fracture location of the eye bar on the side opposite shown in Fig. 30. Figs. 32 and 33 illustrate the appearance of the outer edge of the eye bar and Fig. 34 illustrates the outer surface of the eye bar with the arrow pointing to what was subsequently determined to be the fracture origin. Fig. 35 illustrates the appearance of the fracture face. The section shown at the top in Fig. 35 was cut into four segments and these were cleaned and then examined in the Scanning Electron microscope to determine the fracture origin. Fig. 36 illustrates the outer edge with the yellow arrow pointing to the fatigue fracture origin. At the outer edge of the eye bar, even after partial cleaning, there is the appearance of a thumbnail area emanating from this corner which is indicative of fatigue fracture. Figs. 37 and 38 showed additional views of the two sides of the mating fractured face segments that were submitted. Fig. 39 and 40 illustrate the area of the eye bar where it interfaces with the center pin of the assembly. Figs. 41 and 42 illustrate the segment of the fracture at the eye bar interface location after cleaning with the arrows pointing to the location of the plane of fracture coincident with the pin location. Fig. 43 illustrates the mating fracture faces of the eye

Fig. 31 Overall photo of upper portion of fracture and lower portion of fracture. Opposite side.

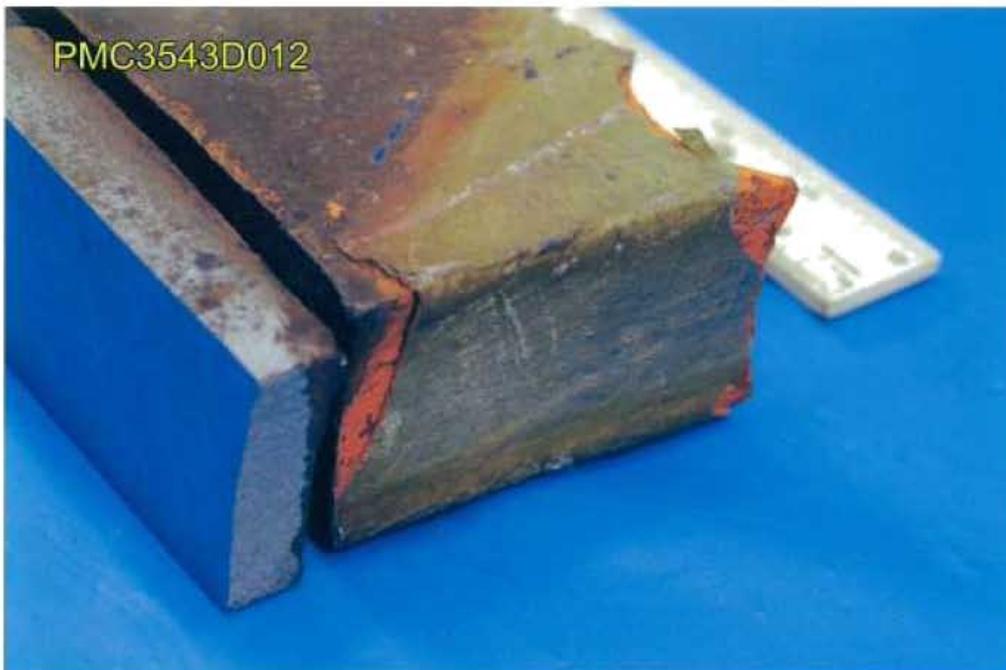
Fig. 32 Outer edge of fracture.

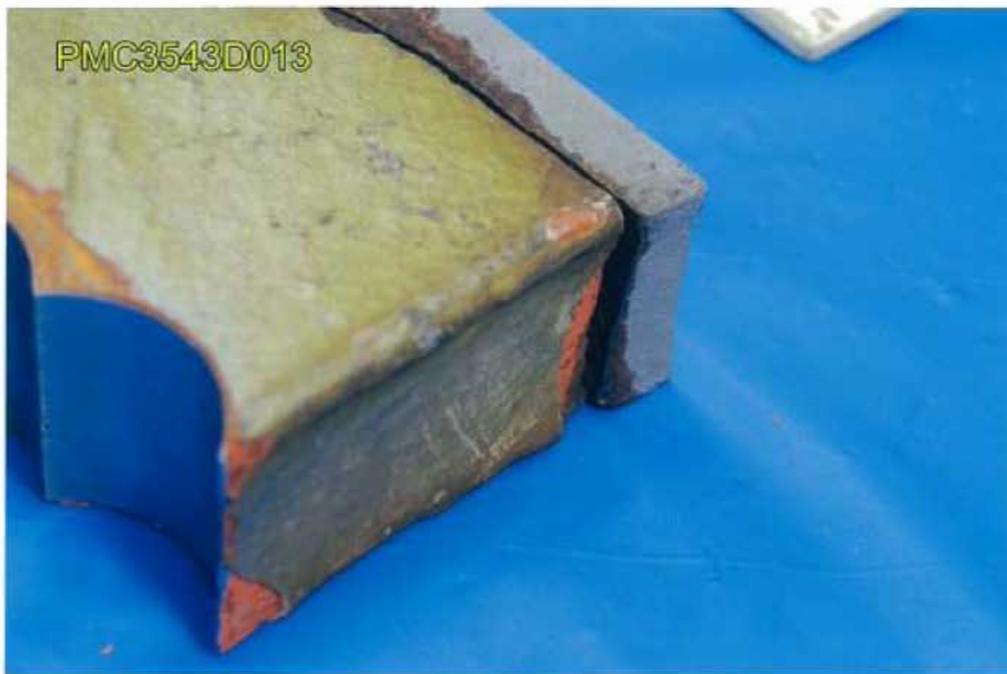
**Fig. 33 Outer edge of fracture. Opposite side.**

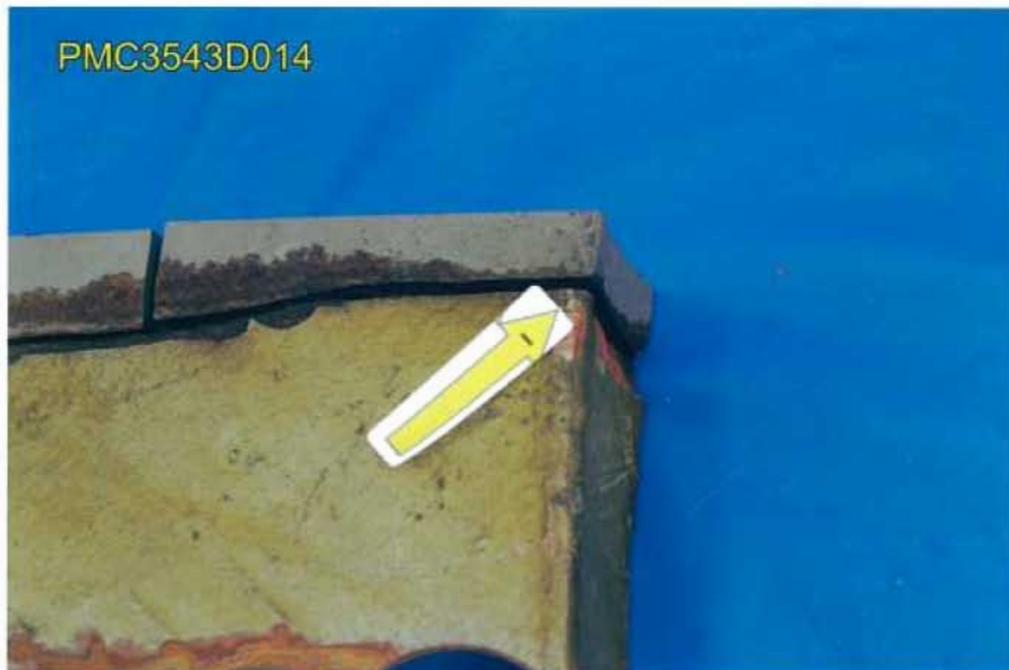
**Fig. 34 Outer edge of fracture. Arrow pointing to fracture origin.**

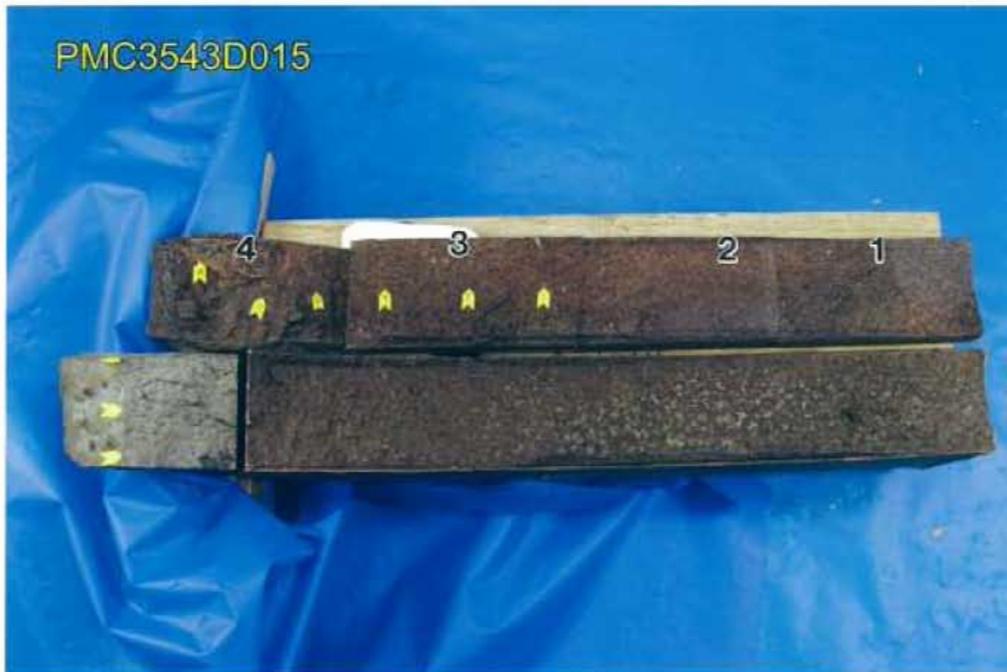
**Fig. 35 Mating fracture faces.**

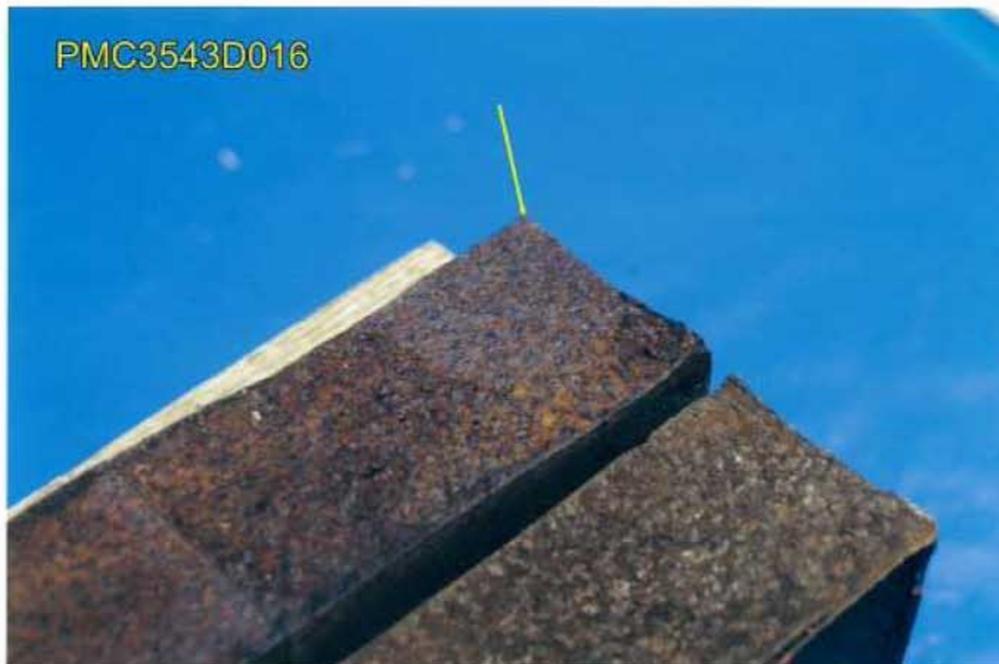
**Fig. 36 Fracture face outer edge. Fracture origin at arrow location.**

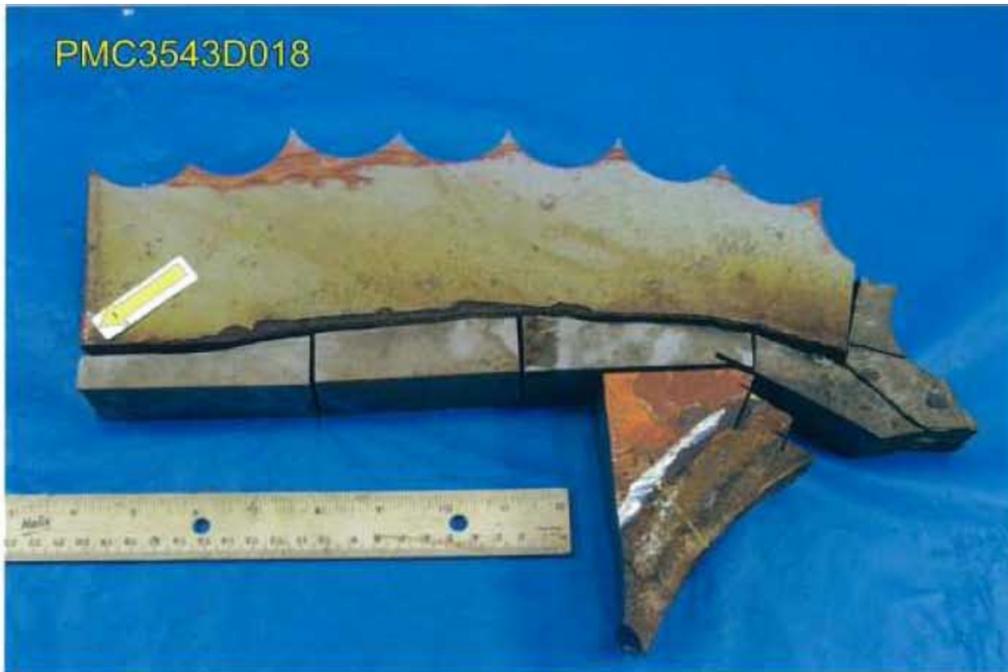
**Fig. 37 Upper and lower portion of fractured eye bar.**

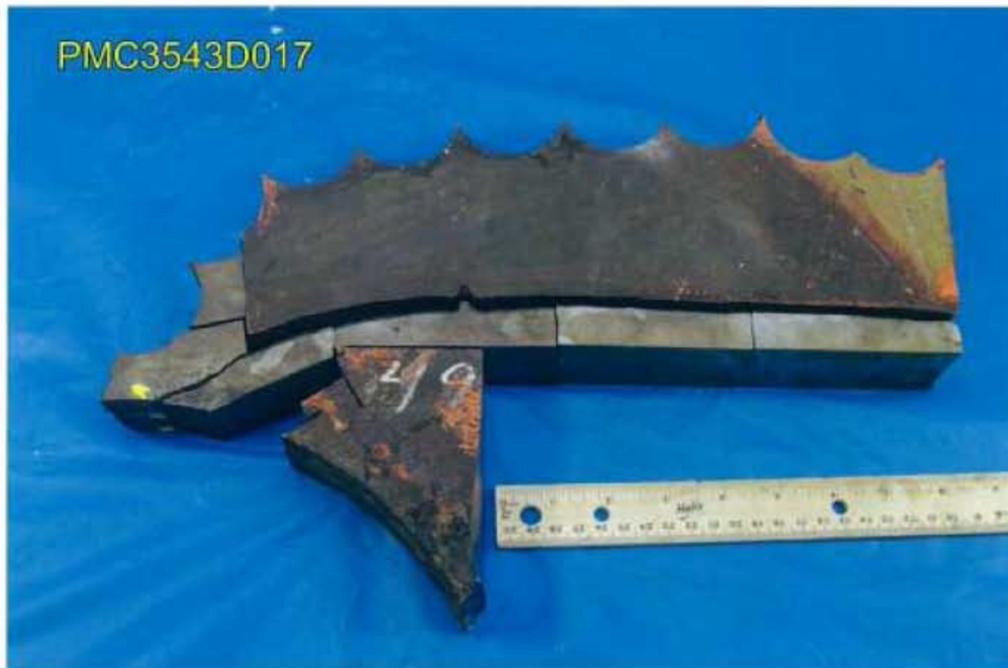
**Fig. 38 Upper and lower portion of fractured eye bar, opposite side.**

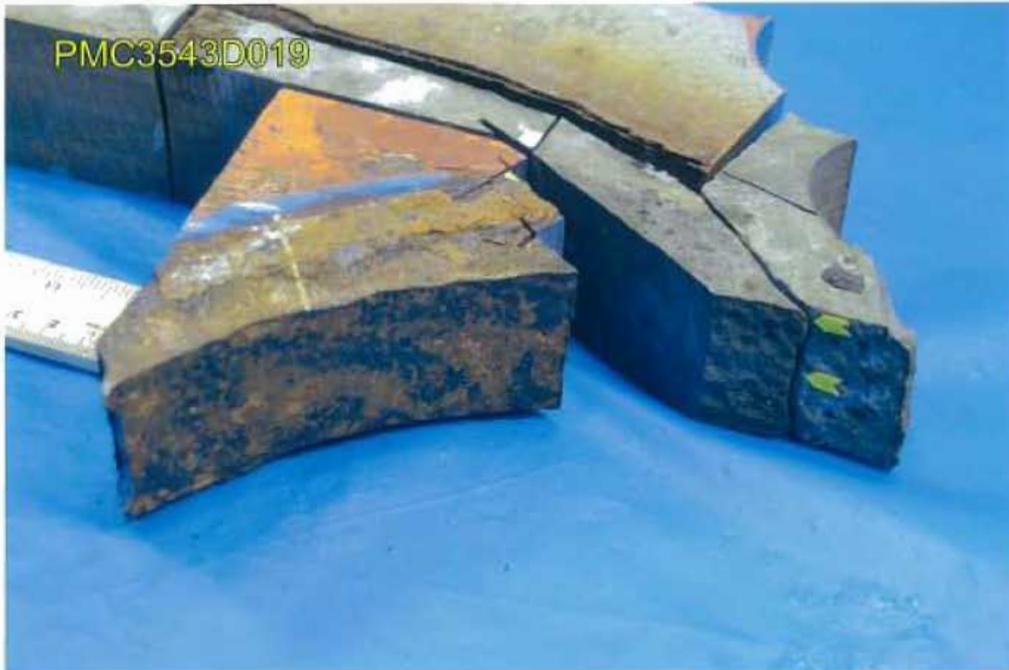
**Fig. 39 Inside diameter surface of eye bar pin location.**

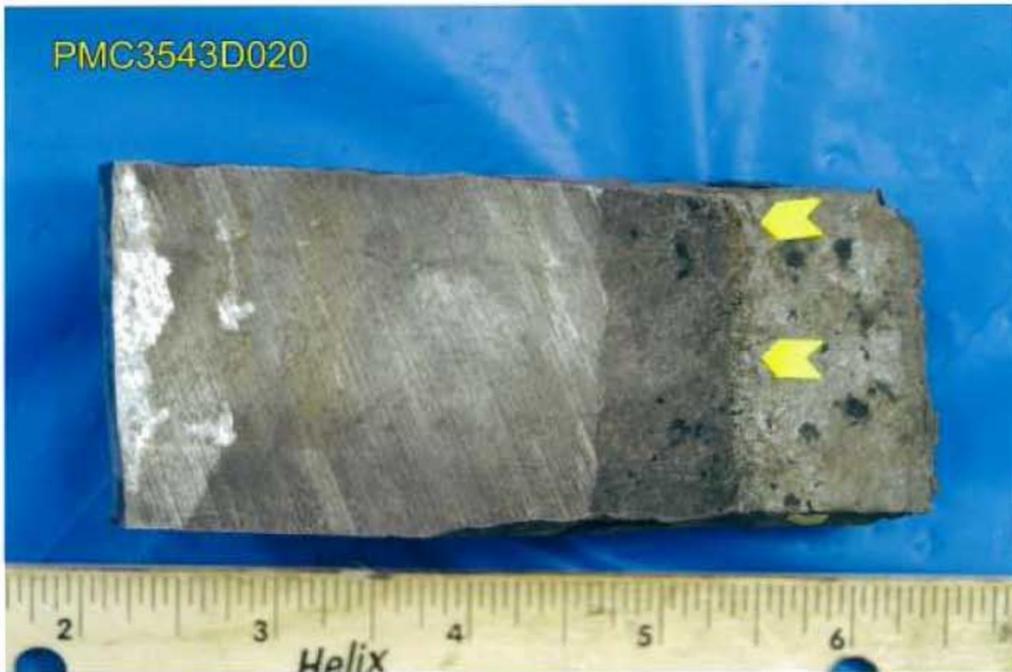
**Fig. 40 Inside portion of fracture face, adjacent to pin location, after cleaning of oxide layer.**

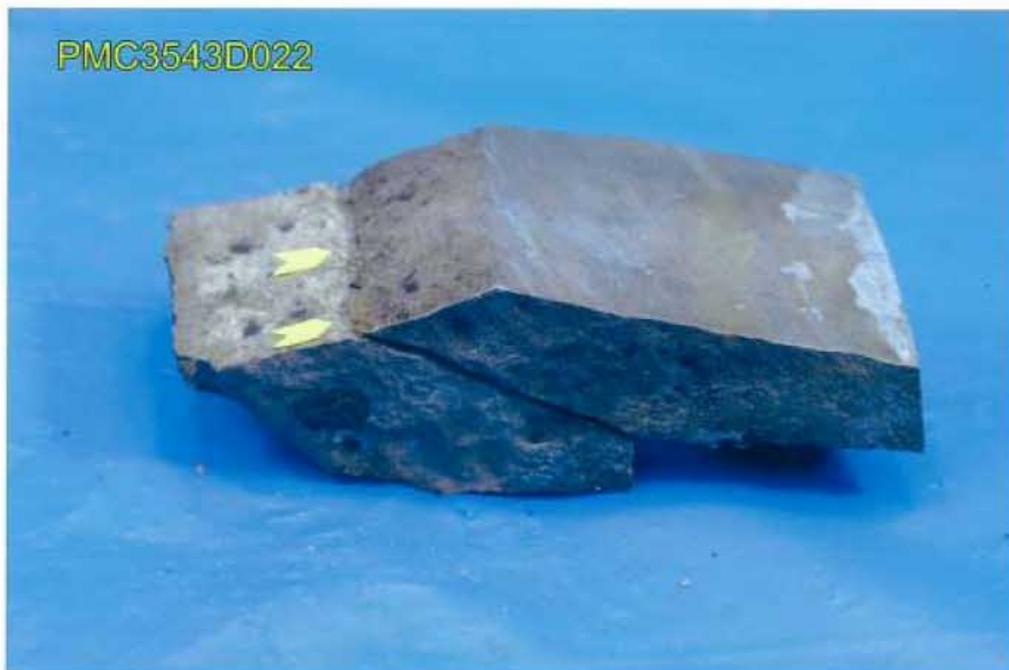
**Fig. 42** Inside diameter surface of eye bar pin location, after cleaning of oxide layer.

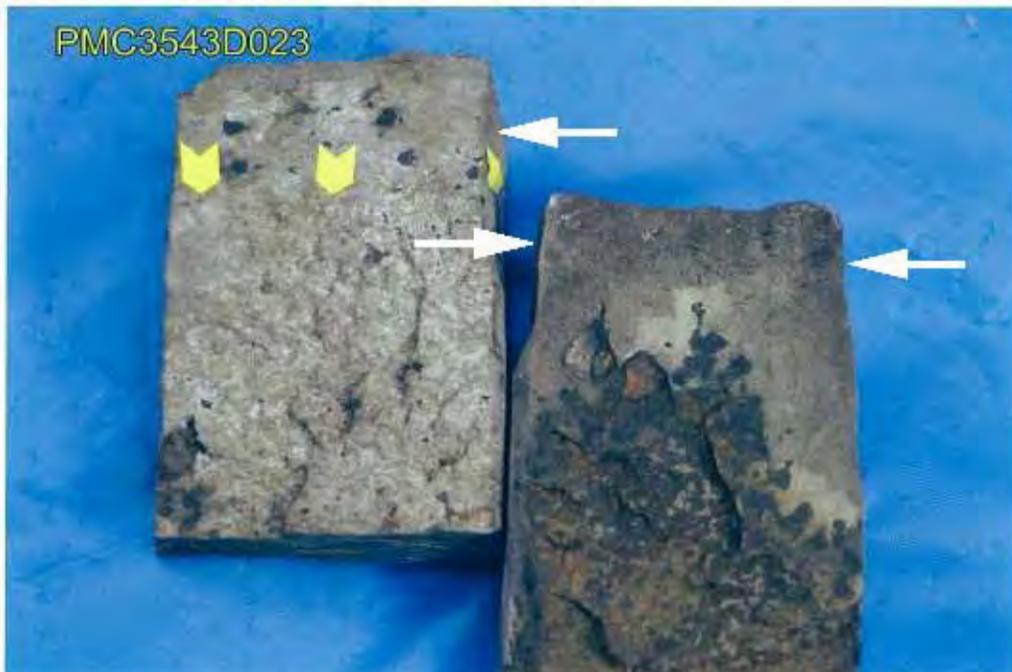
bar at a location just outboard from the pin location, after cleaning of a portion of the oxide layer. One can see in the pictures shown in Figs. 43 and 44 how the thickness of the eye bar was reduced at the pin location due to extensive preferential wear, abrasion, and corrosion between the sides of the eye bar where it interfaced with the sleeve. On the segment shown in Fig. 44 transverse and longitudinal microsections were prepared thru the heavy oxide chip on the plane of fracture and these examined for microstructure. Results of these analyses are covered in the microsection portion of the report.

**Fig. 43** Mating fracture faces of eye bar outboard from pin location, after cleaning of oxide layer.

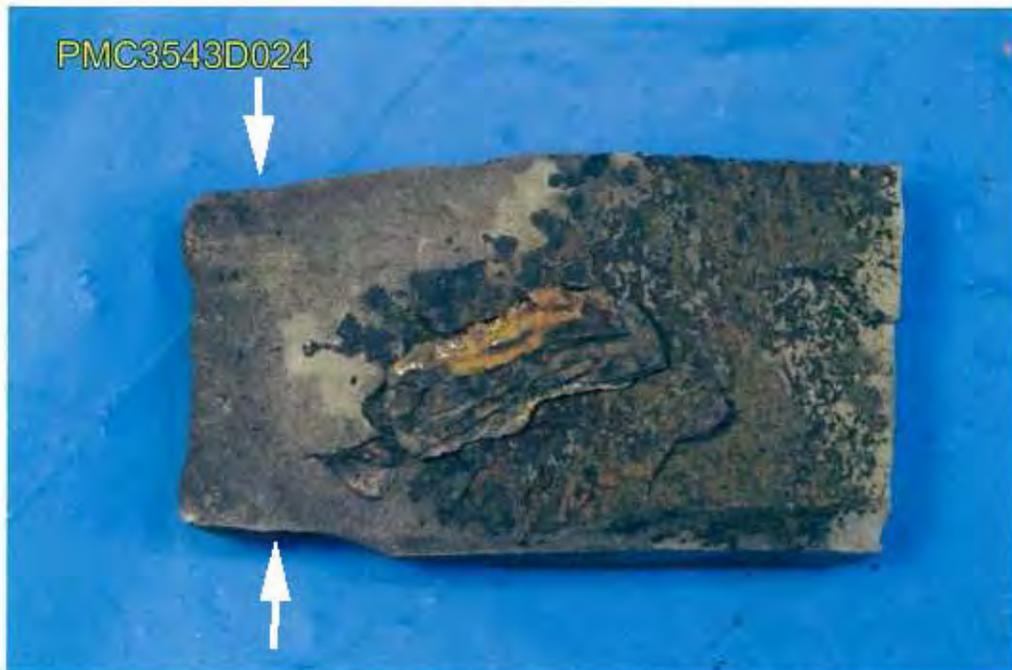
**Fig. 44** Fracture face of eye bar outboard from pin location, after cleaning of oxide layer.
