**Summary of SFOBB East Span Eye Bar Failure Analysis**

March 17, 2010

04-0G8404

SFOBB Emergency Eye Bar Repair

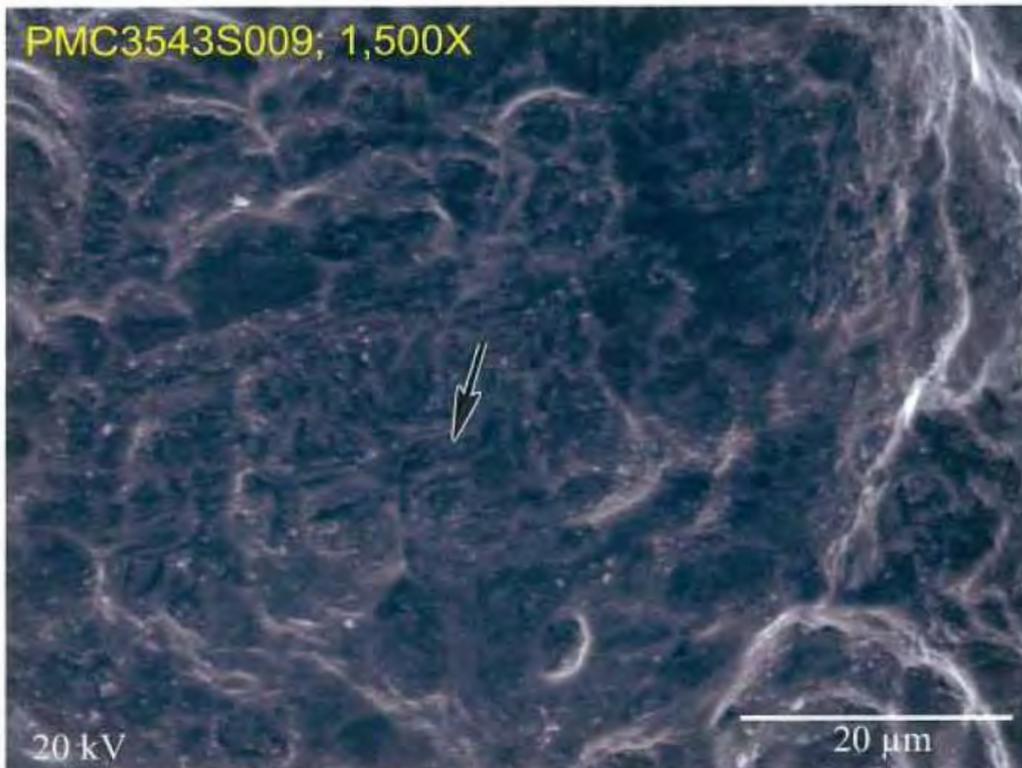
**Fig. 49 S.E.M photo of eye bar fracture surface at fracture origin, location 9 in fig. 45. 1,500X.**

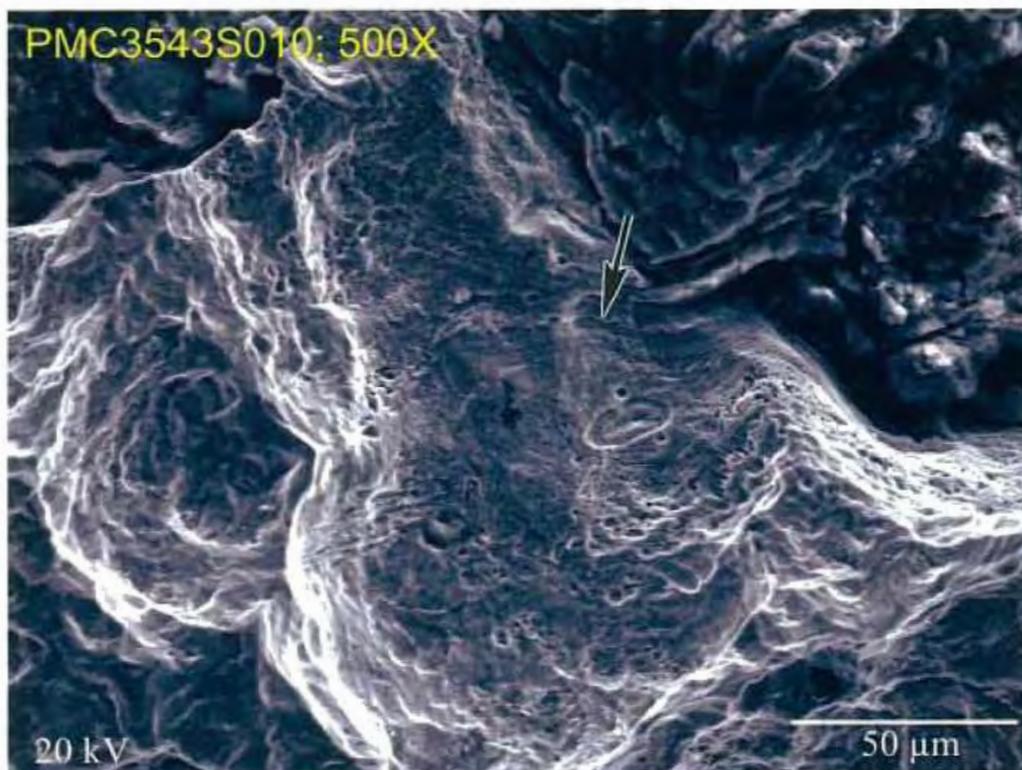
**Fig. 50 S.E.M photo of eye bar fracture surface at fracture origin, in fig. 45. 500X.**

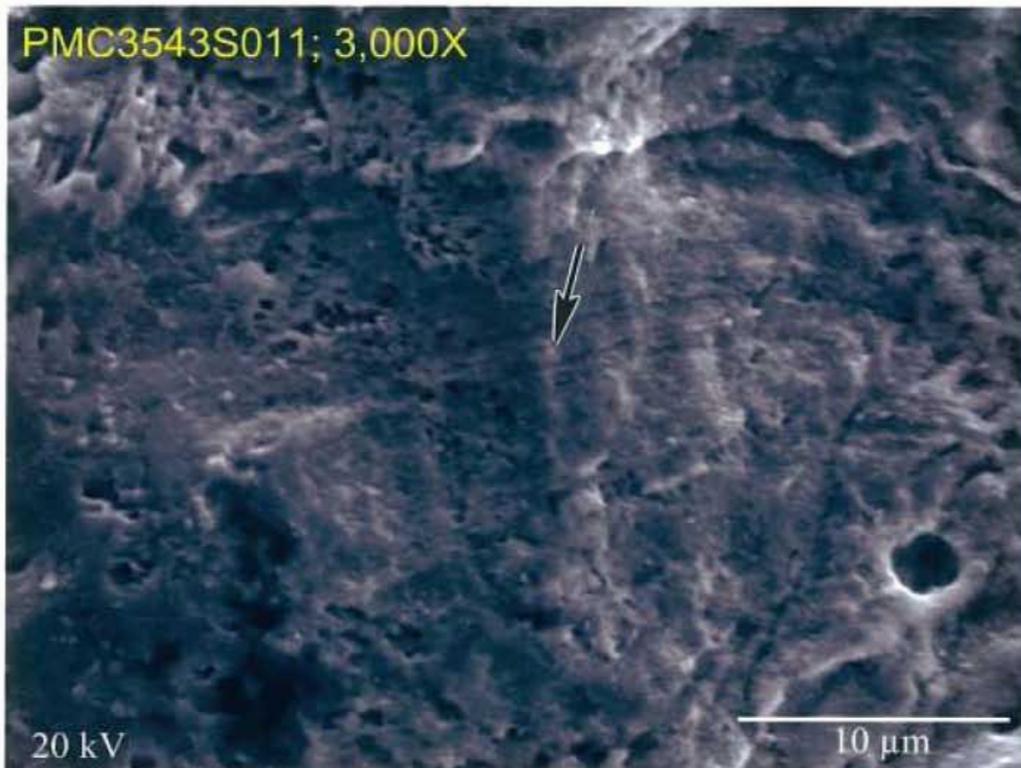
**Fig. 51 S.E.M photo of eye bar fracture surface at fracture origin, in fig. 50. 3,000X**

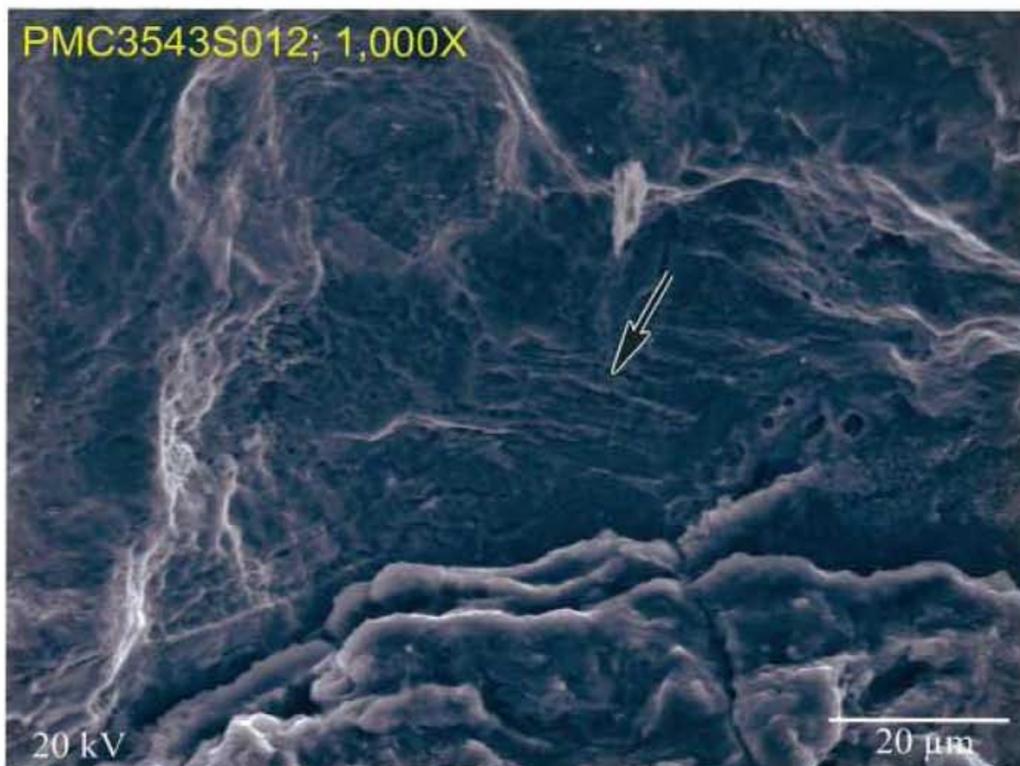
**Fig. 52 S.E.M photo of eye bar fracture surface at fracture origin, in fig. 45. 1000X.**

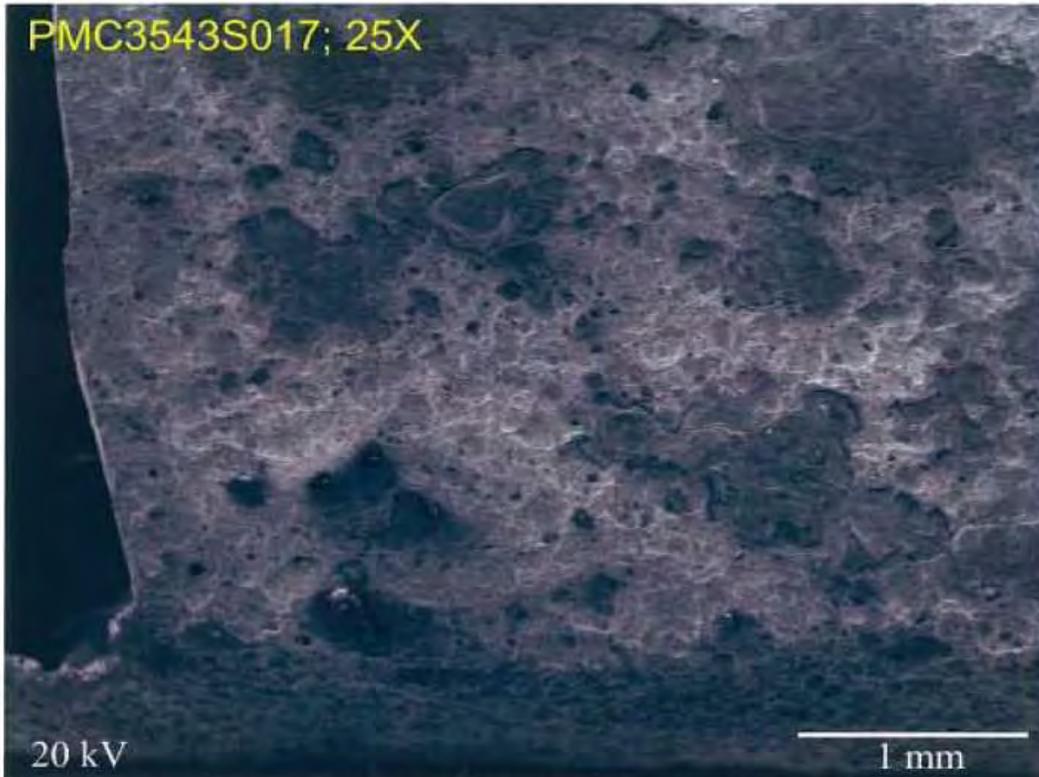
**Fig. 61 S.E.M photo of eye bar fracture surface, 2nd segment in fig. 35 at location 2, Shear lip. 25X.**

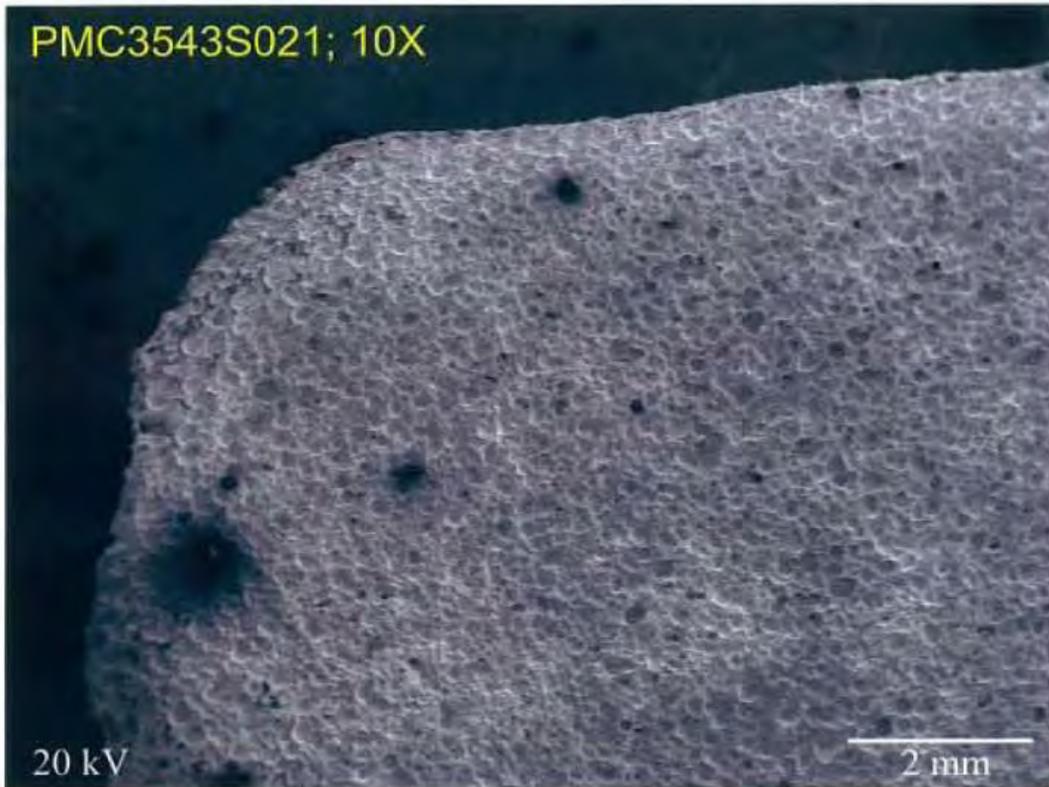
The fourth segment of the fracture face which is illustrated in Fig. 35 was also placed in the SEM. Figs. 65 and 66 illustrate the appearance of the fracture at the inside diameter edge of the eye bar close to the pin location where the fracture surface was relatively clean. This shows evidence of etch pitting and small traces of oxide on the plane of fracture. In the central portion of fracture segment No. 4 there were heavy oxide scale deposits which are illustrated in Figs. 67, 68, 69 and 70. In these photographs there was only slight evidence of dimple rupture and tensile overload. There was no evidence of fatigue, intergranular, fracture or cleavage.

**Fig. 65 S.E.M photo of eye bar fracture surface, 4th segment in fig. 35 at location 4, top edge, area 1. 10X.**

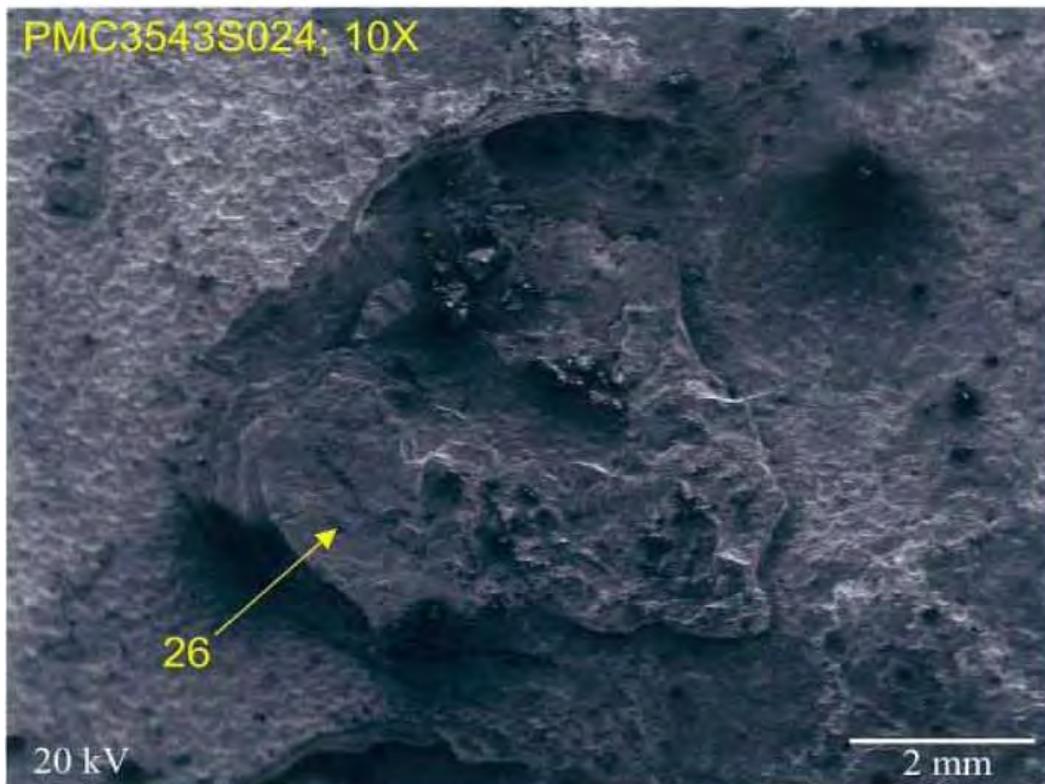
**Fig. 68 S.E.M photo of eye bar fracture surface, 4th segment in fig. 35 at location 4, transition, area 2. 100X.**

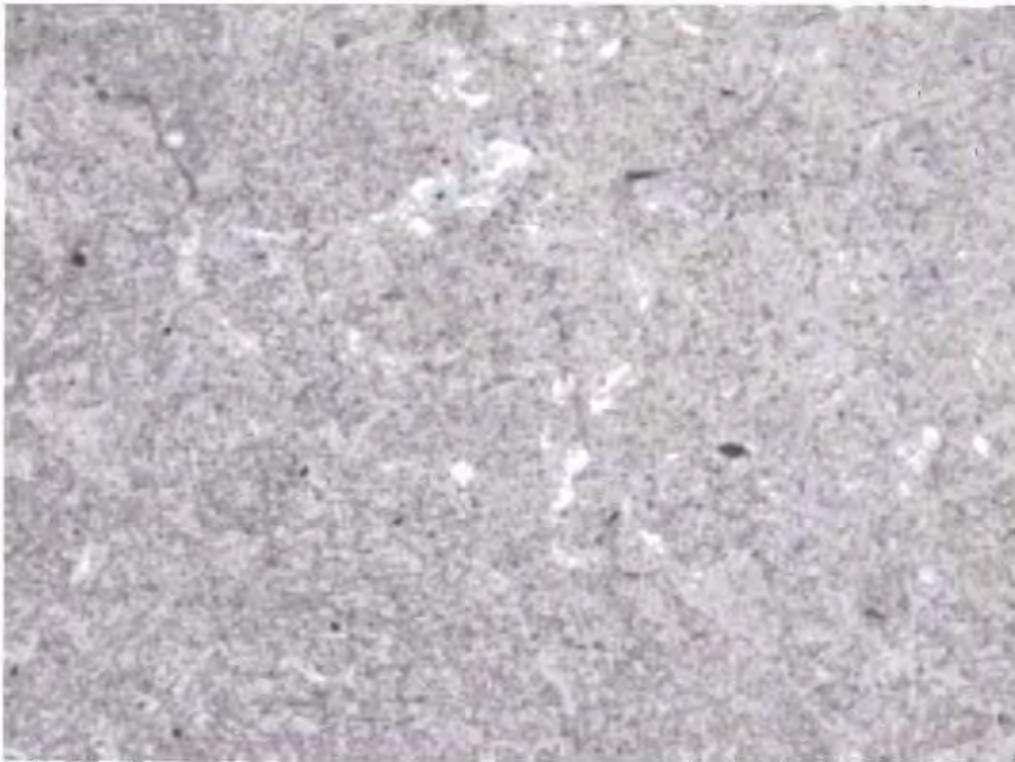
**Fig. 72 Microstructure near top corner sample #1 in fig. 71. 200X Etched.**

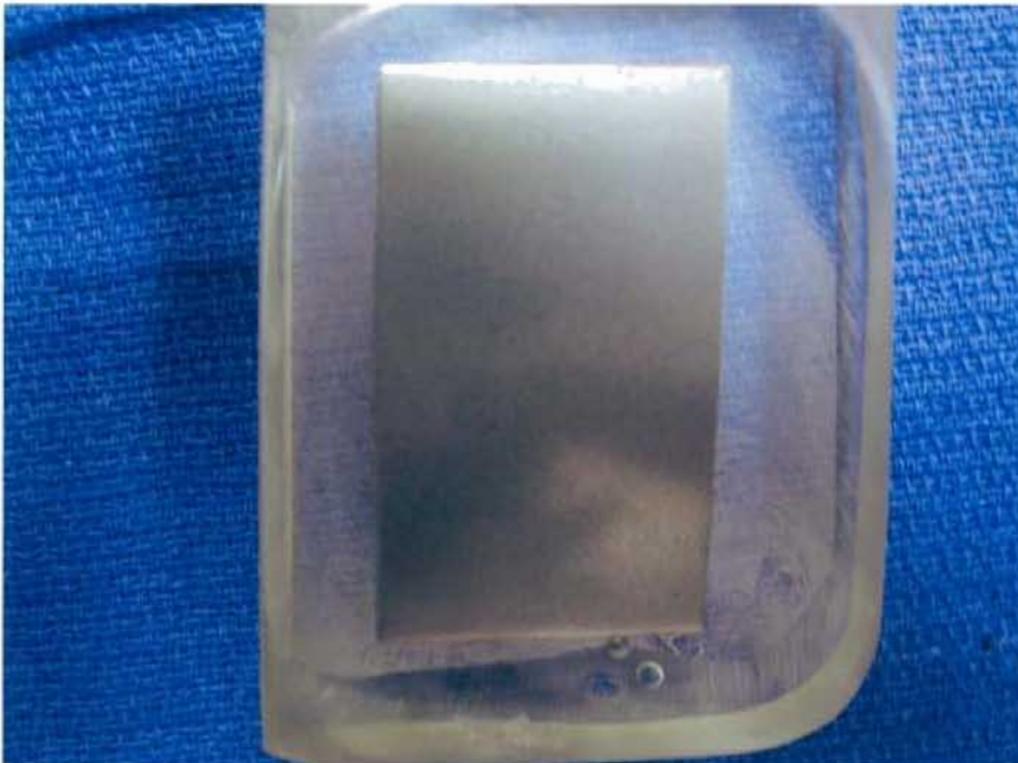
**Fig. 76 Microsection made below fracture surface at location 2 in fig. 20.**

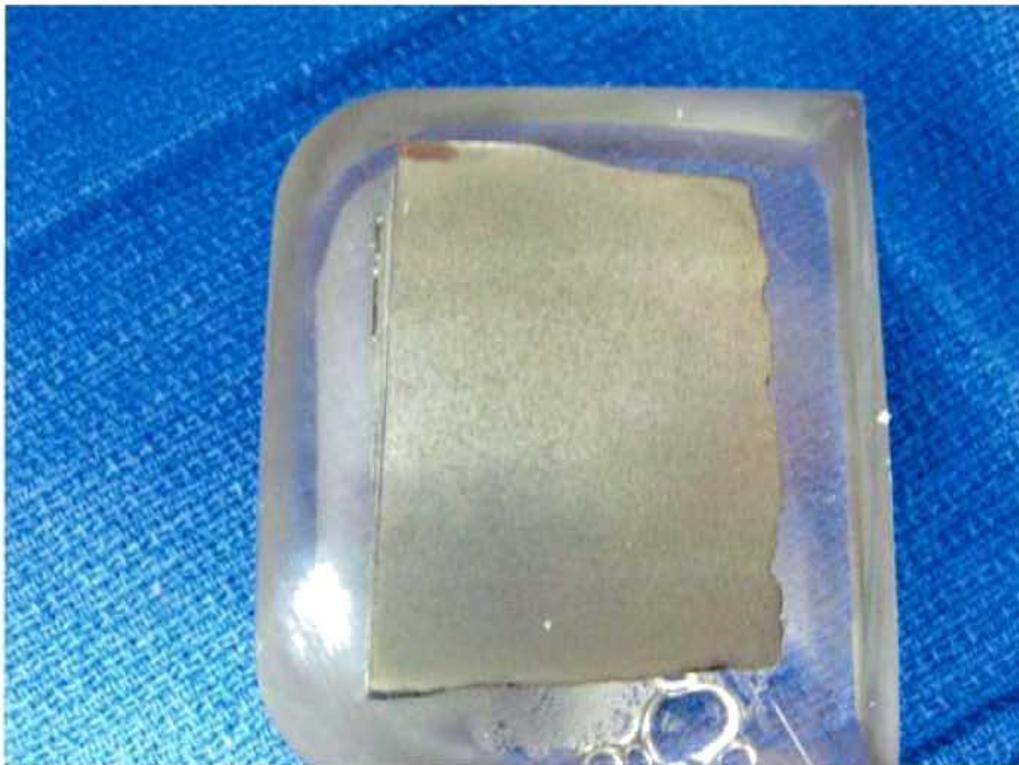
**Fig. 78 Microsection made below fracture surface at location 3 in fig. 20.**

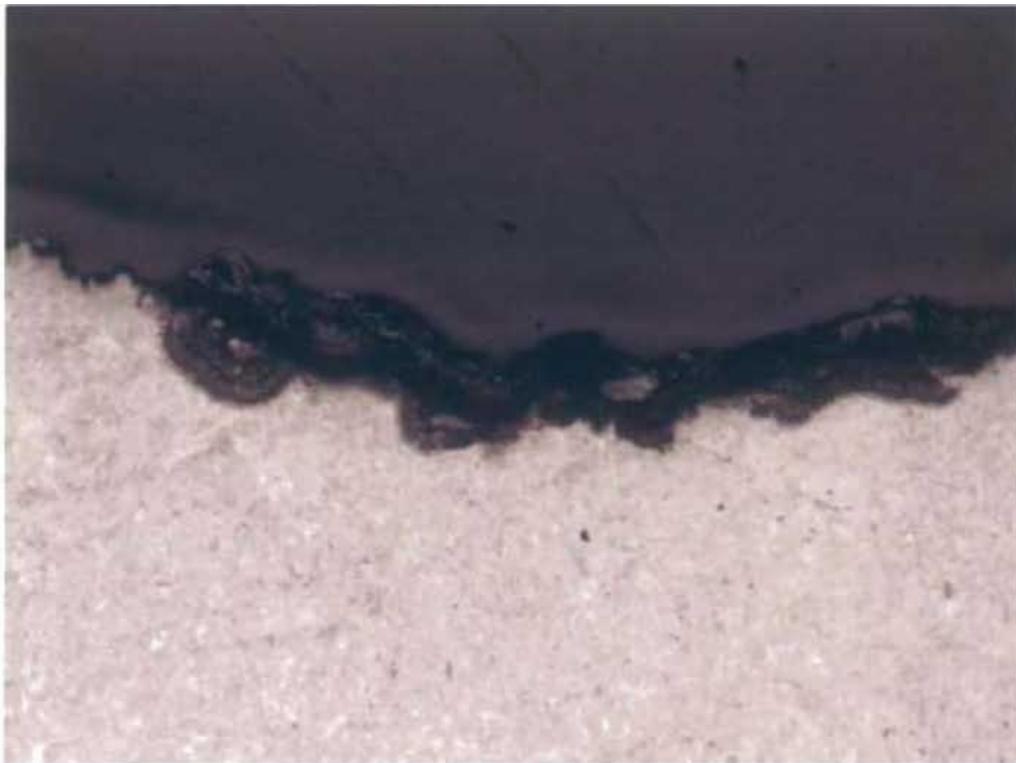
**Fig. 79 Top surface of sample # 3 in fig. 78. 50X Etched.**

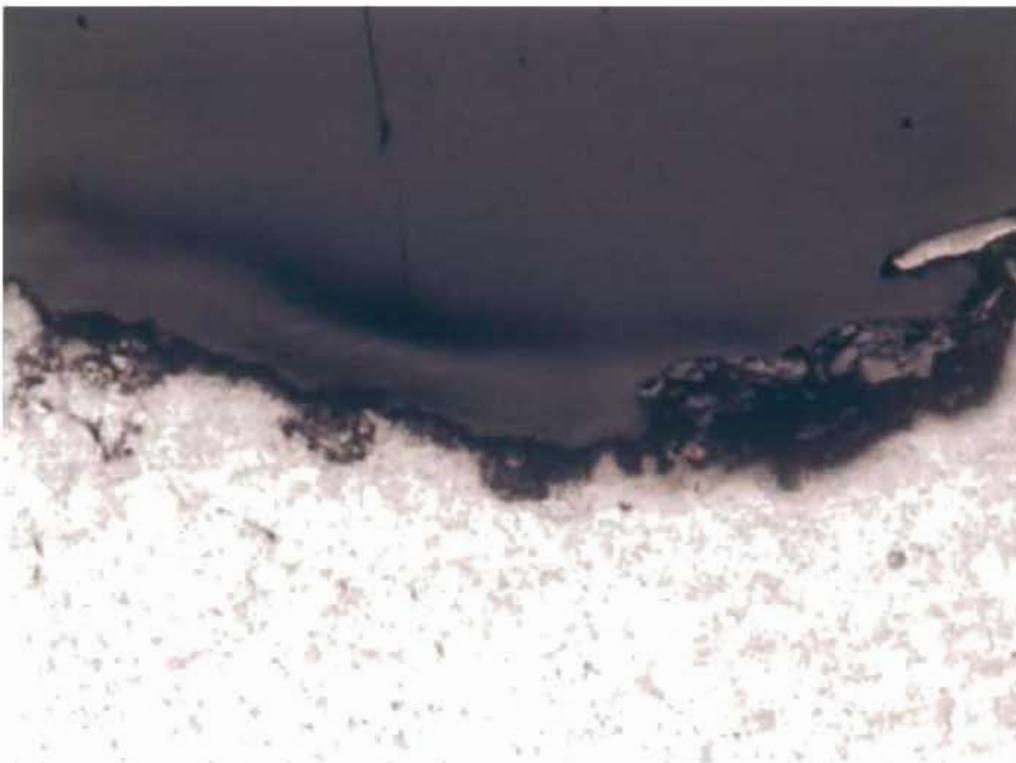
**Fig. 80 Top surface of sample # 3 in fig. 78. 50X. Etched.**

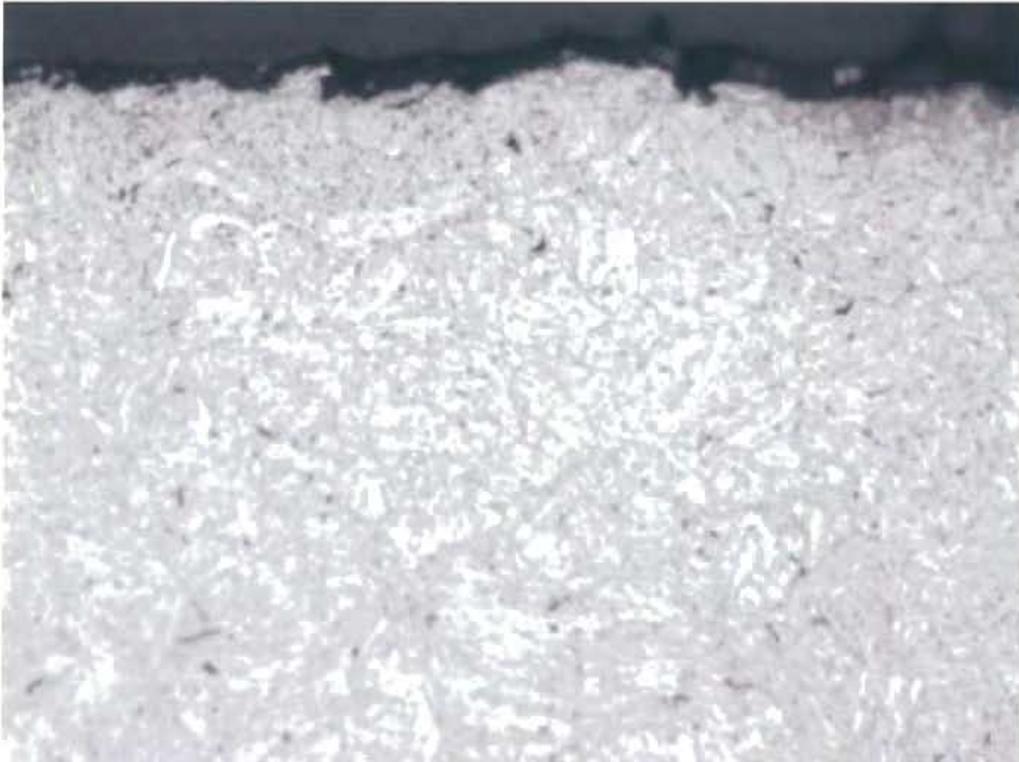
**Fig. 83 Microstructure near top surface of sample # 4, 200X. Etched.**

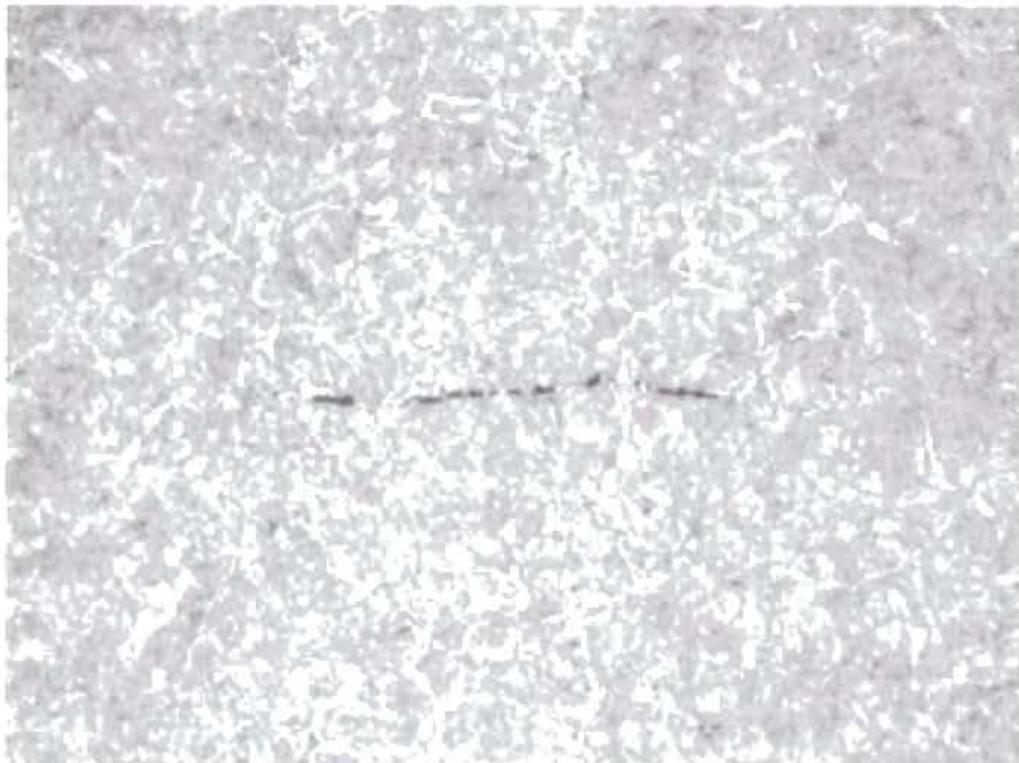
Fig. 84 illustrates the appearance of the longitudinal elongated inclusion in the core area that exhibits a different microstructure. Fig. 85 illustrates the microstructure at the location of the inclusion which shows martensitic grains surrounded by ferrite. Fig. 86 illustrates the microsection at location 5. Fig. 87 shows an elongated inclusion running perpendicular to the plane of fracture in this section.

**Fig. 84 Microstructure of sample # 4 showing elongated inclusion. 100X. Etched.**

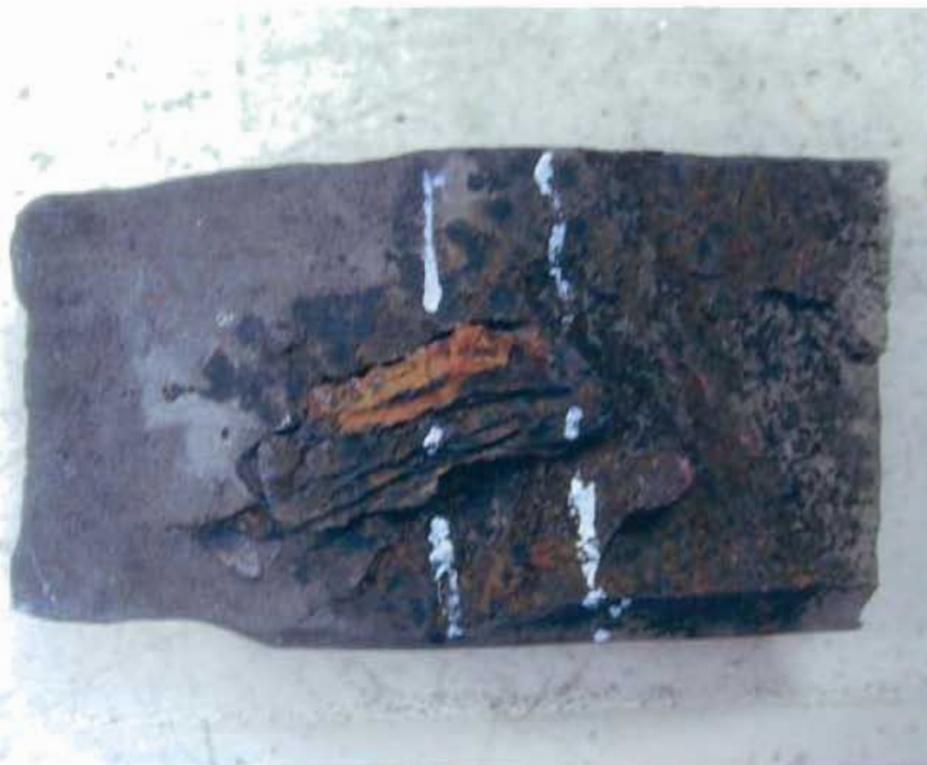
Fig. 88 illustrates the fracture face near the inboard side near the center pin location in the assembly. At this location there was heavy oxide scale on the plane of fracture which is illustrated in Fig. 88. A transverse microsection was prepared along the line showing on the specimen. Fig. 89 and 90 illustrate the nature of the large oxide scale at this location. Fig. 91 illustrates the cross section of the eye bar at this location and Figs. 92 and 93 illustrate the heavy oxide development on the plane of fracture at this location. Fig. 94 illustrates a cross section of the heavy oxide scale shown on the fracture face at this location. The microstructure under this oxide layer is illustrated in Figs. 95 and 96 which show that the microstructure consists of martensite grains surrounded by ferrite. There was no evidence of any decarburization layer associated with the plane of fracture or the location of the heavy oxide scale on the specimen. This indicates that the heavy oxidation was due to environmental corrosion after the fracture opened up and does not indicate that there was a longitudinal oriented heavy oxide scale in the eye bar at this location as manufactured.

**Fig. 88 Transverse cross-section made of eye bar near the center pin location.**

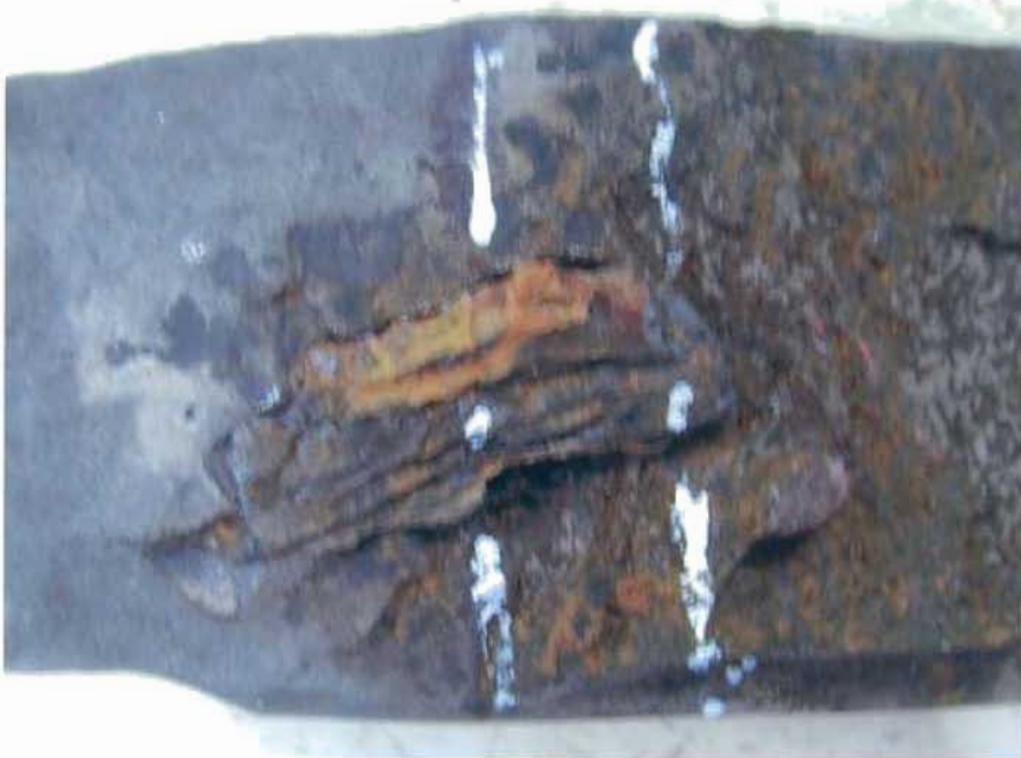
**Fig. 89** Transverse cross-section made of eye bar near the center pin location.

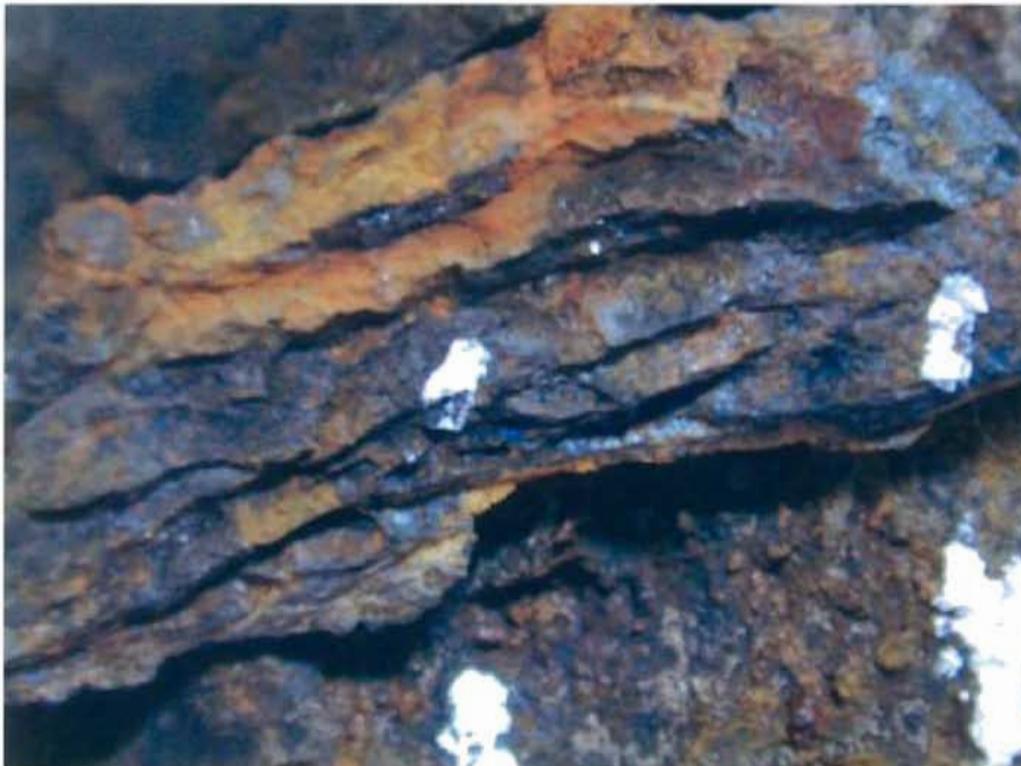
**Fig. 90** Scale on fracture surface of eye bar near the center pin location.

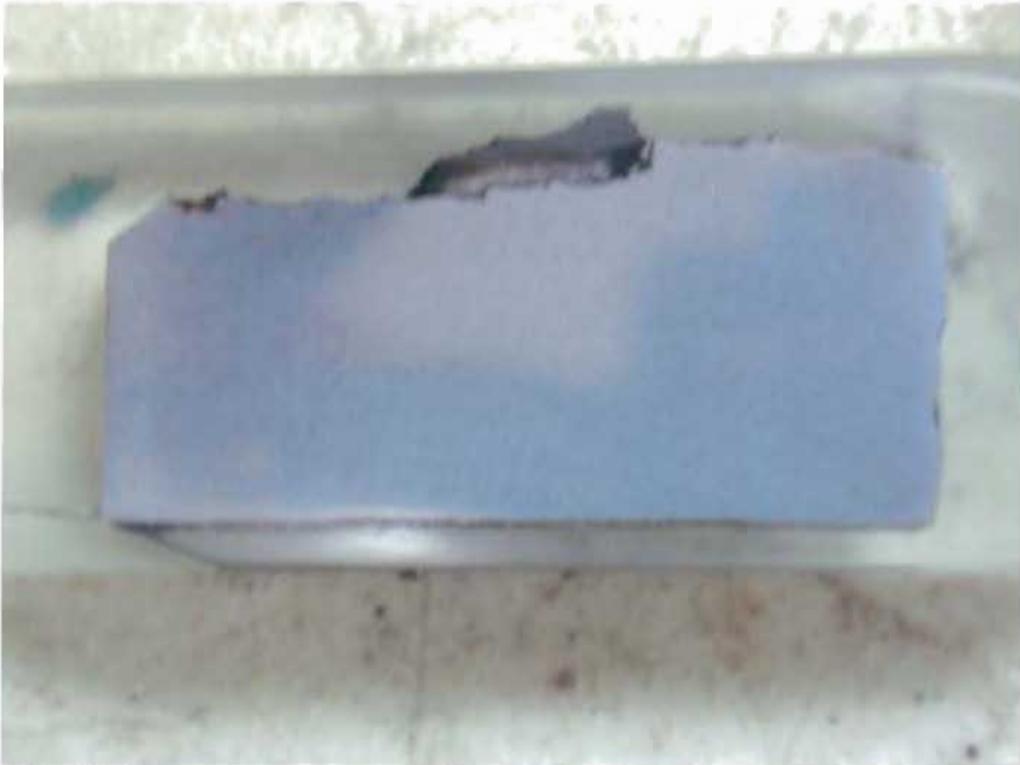
**Fig. 91** Transverse cross-section made of eye bar near the center pin location.

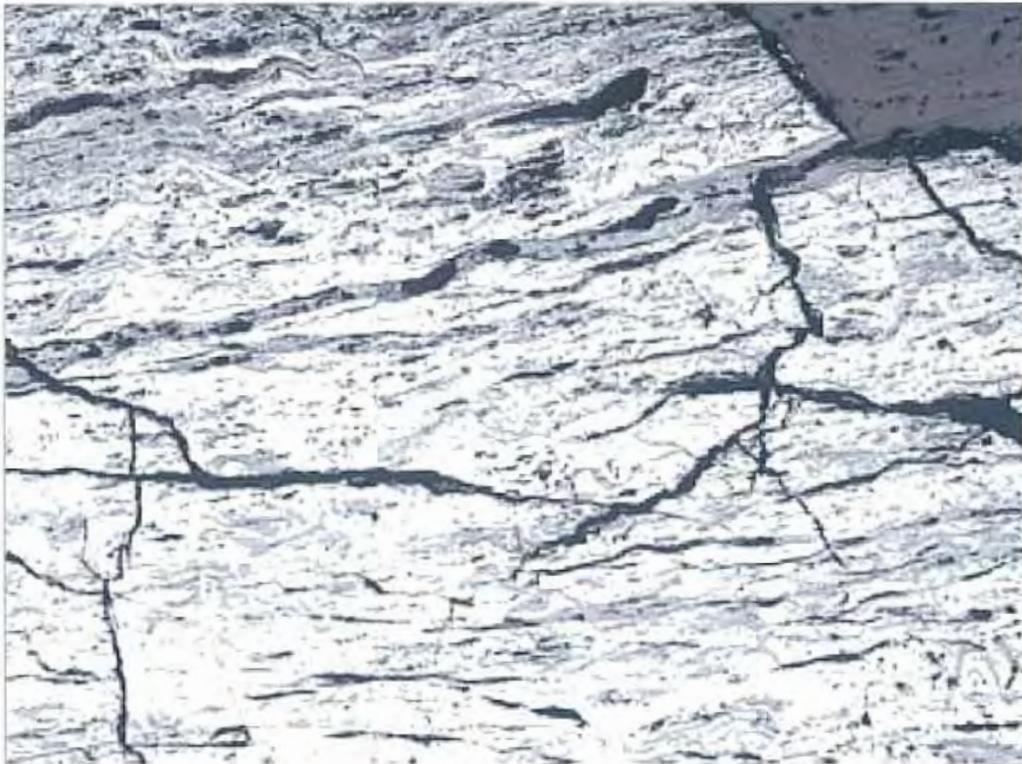
**Fig. 94** Transverse cross-section made of eye bar near the center pin location, showing scale. 100X.

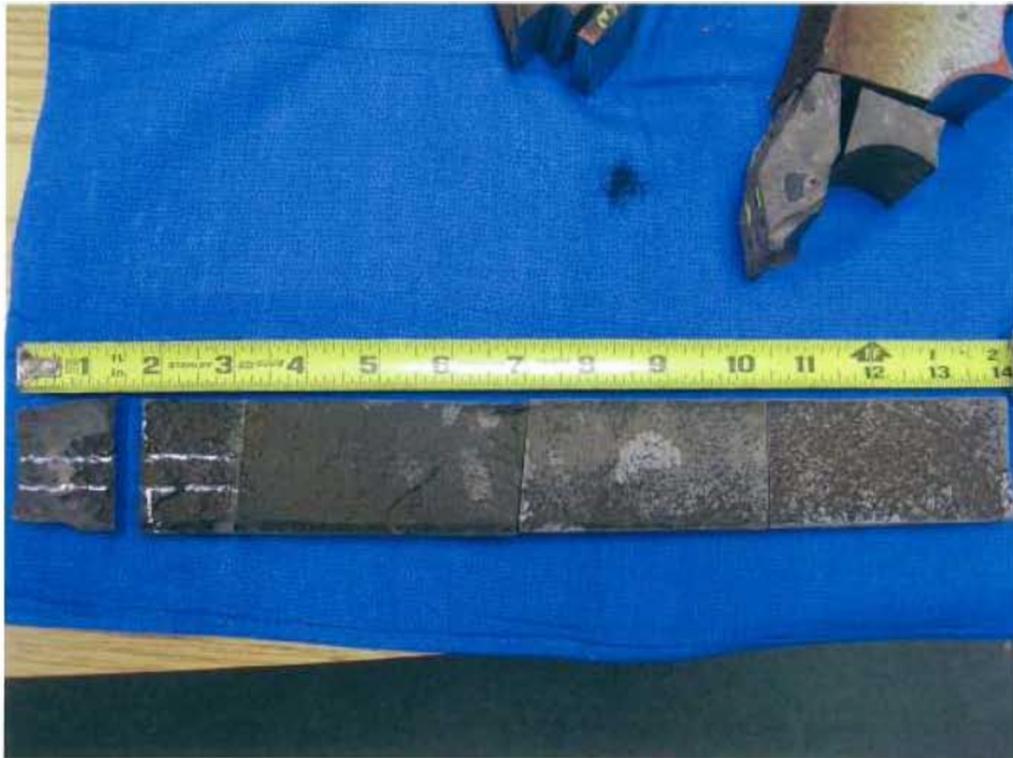
Fig. 97 illustrates another section that was taken in the plane of the fracture through the same oxide development and the sections removed are shown further in Fig. 98.

**Fig. 97** Location where longitudinal microsections were made of eye bar near the center pin location.

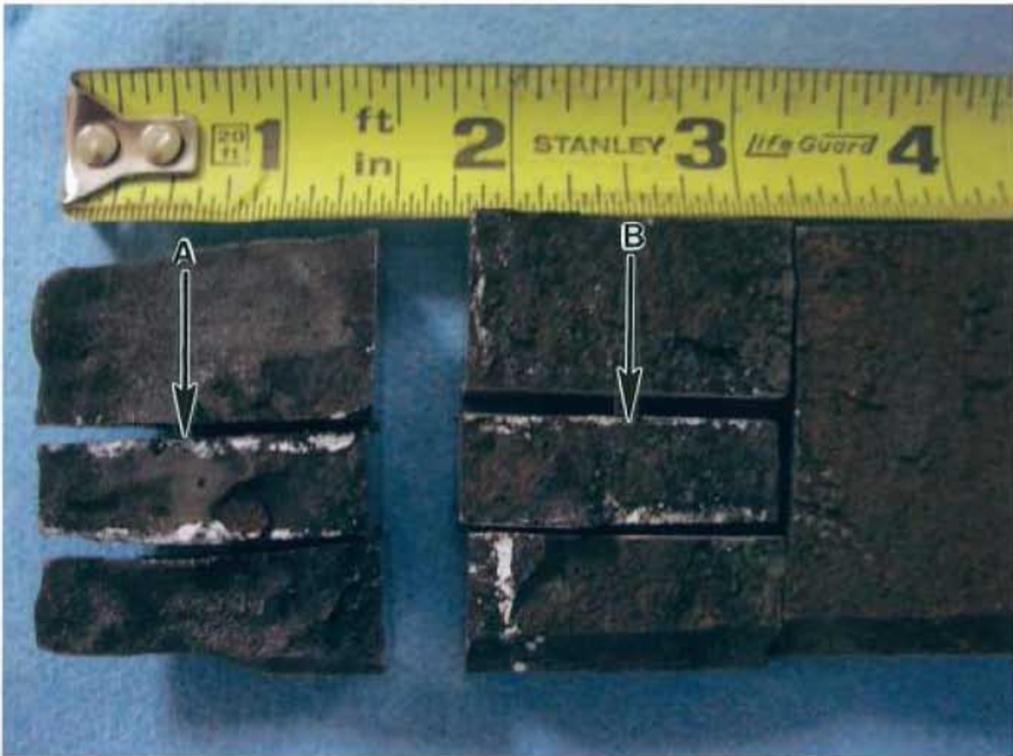
**Fig. 98** Location where longitudinal microsections were made of eye bar near the center pin location.

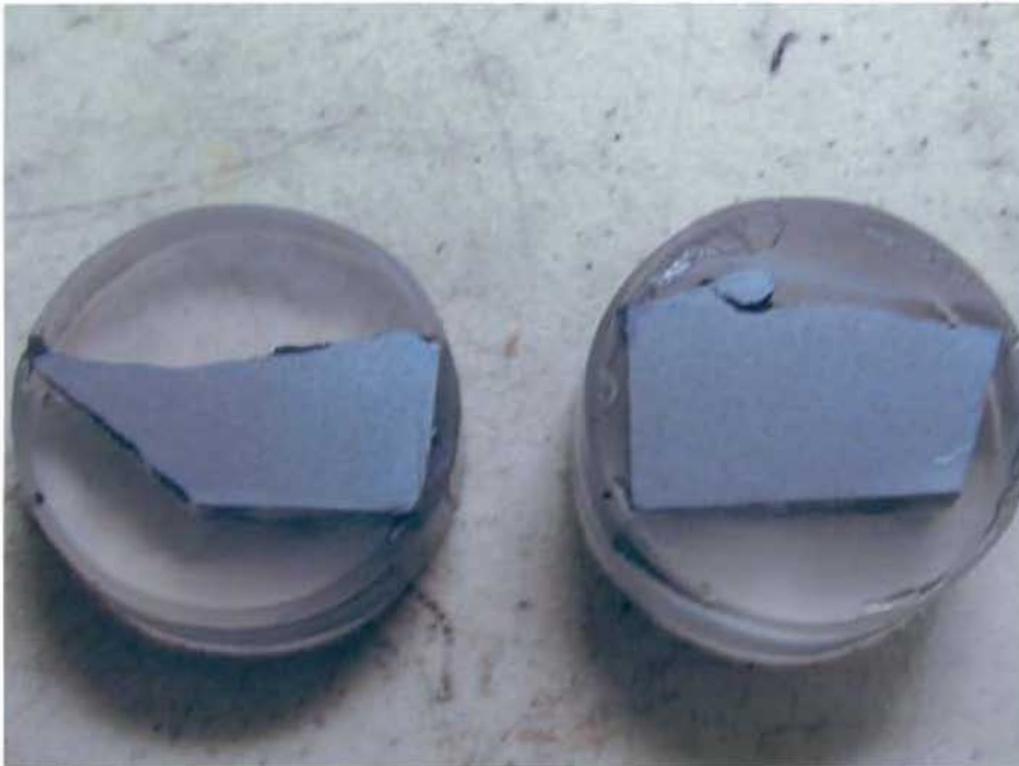
Figs. 99 and 100 illustrate the appearance of these microsections prepared in this direction. Fig. 101 illustrates the microsection along the plane of fracture and again shows no evidence of any decarburization layer or internal flaw below the oxide scale. Fig. 102 illustrates the etched microstructure which shows martensitic grains surrounded by ferrite. Figs. 103 and 104 show additional views of the microstructure which is consistent with the rest of the cross section. Fig. 105 illustrates the cross section taken at location B shown in Fig. 98 which again shows the plane of fracture and the oxidized fracture surface at the top portion.

**Fig. 99** Longitudinal microsections of eye bar near the center pin location, in fig. 98.

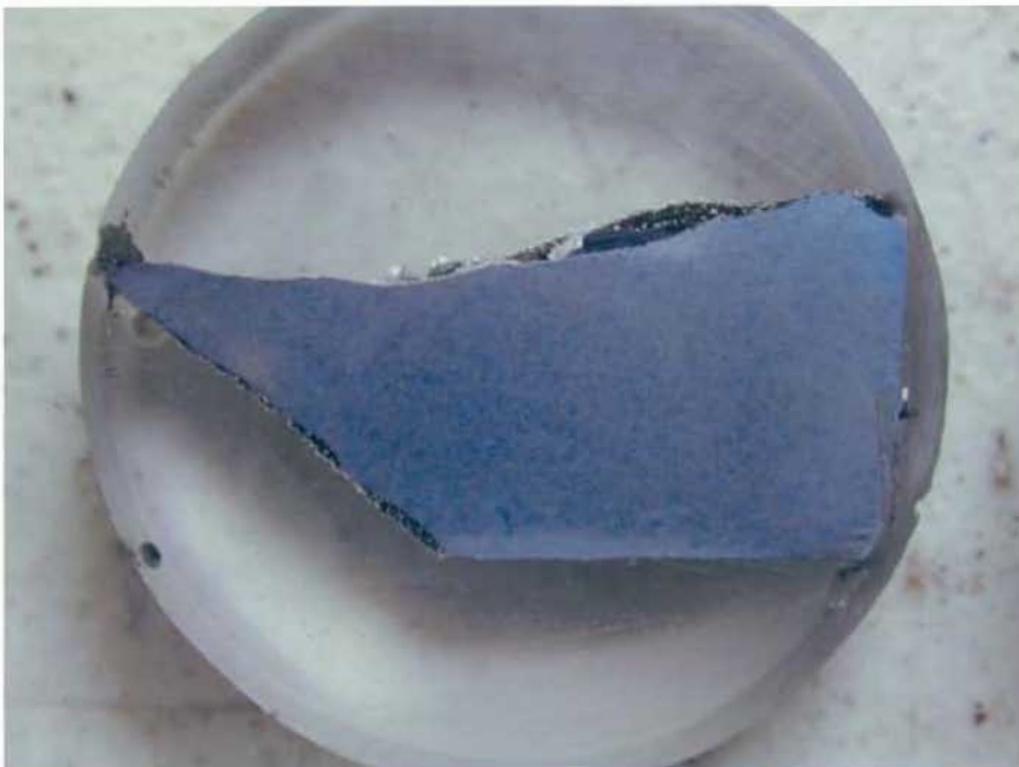
**Fig. 100** Longitudinal microsection of eye bar near the center pin location, in fig. 98, location A.

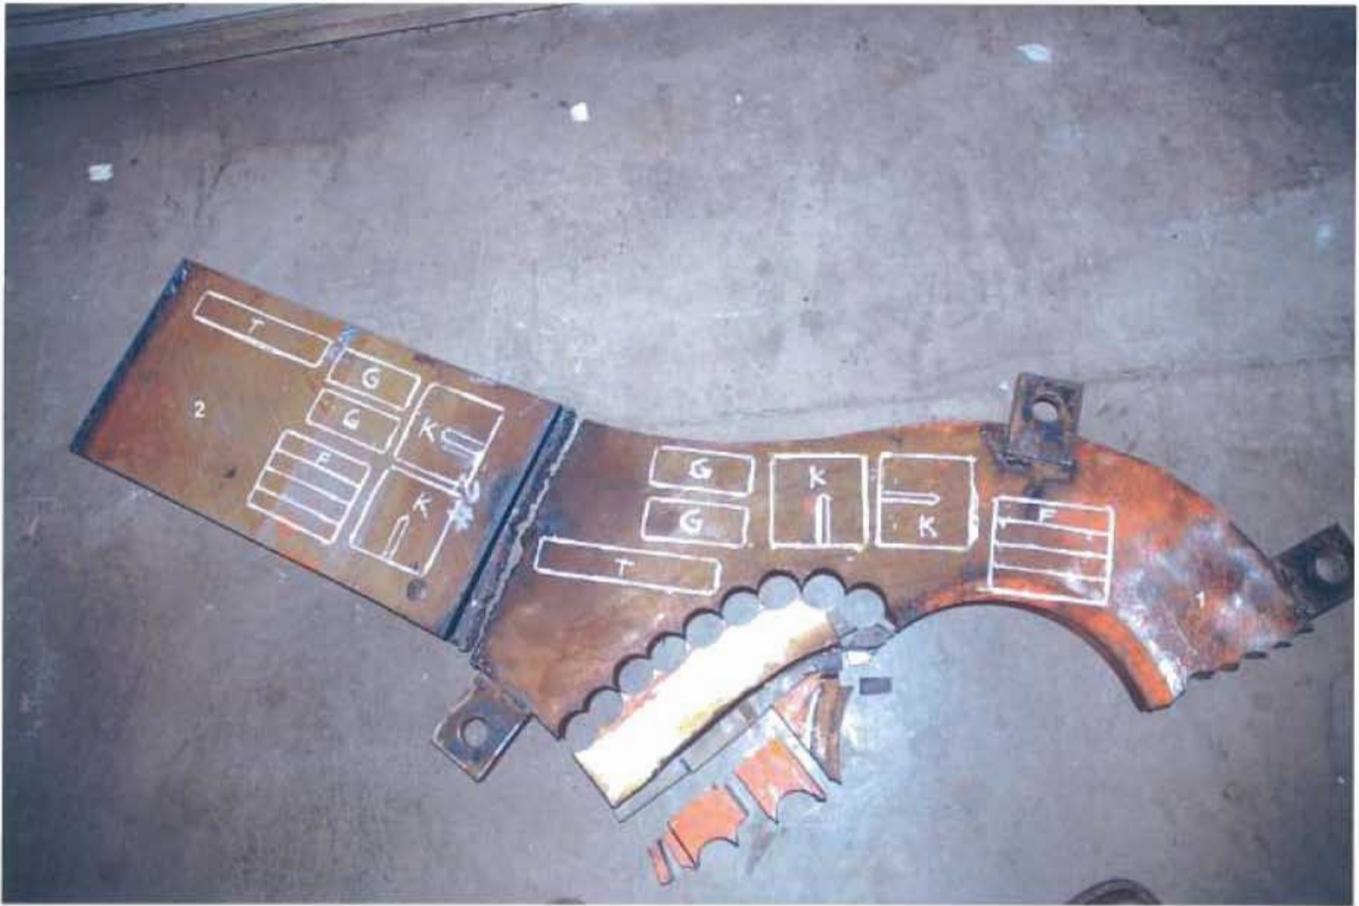
After this initial analyses was conducted larger portions of the eye bar were submitted to the laboratory for additional mechanical testing. Fig. 106 in the report shows the additional segments that were submitted to the laboratory and illustrate the lay out of additional mechanical tests that are to be conducted. These tests include additional tensile specimens which were identified as T in segments 1 and 2 of the bar and fracture toughness specimens taking in two different directions out of segments 1 and 2. In addition, there are specimens to be removed identified as "G" which are for dynamic modulus testing. These specimens are to be machined into ASTM E 1876 specimen configuration. Two additional blocks are to be cut out for possible fatigue testing. These were identified as "F" on the surface of the segments 1 and 2. At this time the fatigue testing coupons will be set aside for possible testing if required. At this point in time no additional testing of the eye bar is being contemplated.

**Fig. 106 Test plan for mechanical properties from eye bar segments 1 and 2**

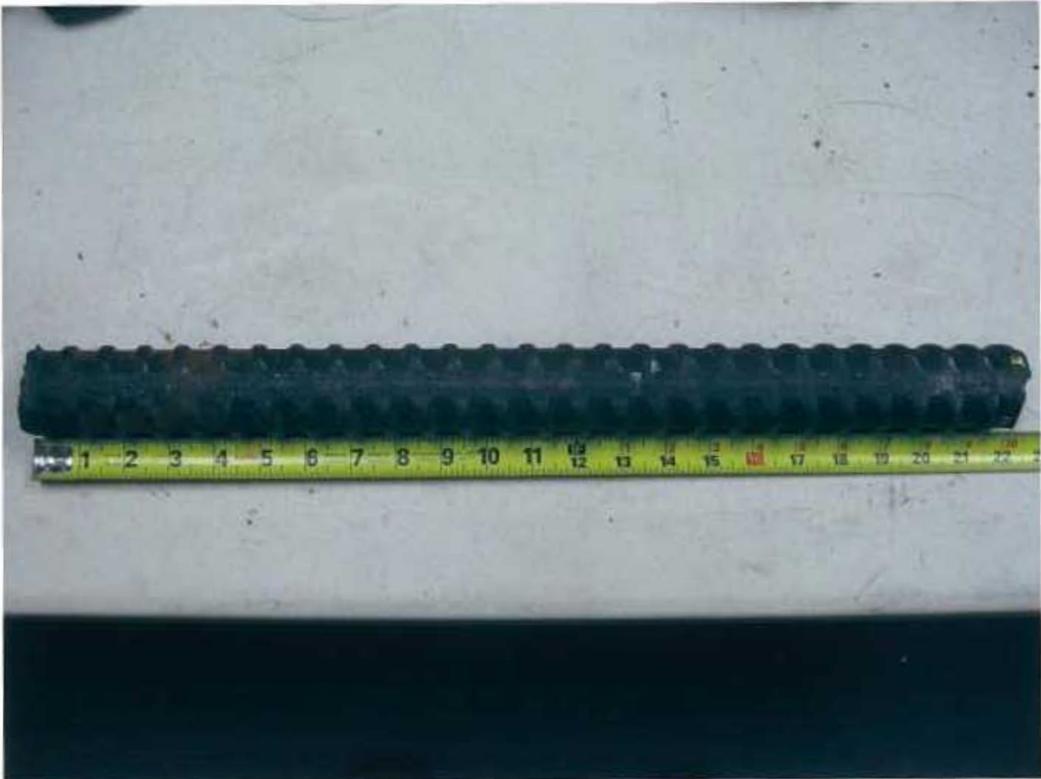
Fig. 1 illustrates the bar support that was submitted for analyses. Fig. 2 illustrates the end of the bar with the fracture face illustrated at the right side as shown in the photograph. The fracture origin was identified as the 12 O'clock position. Fig. 3 illustrates the appearance of the side of the bar at the 12 O'clock position. Figs. 4, 5, and 6 illustrates the markings on the bar along its length. Fig. 7 illustrates the appearance of the bar at the 3 O'clock position and Fig. 8 illustrates the bar at the 6 O'clock position. The markings on the left side of the protrusions or the ribs on the outside of the bar suggest that the marks made are from interaction with the fastening nut on the assembly. Fig. 9 illustrates the appearance of the bar at the 9 O'clock position. Fig. 10 illustrates the appearance of the fracture face and Figs. 11 and 12 show additional views of the fracture face. The fracture at the origin shows the appearance of the thumbnail shape of the fracture which is indicative of a fatigue failure. This fracture face was later examined in the Scanning Electron microscope. Fig. 14 illustrates the location of two transverse cuts that were made in the bar. The cut to the right was made to remove the fracture face portion and the second cut was made to remove a longitudinal oriented microsection thru the entire bar. These sections are further shown in Fig. 15. Figs. 16, 17 and 18 show additional views of the fracture origin and the appearance of oxidation and discoloration over the depth of the fatigue crack. The fatigue crack depth at this location measured .404" inboard on plane

Fig. 1 As received failed support rod from east span.
