**Summary of SFOBB East Span Eye Bar Failure Analysis**

March 17, 2010

04-0G8404

SFOBB Emergency Eye Bar Repair

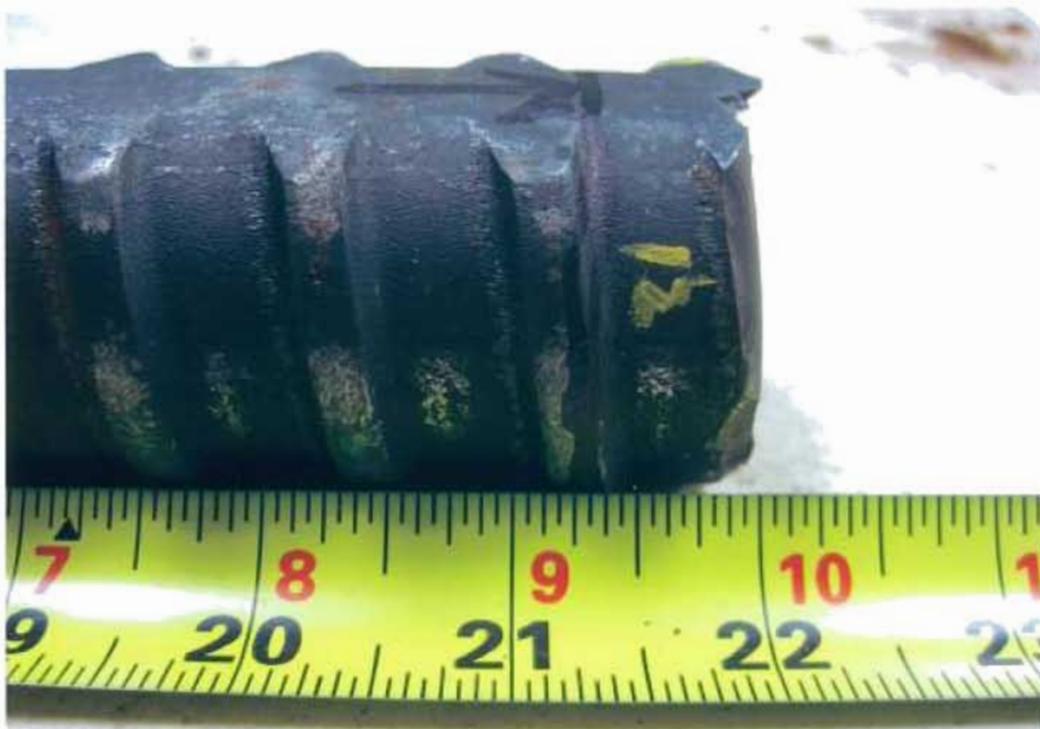
Fig. 1 illustrates the bar support that was submitted for analyses. Fig. 2 illustrates the end of the bar with the fracture face illustrated at the right side as shown in the photograph. The fracture origin was identified as the 12 O'clock position. Fig. 3 illustrates the appearance of the side of the bar at the 12 O'clock position. Figs. 4, 5, and 6 illustrates the markings on the bar along its length. Fig. 7 illustrates the appearance of the bar at the 3 O'clock position and Fig. 8 illustrates the bar at the 6 O'clock position. The markings on the left side of the protrusions or the ribs on the outside of the bar suggest that the marks made are from interaction with the fastening nut on the assembly. Fig. 9 illustrates the appearance of the bar at the 9 O'clock position. Fig. 10 illustrates the appearance of the fracture face and Figs. 11 and 12 show additional views of the fracture face. The fracture at the origin shows the appearance of the thumbnail shape of the fracture which is indicative of a fatigue failure. This fracture face was later examined in the Scanning Electron microscope. Fig. 14 illustrates the location of two transverse cuts that were made in the bar. The cut to the right was made to remove the fracture face portion and the second cut was made to remove a longitudinal oriented microsection thru the entire bar. These sections are further shown in Fig. 15. Figs. 16, 17 and 18 show additional views of the fracture origin and the appearance of oxidation and discoloration over the depth of the fatigue crack. The fatigue crack depth at this location measured .404" inboard on plane

Fig. 3 As received failed support rod from east span. 12 O'clock position, fracture origin.

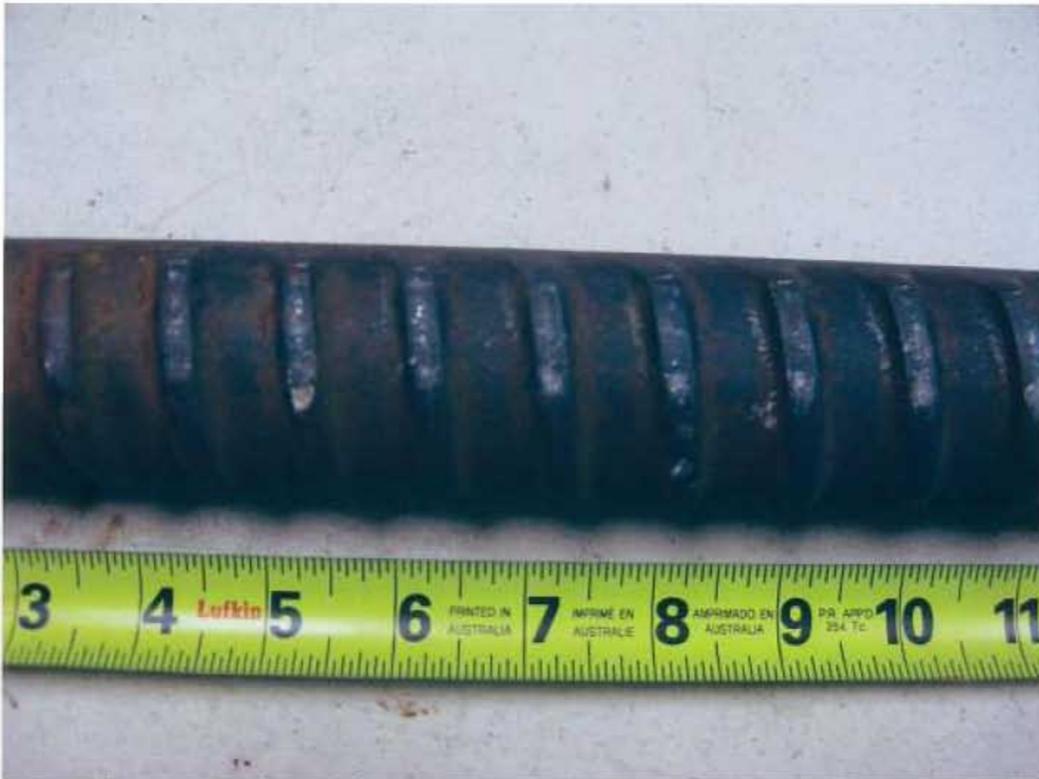
**Fig. 5** As received failed support rod from east span. 12 O'clock position.

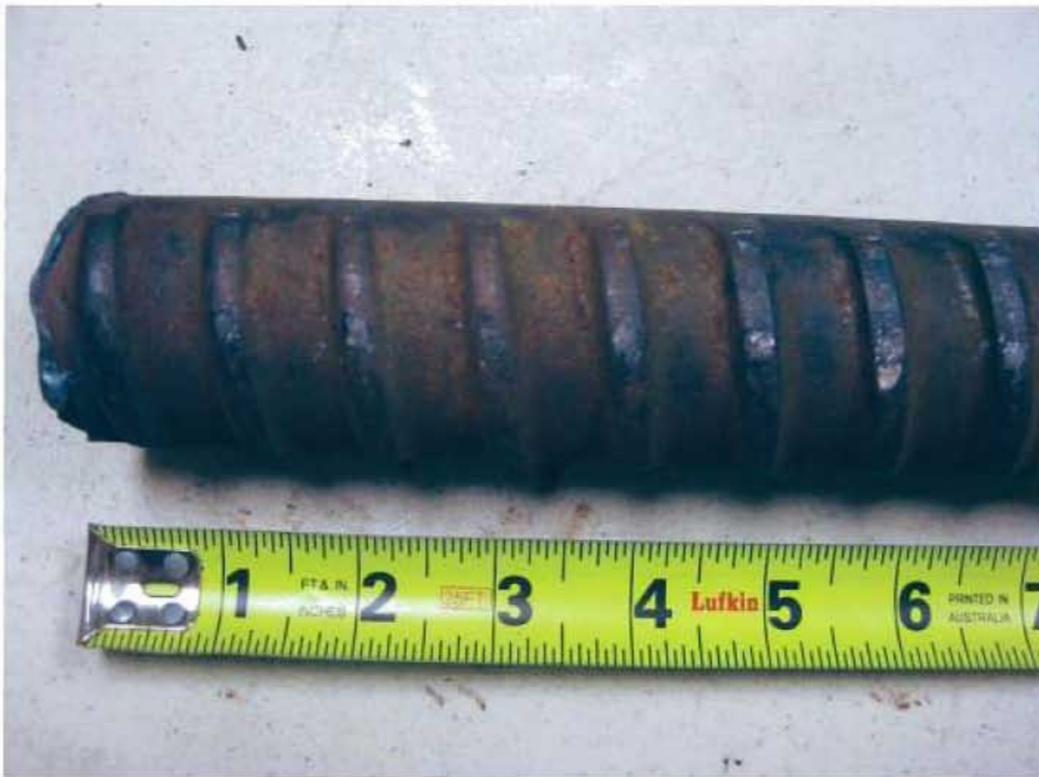
**Fig. 6** As received failed support rod from east span. 12 O'clock position.

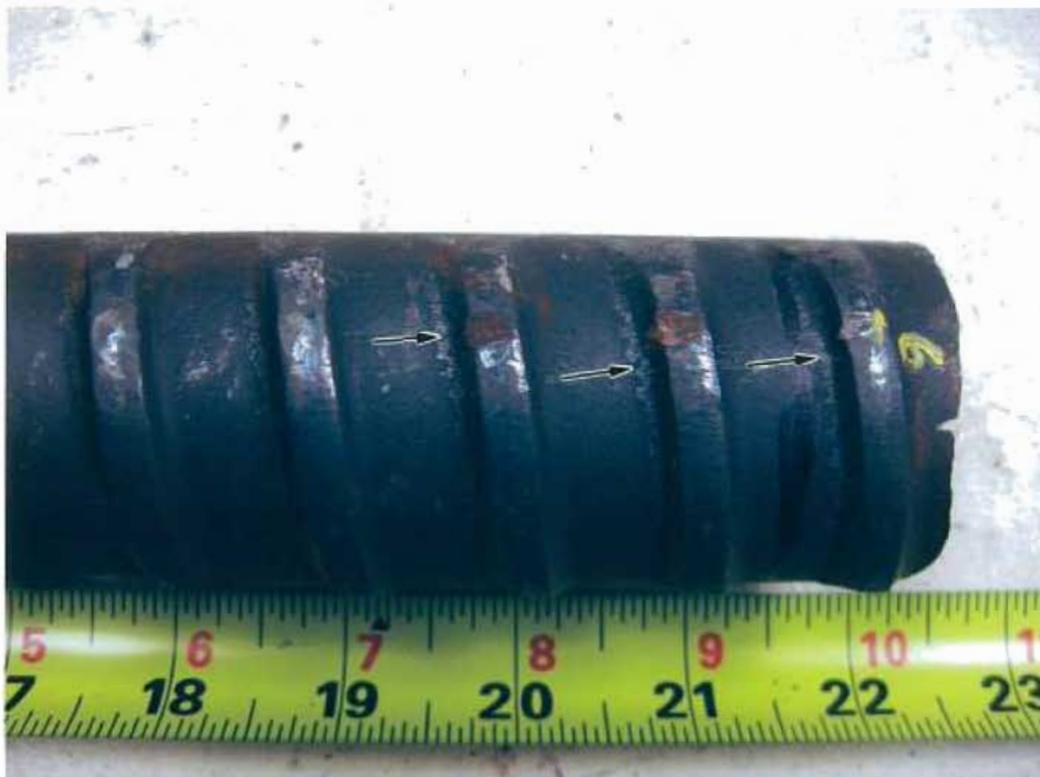
Fig. 8 As received failed support rod from east span. 6 O'clock position.

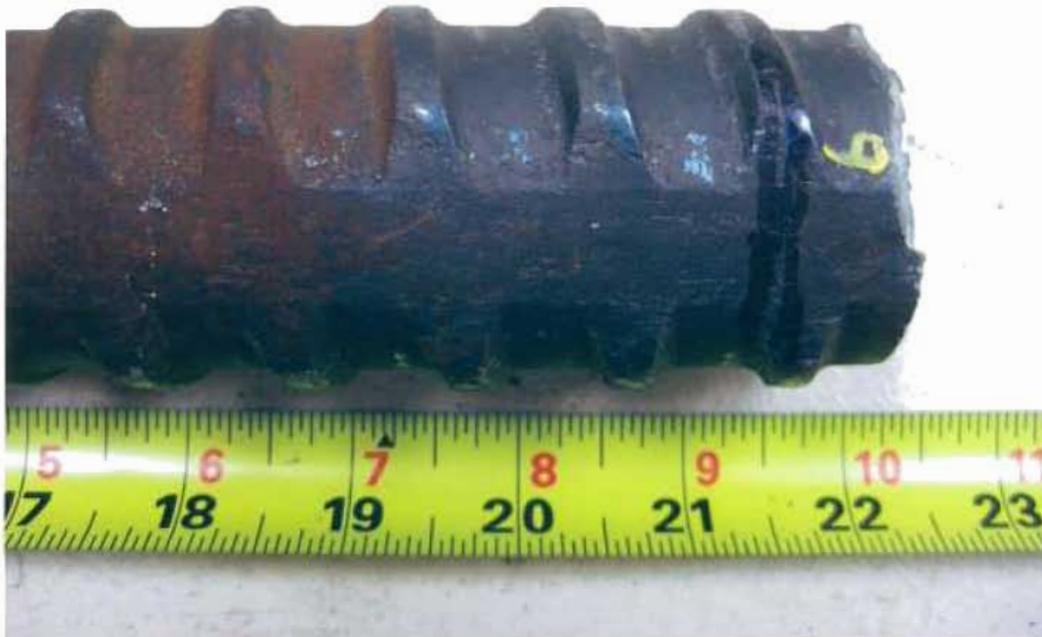
**Fig. 9 As received failed support rod from east span. 9 O'clock position.**

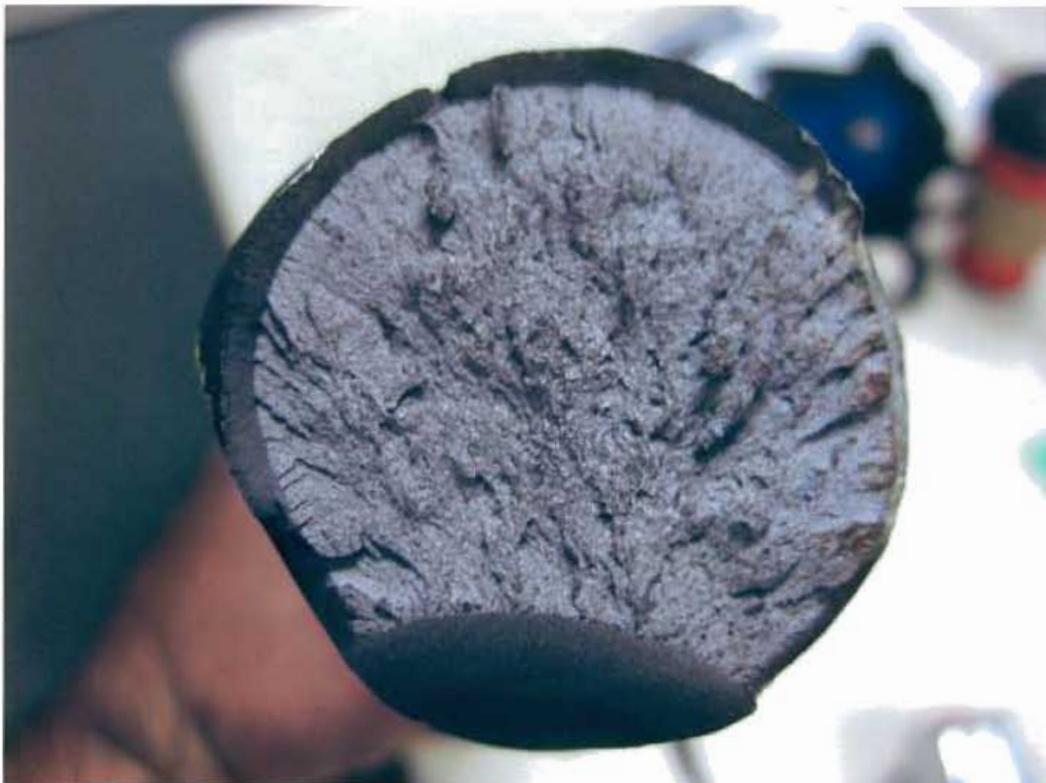
**Fig. 10 As received failed support rod from east span. Fracture sureface.**

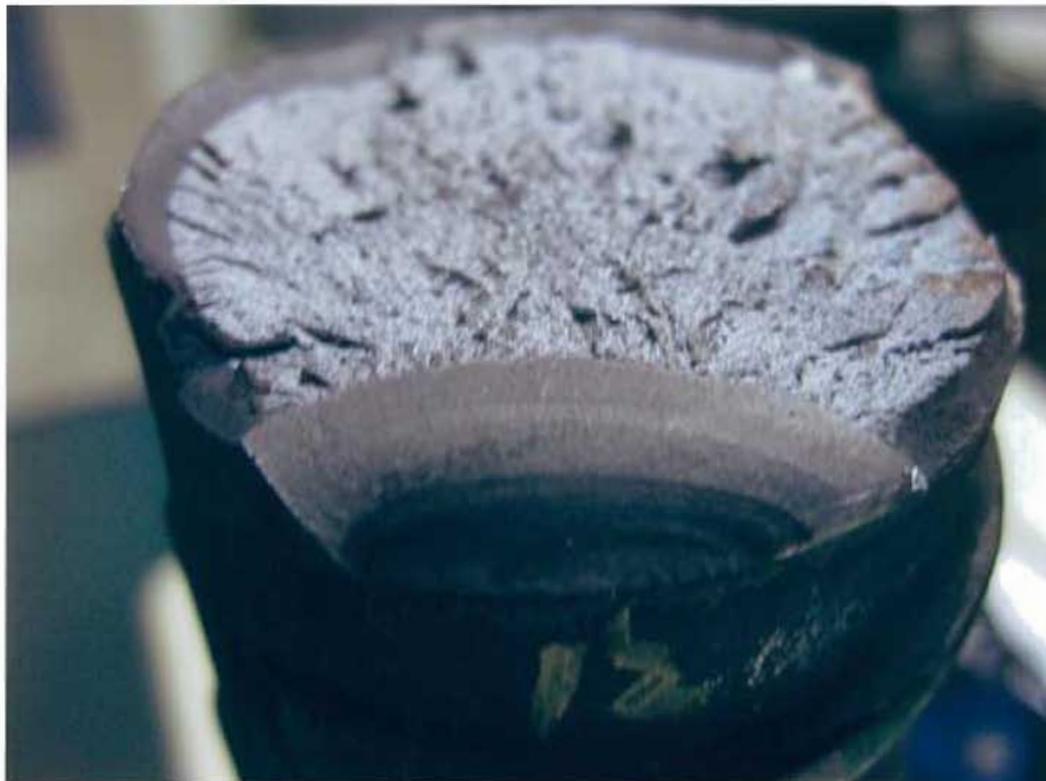
**Fig. 12 As received failed support rod from east span. Fracture sureface.**

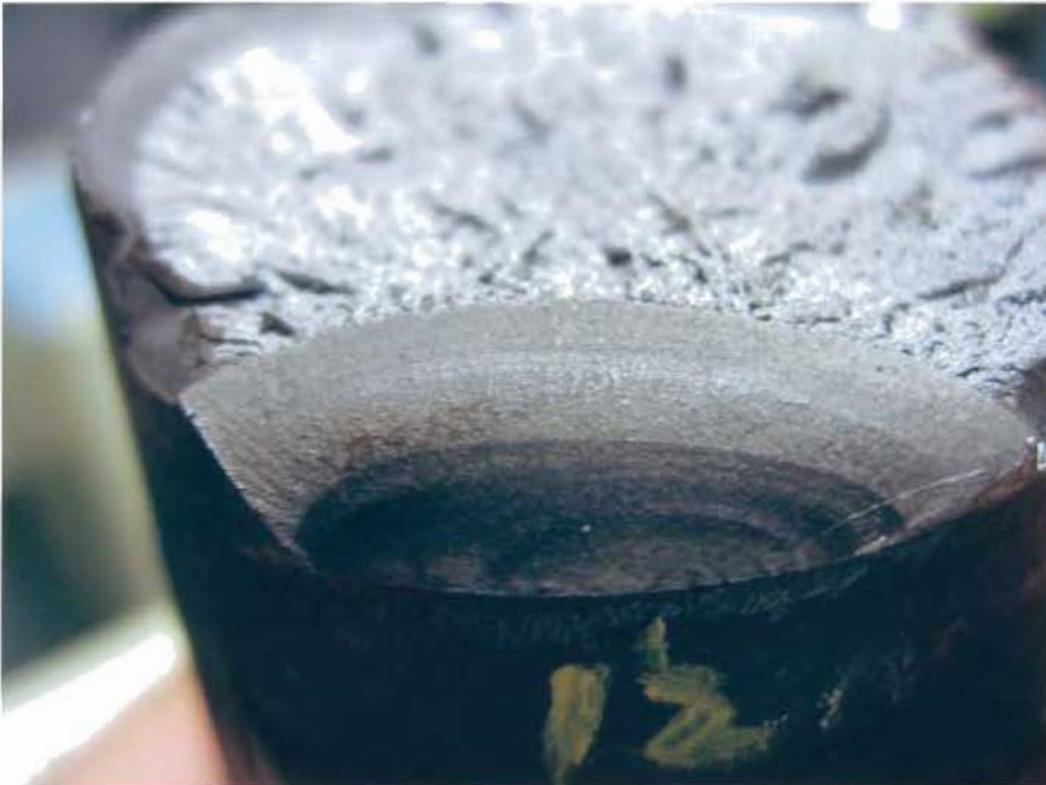
**Fig. 13 As received failed support rod from east span. Fracture sureface.**

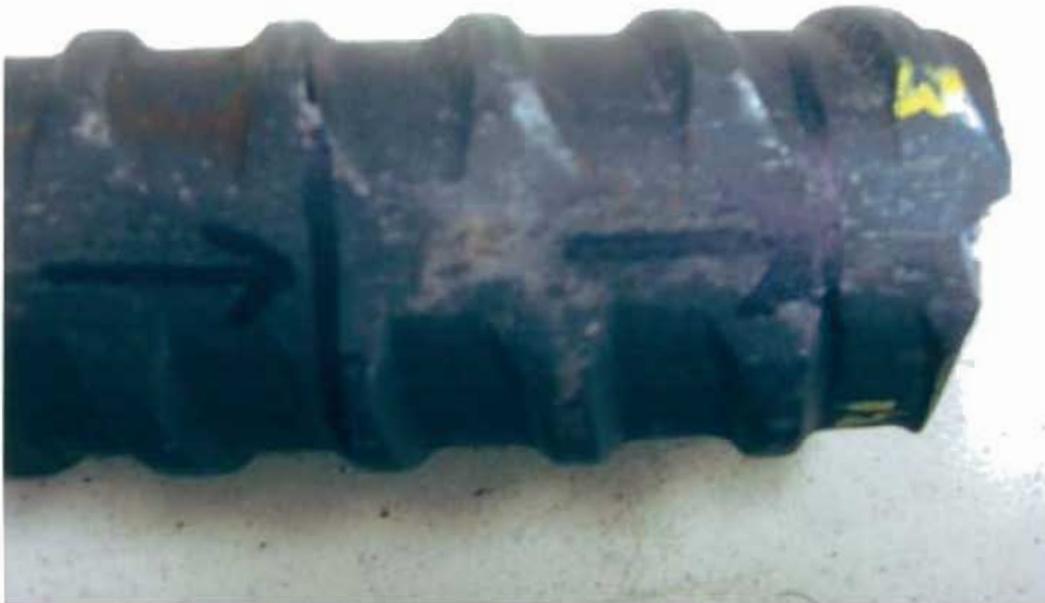
**Fig. 14 As received failed support rod from east span. Location where longitudinal microsection was made.**

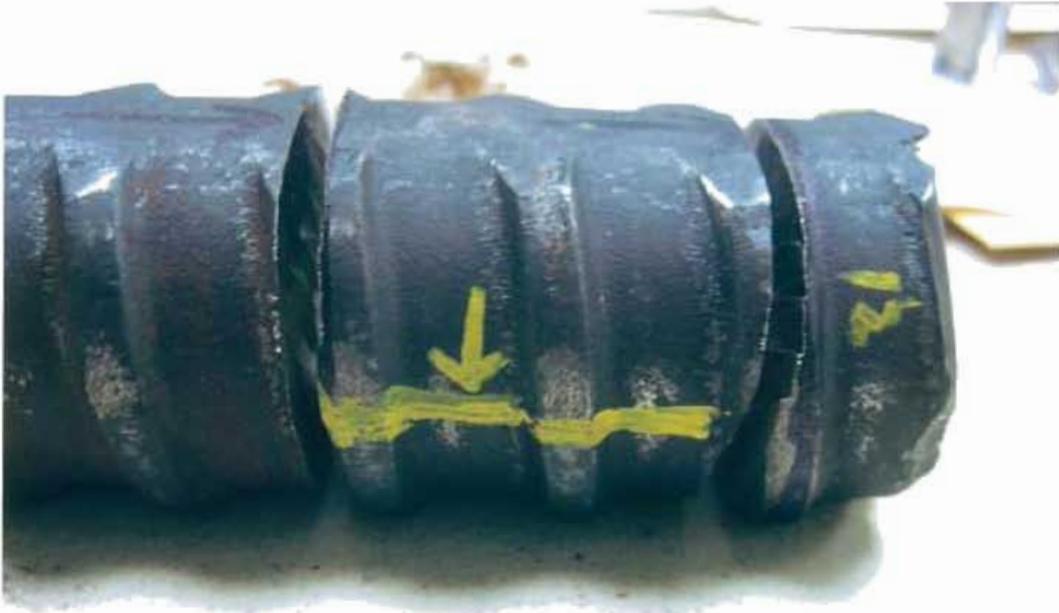
**Fig. 15** As received failed support rod from east span. Location where longitudinal microsection was made.

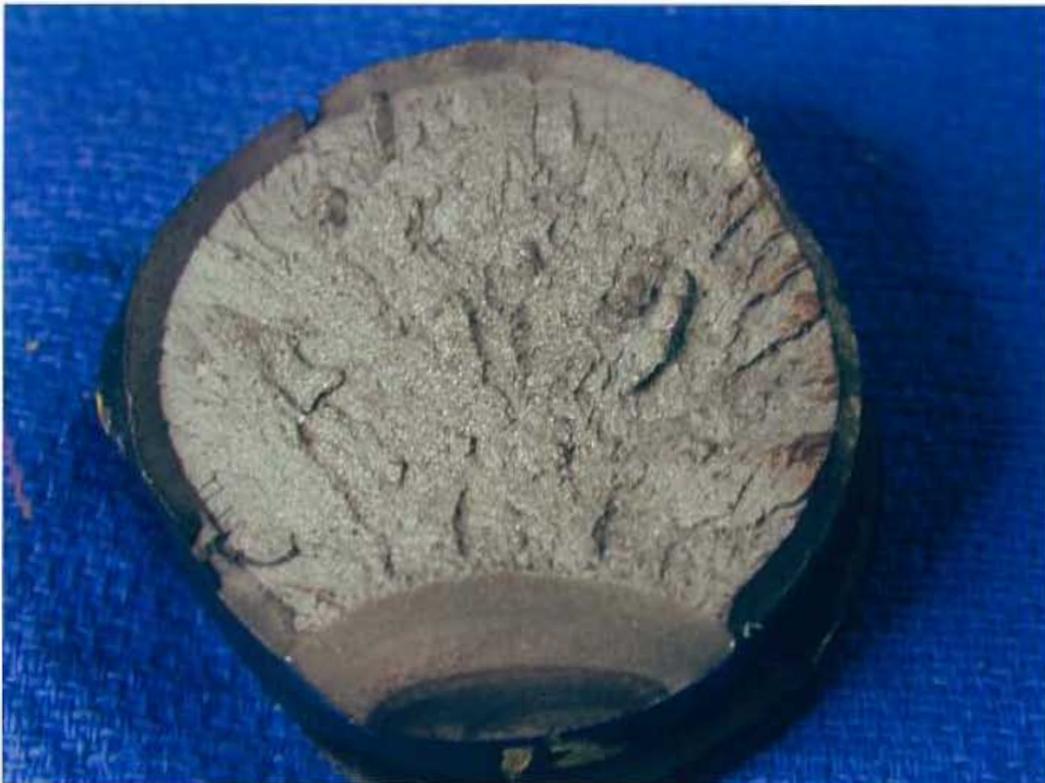
**Fig. 16** As received failed support rod from east span. Fracture surface.

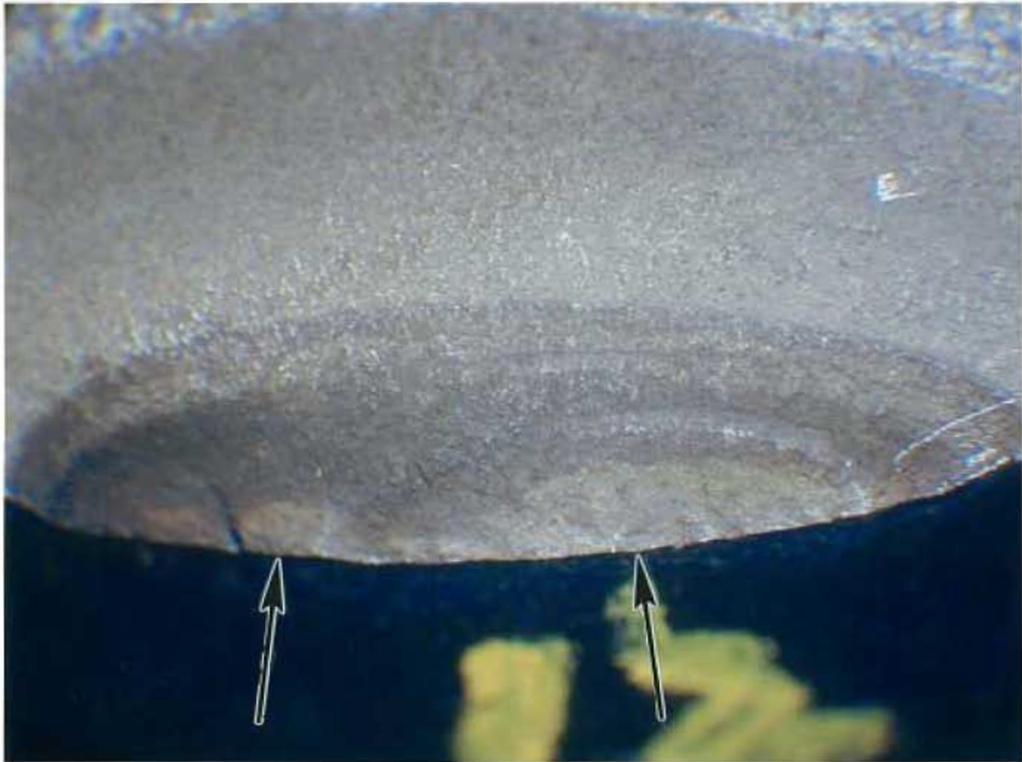
of fracture and the length of the fatigue crack zone measured 1.065". At this location the diameter of the bar at the plane of fracture measured 1.844". The arrow in Fig. 18 illustrates the primary fatigue crack origin location. One can see radiating beach marks propagating away from this particular point. A small secondary fatigue crack is indicated by the small arrow shown in the left in Fig. 18. Fig. 19 illustrates an additional view of the fatigue fracture origin area. Figs. 20, 21 and 22 illustrate the appearance of the markings at the corner of the rib coincident with the fracture origin location. The oxide in this area was chipped and cracked apparently due to the interaction with the thread zone in the nut. Figs. 23, 24, 25 and 26 illustrate the appearance of the mill scale oxide and the cracking of the mill scale below the fracture origin location. This was caused by bearing against the threads of the nut. Fig. 27 illustrates the fracture origin location which shows evidence of rubbing degradation and also rubbing on the plane of fracture. Fig. 28 illustrates the appearance of the fracture origin. Fig. 29 illustrates the appearance of the fracture surface which shows evidence of rubbing and oxidation. Fig. 30 illustrates the appearance of the fracture inboard from the fracture origin which again shows significant evidence of rubbing degradation and oxidation. Fine fatigue striations could not be identified in this area although the fracture mode is fatigue. The first zone at the plane of fracture origin is shown in Fig. 17 and Fig. 31. Fig. 32 illustrates the appearance of the fracture in zone 2 which is the second step in the fatigue zone. Fig. 33 and 34 illustrate definite evidence of fatigue cracking damage in this area. Fig. 35

Fig. 18 As received failed support rod from east span. Fracture origin.

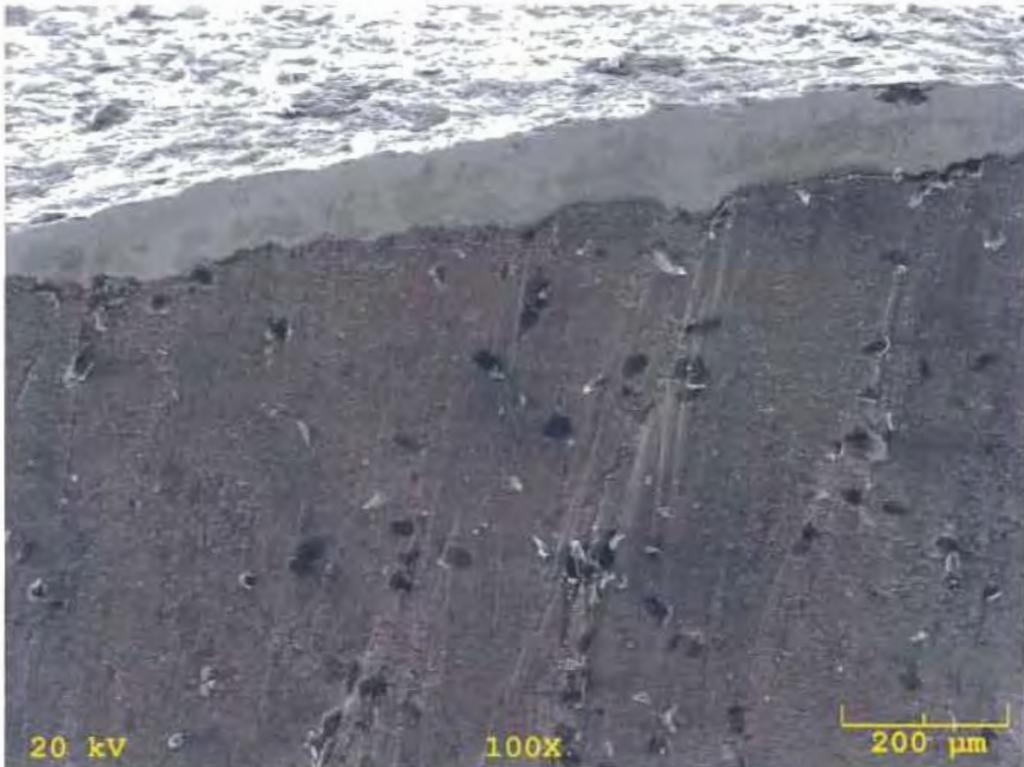
Fig. 23 S.E.M photo of failed support rod from east span. Edge, below fracture origin. 100X.

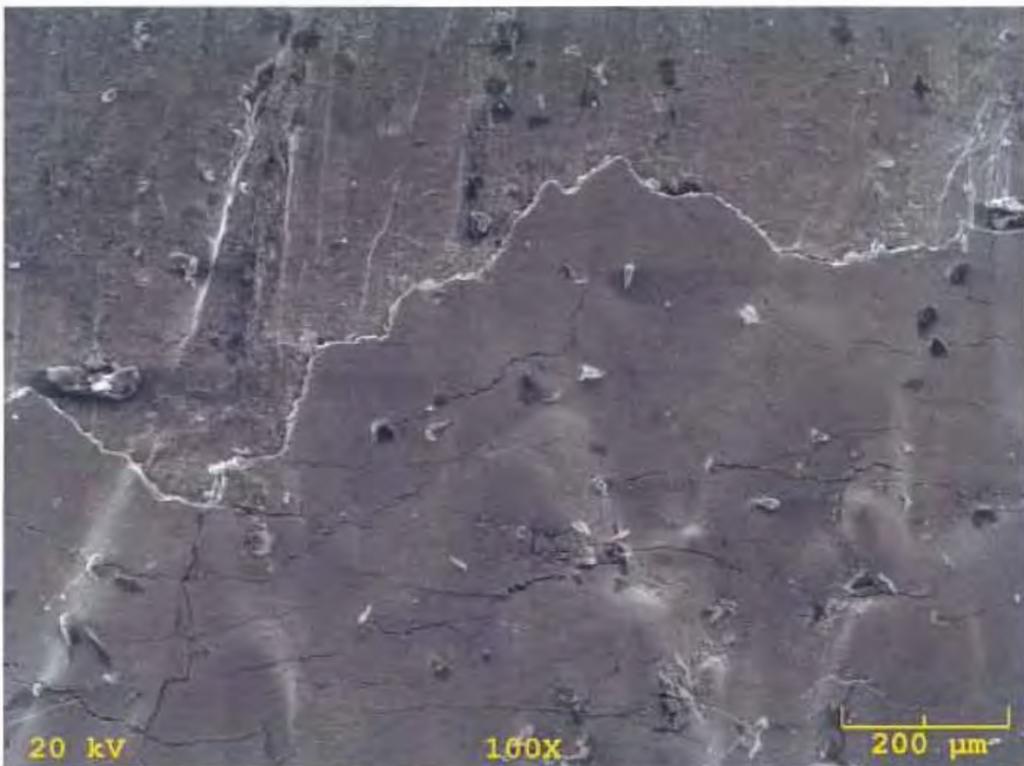
Fig. 24 S.E.M photo of failed support rod from east span. Edge, below fracture origin. 100X.

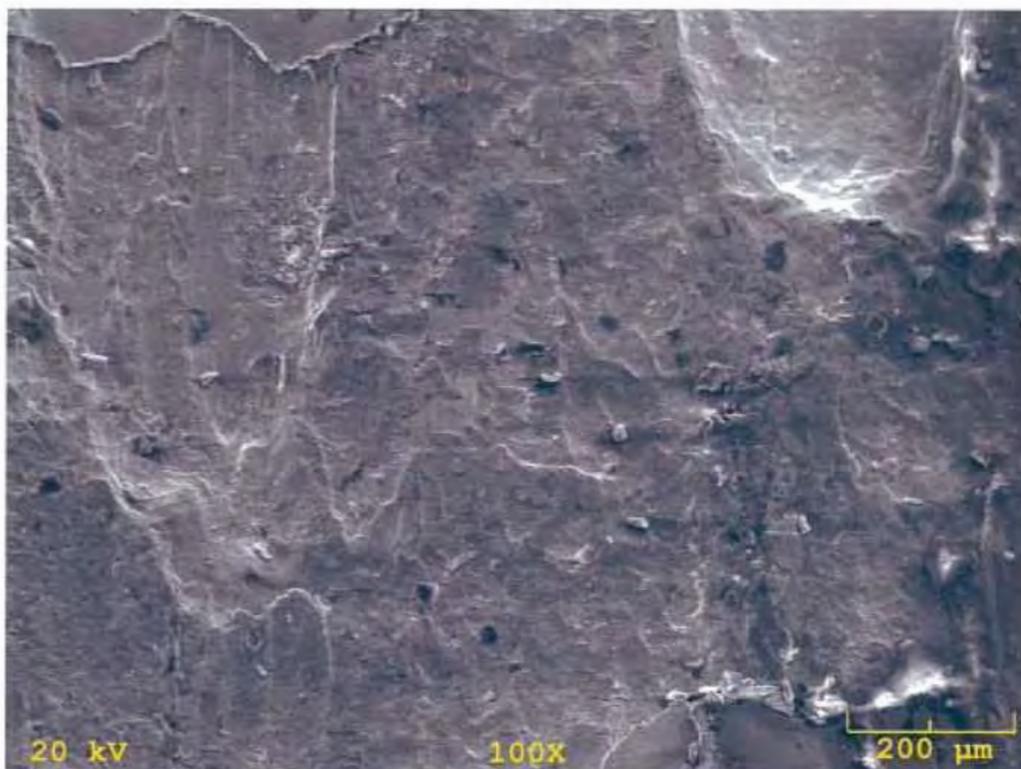
**Fig. 26 S.E.M photo of failed support rod from east span. Edge, below fracture origin. 100X.**

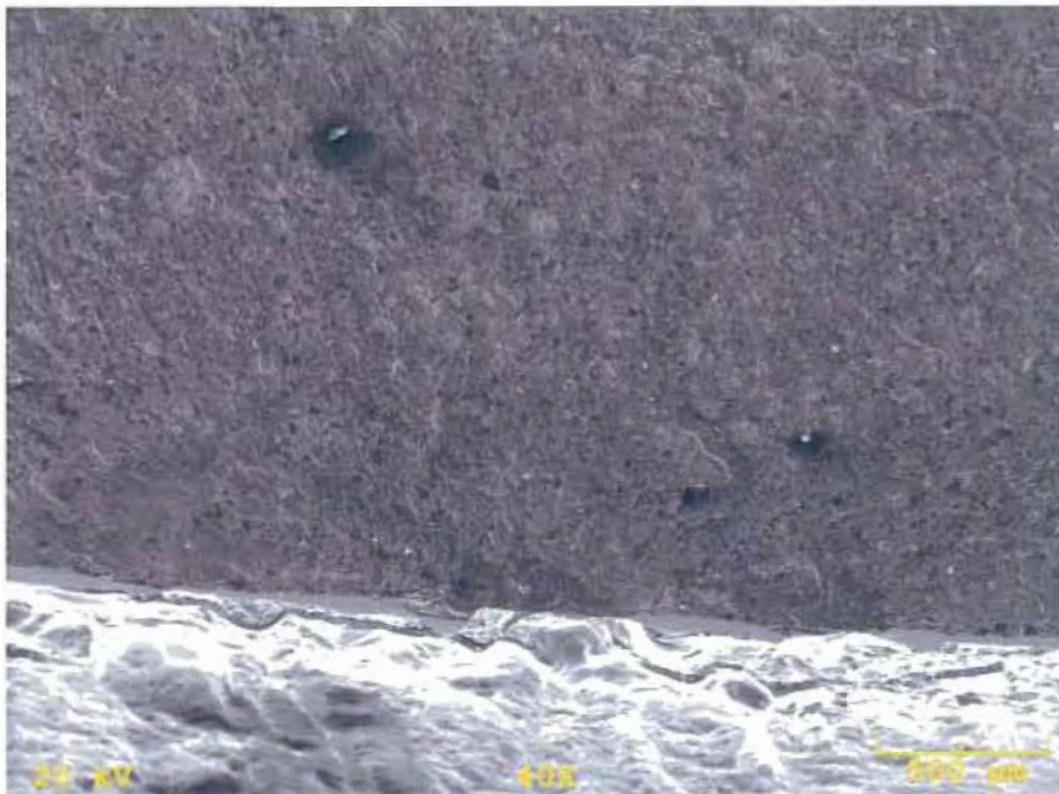
**Fig. 28 S.E.M photo of failed support rod from east span. Edge, at fracture origin. 40X.**

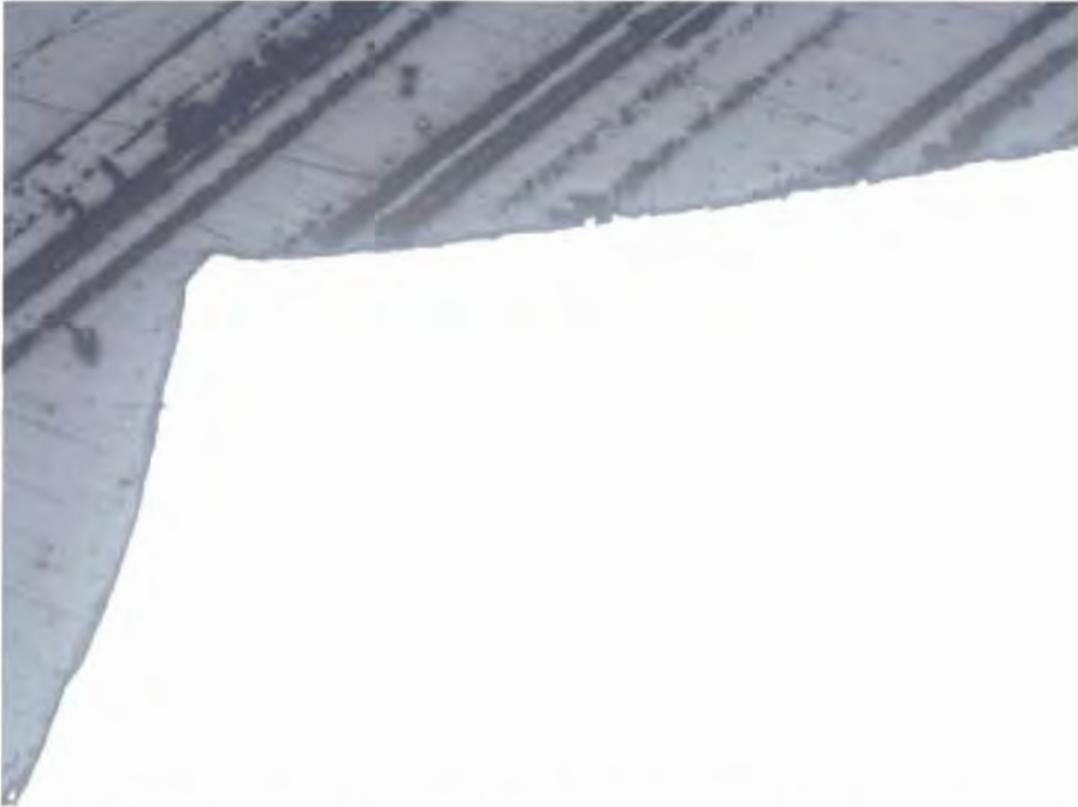
A microsection was also prepared exactly at the fracture origin location and 90° to the plane of fracture. Fig. 47 illustrates the fracture origin at 50X and Fig. 48 illustrates the appearance of the fracture origin in the unetched condition at 500X. There was no indication of any metallurgical defects or cracks within the bar and there were no secondary cracks below the plane of fracture in the material. Figs. 49 and 50 illustrate the appearance of the martensitic microstructure at the fracture origin which again shows no evidence of any metallurgical defects. The hardness at the origin was checked by microhardness technique and showed a hardness of 37 to 34.5 RC. At the center of the bar the minimum core hardness was 31 RC.

**Fig. 47** Cross-section of failed support rod from east span at fracture origin in fig. 16. 50X.

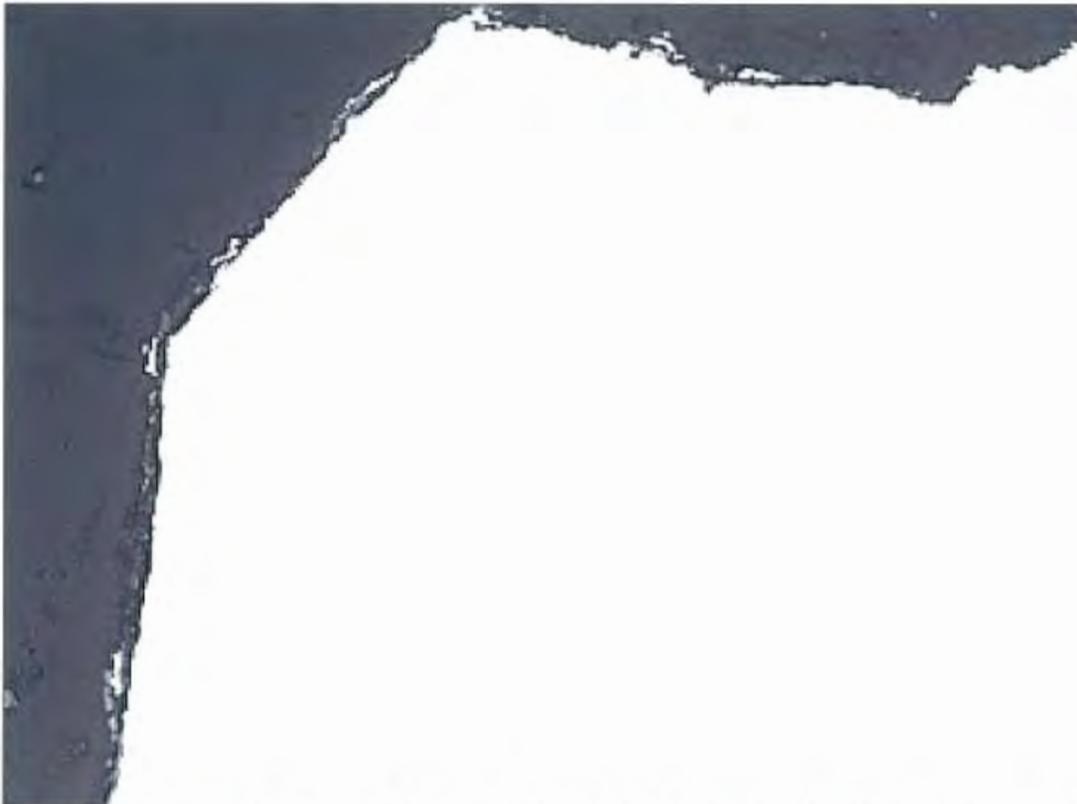
**Fig. 48** Cross-section of failed support rod from east span at fracture origin in fig. 16. 500X.

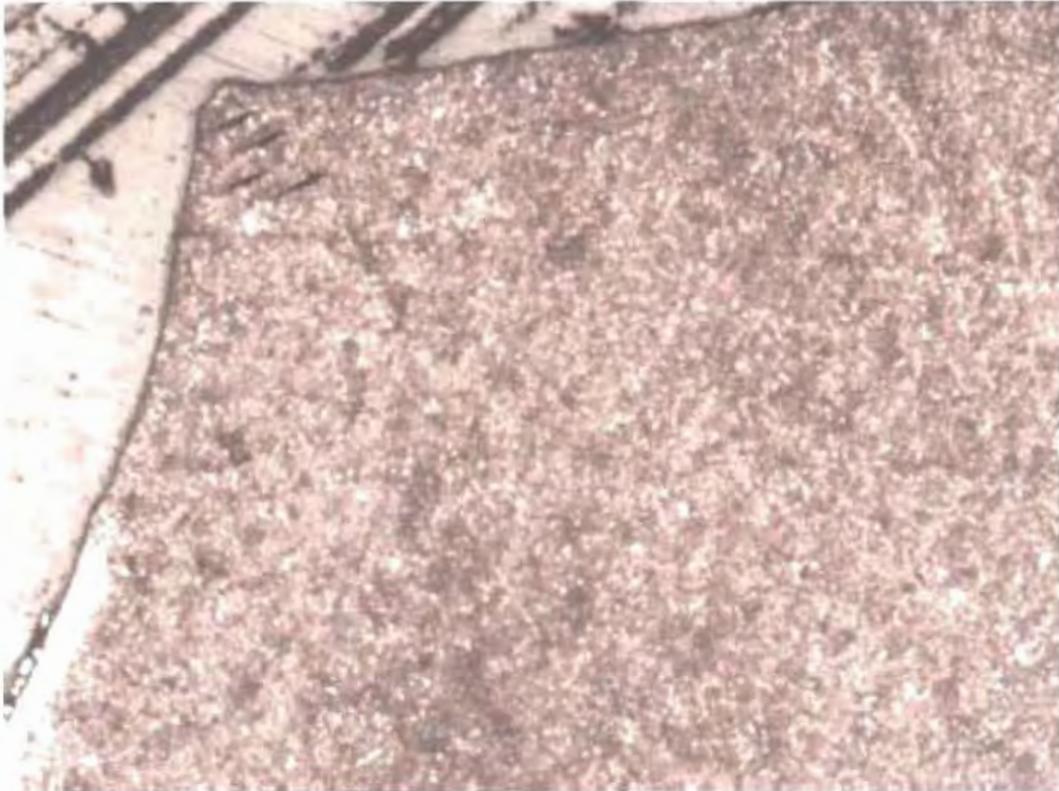
**Fig. 49** Cross-section of failed support rod from east span at fracture origin in fig. 16. 50X. Etched.

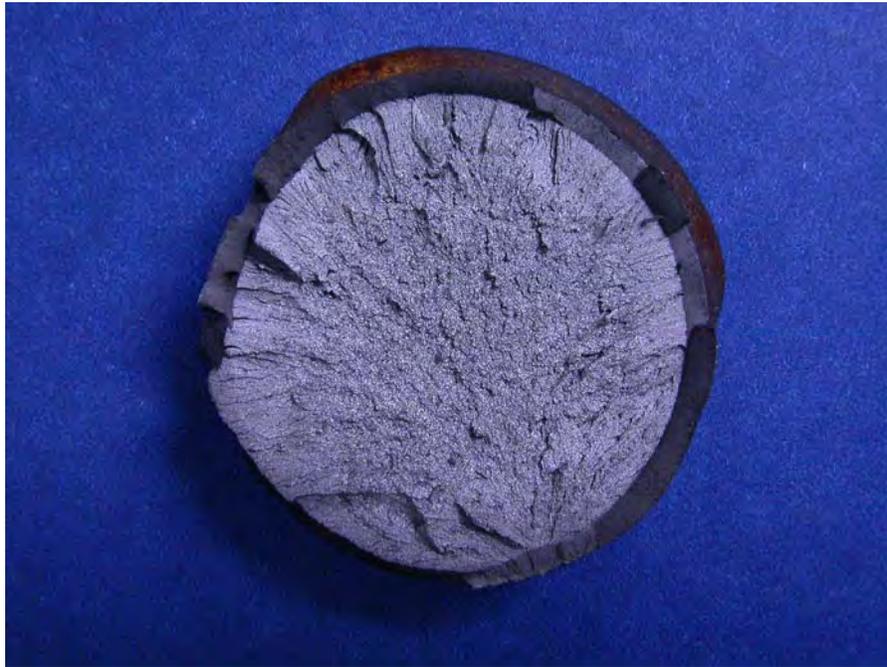
Fig 1

The appearance of the un-notched fracture face is shown in figure 1 and fracture face of the notched bar is shown in figure 2. The two fractures were placed in the Scanning Electron Microscope (SEM) and fracture mode determined. Figures 3, 4 and 5 illustrate the fracture mode in the un-notched bar and figures 6, 7, and 8 illustrate the fracture mode in the notched bar. In both cases the fracture mode was found to be cleavage as documented in SEM photographs. These results are exactly comparable to the overload portion of the fracture on the saddle bar that had the fatigue crack in it and which had broken on the bridge.
