<b>1. REPORT NO.</b>  <p style="text-align: center;">FHWA/CA25-3170</p>	<b>2. GOVERNMENT ACCESSION NO.</b>  	<b>3. RECIPIENT'S CATALOG NO.</b>  
<b>4. TITLE AND SUBTITLE</b> DEVELOPMENT AND CRASH TESTING OF A CONCRETE POST-AND-BEAM BRIDGE RAILING, CALIFORNIA TYPE 86H, MASH TL-4		<b>5. REPORT DATE</b>  <p style="text-align: center;">October 2024</p>
		<b>6. PERFORMING ORGANIZATION CODE</b>  
<b>7. AUTHOR(S)</b>  Victor O. Lopez, Robert Meline, David Whitesel, Christopher Caldwell		<b>8. PERFORMING ORGANIZATION REPORT NO.</b>  <p style="text-align: center;"><b>FHWA/CA25-3170</b></p>
<b>9. PERFORMING ORGANIZATION NAME AND ADDRESS</b>  Roadside Safety Research Group California Department of Transportation 5900 Folsom Blvd., Sacramento, CA. 95819		<b>10. WORK UNIT NO.</b>  
		<b>11. CONTRACT OR GRANT NO.</b>  <p style="text-align: center;"><b>FHWA/CA25-3170</b></p>
<b>12. SPONSORING AGENCY NAME AND ADDRESS</b>  California Department of Transportation 5900 Folsom Blvd., Sacramento, CA. 95819		<b>13. TYPE OF REPORT &amp; PERIOD COVERED</b>  <p style="text-align: center;">FINAL</p>

# DEVELOPMENT AND CRASH TESTING OF A CONCRETE POST-AND-BEAM BRIDGE RAILING, CALIFORNIA TYPE 86H, MASH TL-4

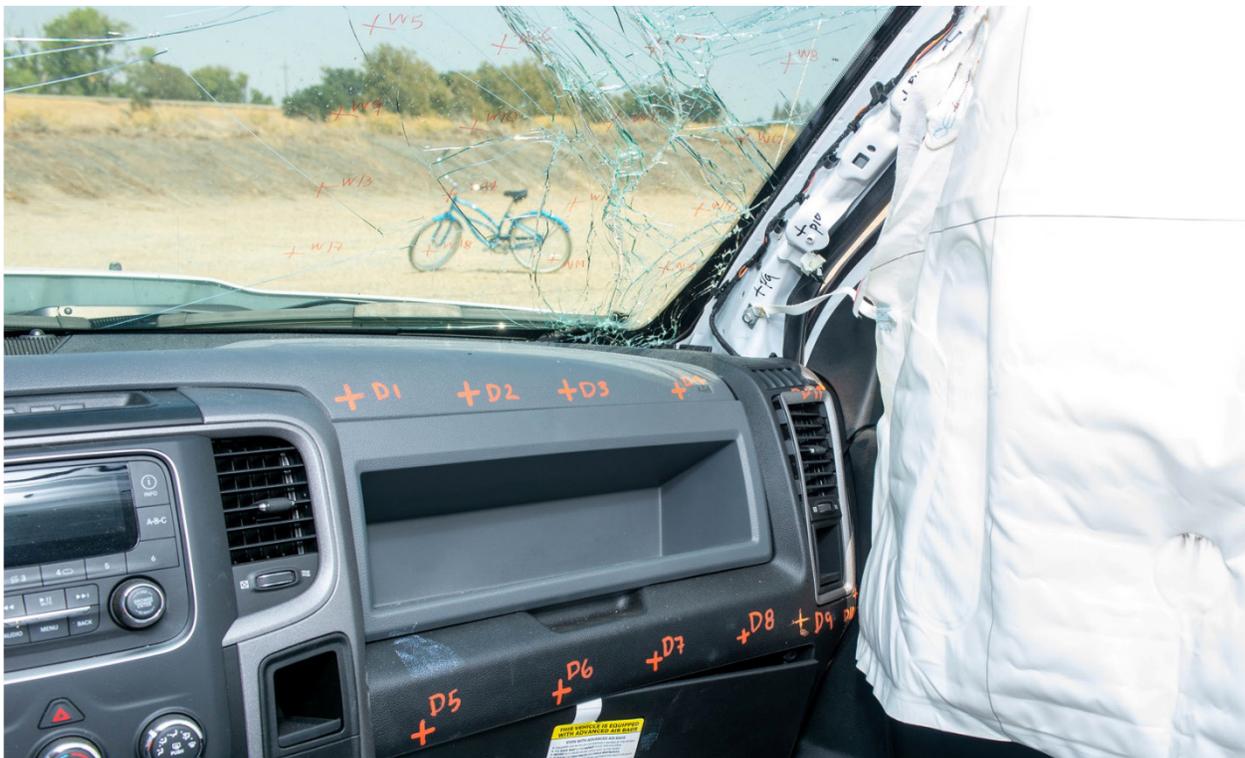
Figure 6-19 Test 4-11 Test Vehicle Damage Windshield / Interior View

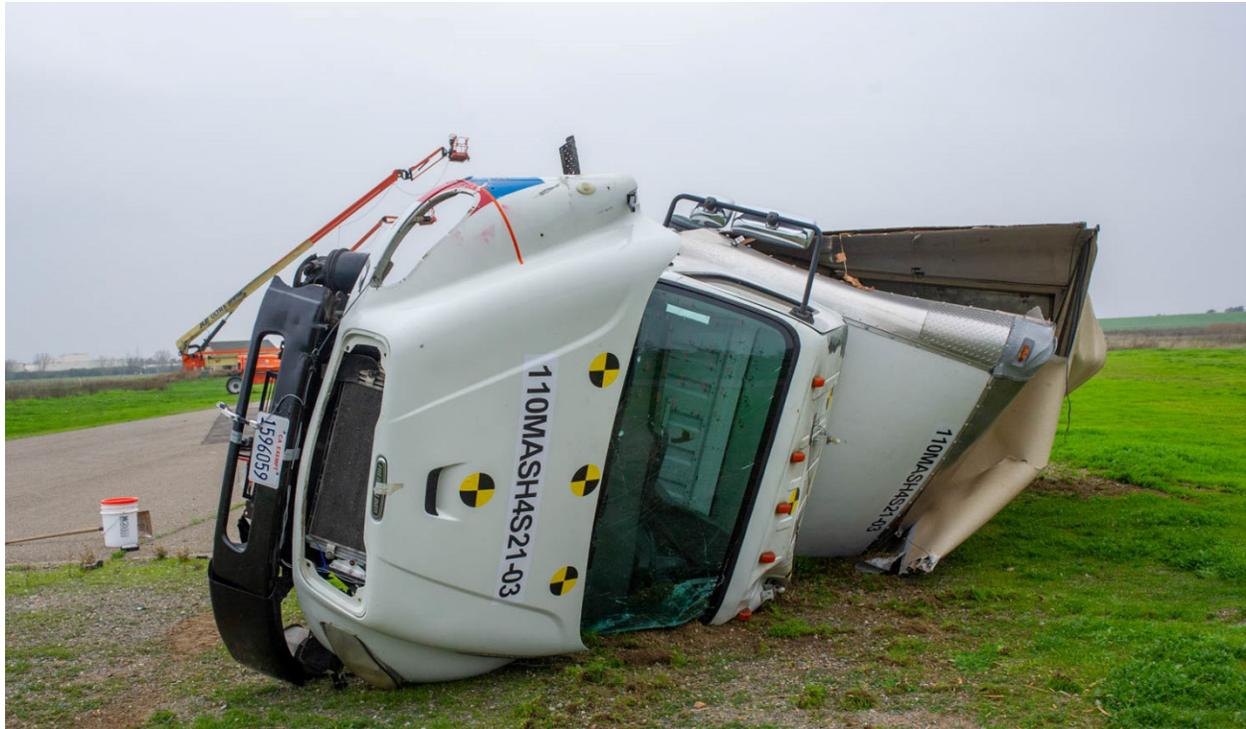
The 1000S front right corner and passenger side of the vehicle sustained most of the damage from the initial impact with the concrete post and beam system. During the impact the vehicle remained upright as it traveled downstream within the length of the bridge rail, exiting the bridge rail within the exit box criteria. Upon impact with the concrete curb and beam, the right front tire was pushed up and into the engine area, causing the U-bolt connections of the axle to fail, ultimately resulting in a complete detachment of the front axle from the truck. The front right corner of the cab initially rolled towards the barrier along with the box. However, while exiting the rail, the cab and box rolled away from the rail with enough momentum to cause the 1000S to roll onto the driver's side and slide to a stop. The detached axle continued to roll coming to a stop approximately 12 m (39 ft) downstream from the front of the van body. The van body truck came to a stop on its side, downstream from the end of the barrier rail, approximately 80.0 m (262.6 ft) downstream of the critical impact point and 11.1 m (36.4 ft) behind the traffic-face of the rail. The fact that the vehicle rolled onto its side is not a failure in the MASH 2016 criteria for this test. The passenger side of the front bumper was deformed, the passenger side headlight was damaged, and the right front fender was detached. The rear suspension remained attached as did the rear wheels and tires. All tires remained inflated. The steps on the passenger side were partially deformed and the top step was partially detached and rotated due to contact with the concrete rail. The driver's side door, A-pillar, fender, and cab roof were deformed from the impact with the ground after the vehicle left the Type 86H. All the window glass was undamaged during interaction with the test article. The cracking of the windshield occurred after the cab impacted the ground. Nearly all the damage to the cargo box also occurred when the vehicle rolled onto its side. The shear plates and bolts that were installed on the frame remained intact (see Figure 7-21 thru Figure 7-24). The bed shifted a minor amount. The threaded rods used to secure the ballast were undamaged and kept the motion of the ballast to a minimum. The maximum amount of passenger compartment deformation measured by known points was 100 mm (4 in.), which occurred at the roof. This deformation was most likely due to the impact of the driver side of test vehicle with the ground after rolling on its side after the vehicle separated from the rail. The roof deformation over the passenger side was away from the occupant compartment and therefore is acceptable. The largest deformation resulting from the interaction between the test vehicle and the barrier rail occurred at the A and B Pillars. The maximum deformation in this area was 73 mm (2.9 in.). This value is below the MASH 2016 limit of 127 mm (5 in.). The overall exterior vehicle damage is described as Moderate to Heavy. All interior deformation measurements are shown in Appendix A: Table 10-31 through Table 10-35. See Figure 7-13 to Figure 7-26 for pictures of the vehicle damage described above.

Figure 7-13 Test 4-12 Vehicle Damage (front, hood and windshield)

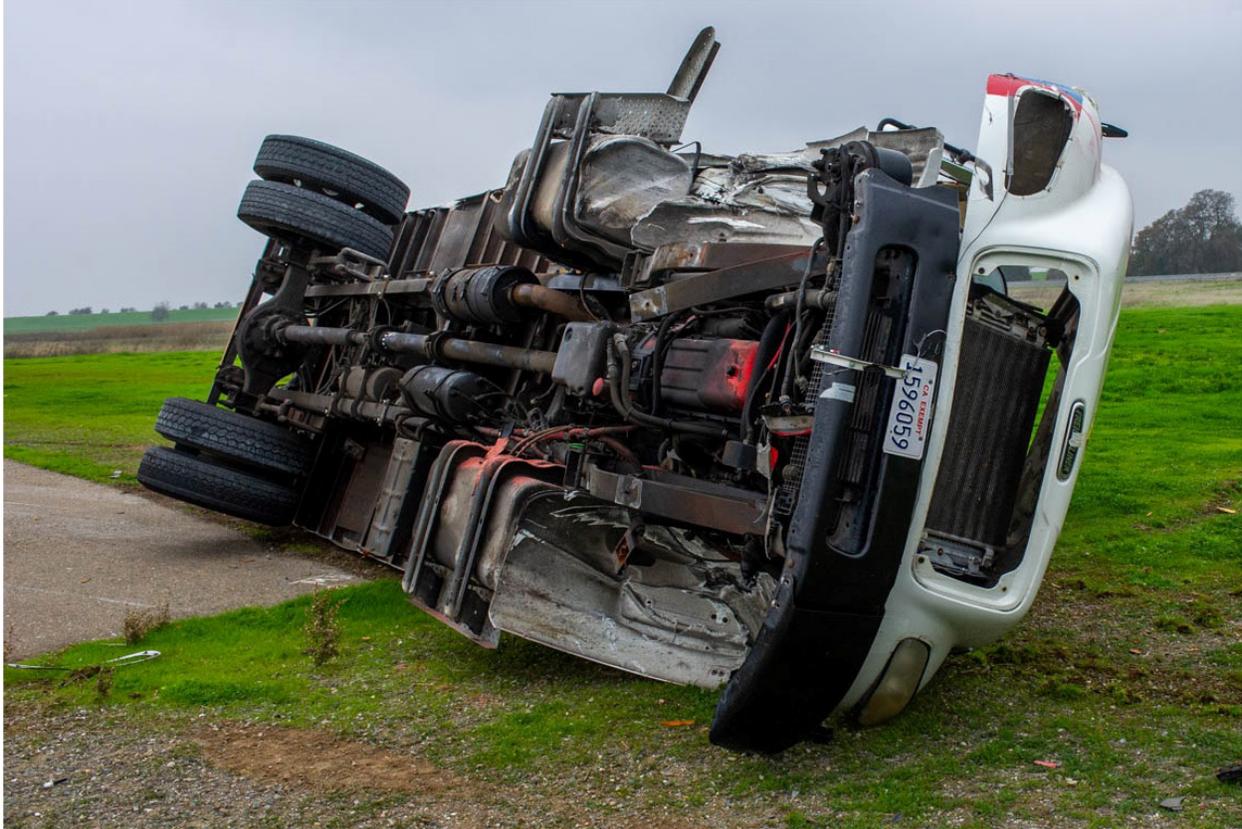
Figure 7-14 Test 4-11 Test Vehicle Damage (front right)

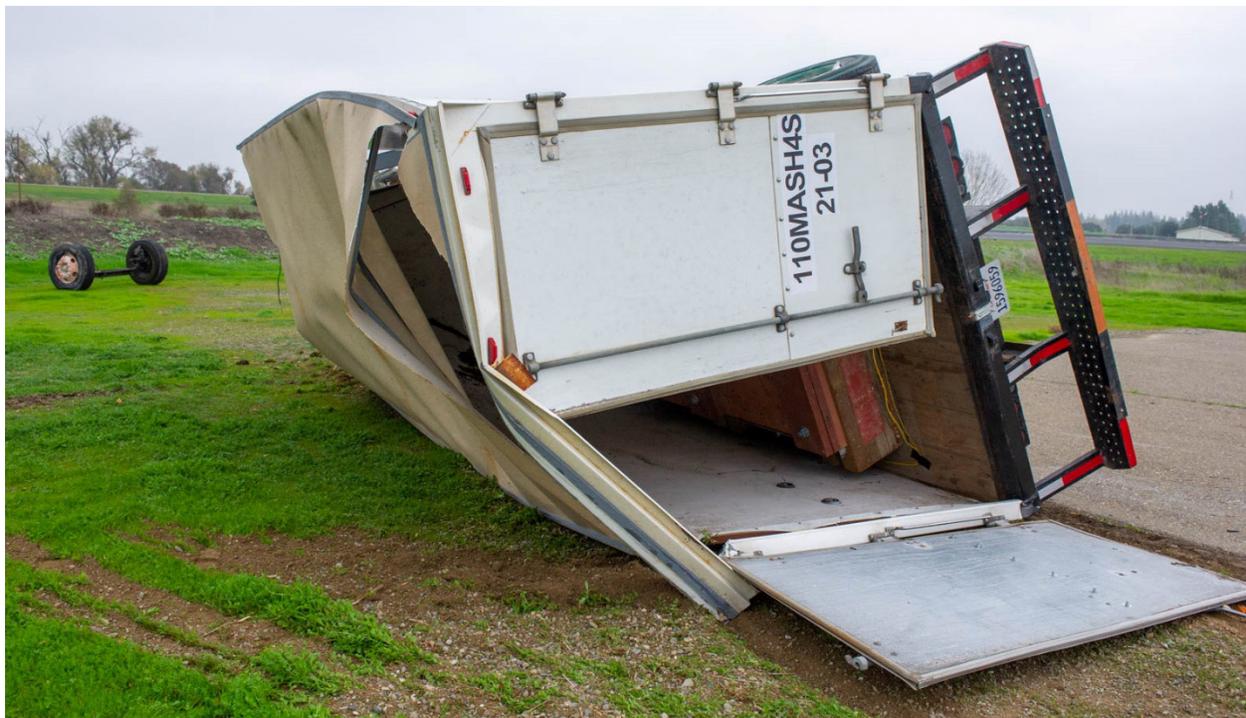
Figure 7-17 Test 4-12 Test Vehicle After Impact (Rear)

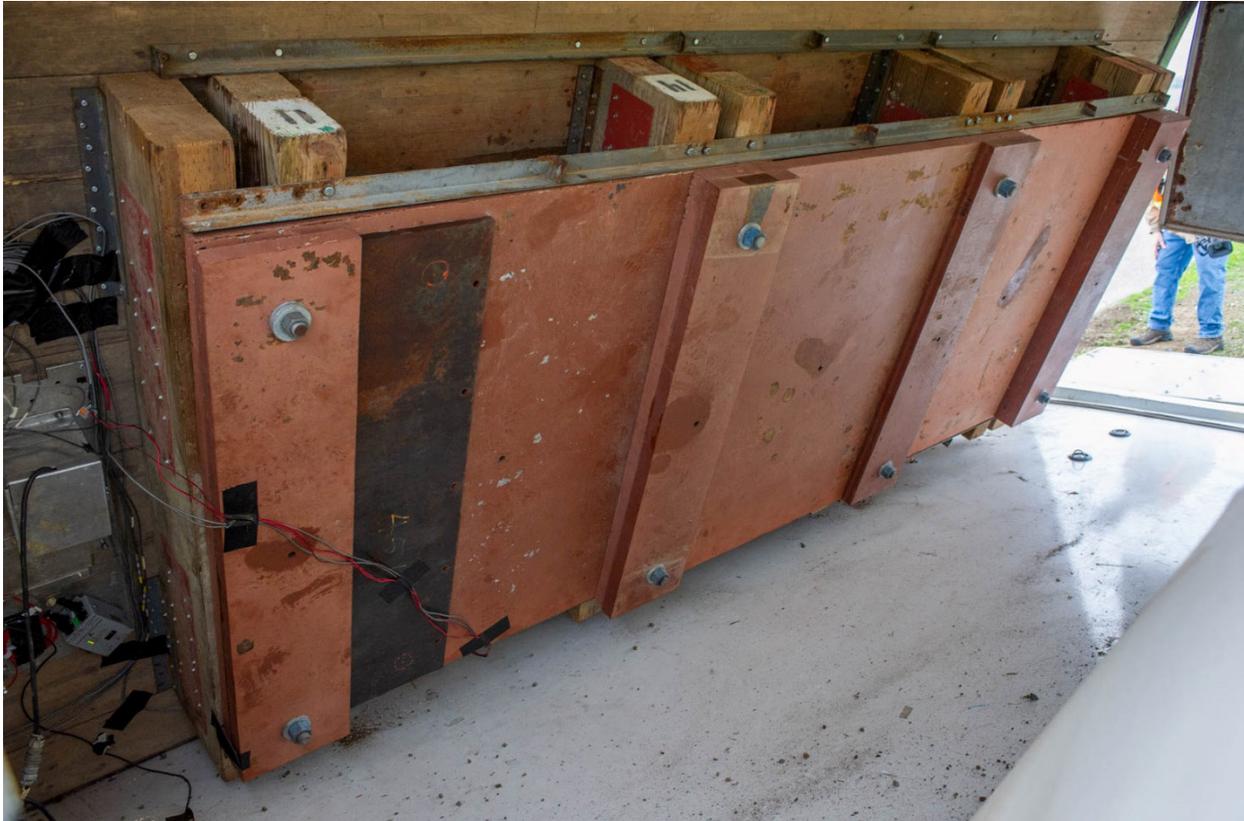
Figure 7-18 Test 4-12 Test Vehicle Ballast After Impact

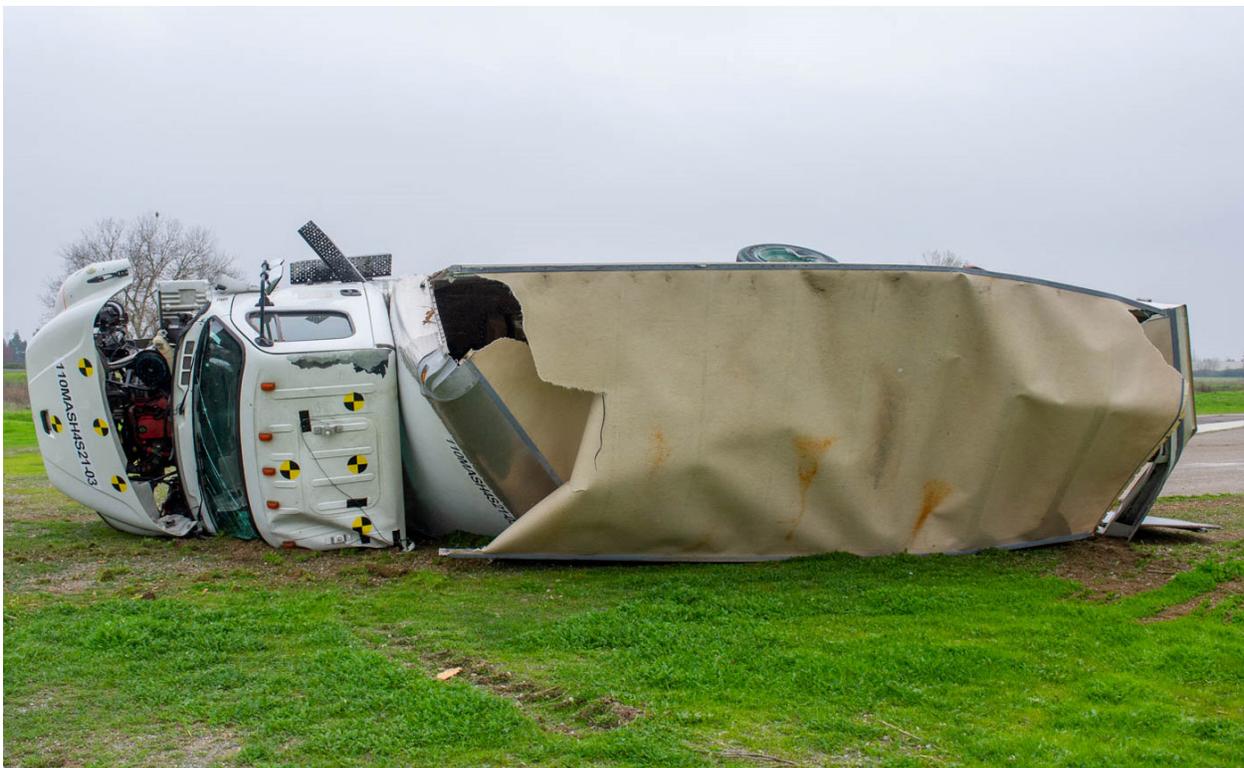
Figure 7-19 Test 4-12 Test Vehicle After Impact (Overall View)

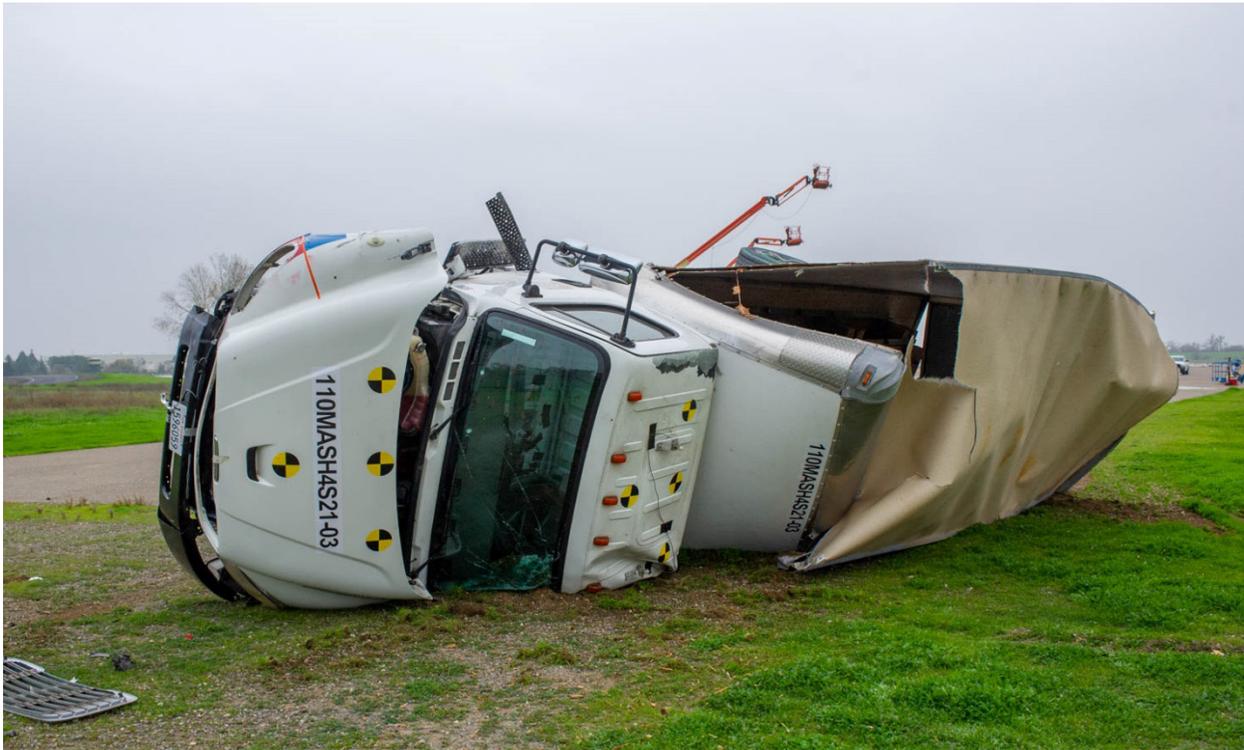
Figure 7-20 Test 4-12 Test Vehicle After Impact (front right)

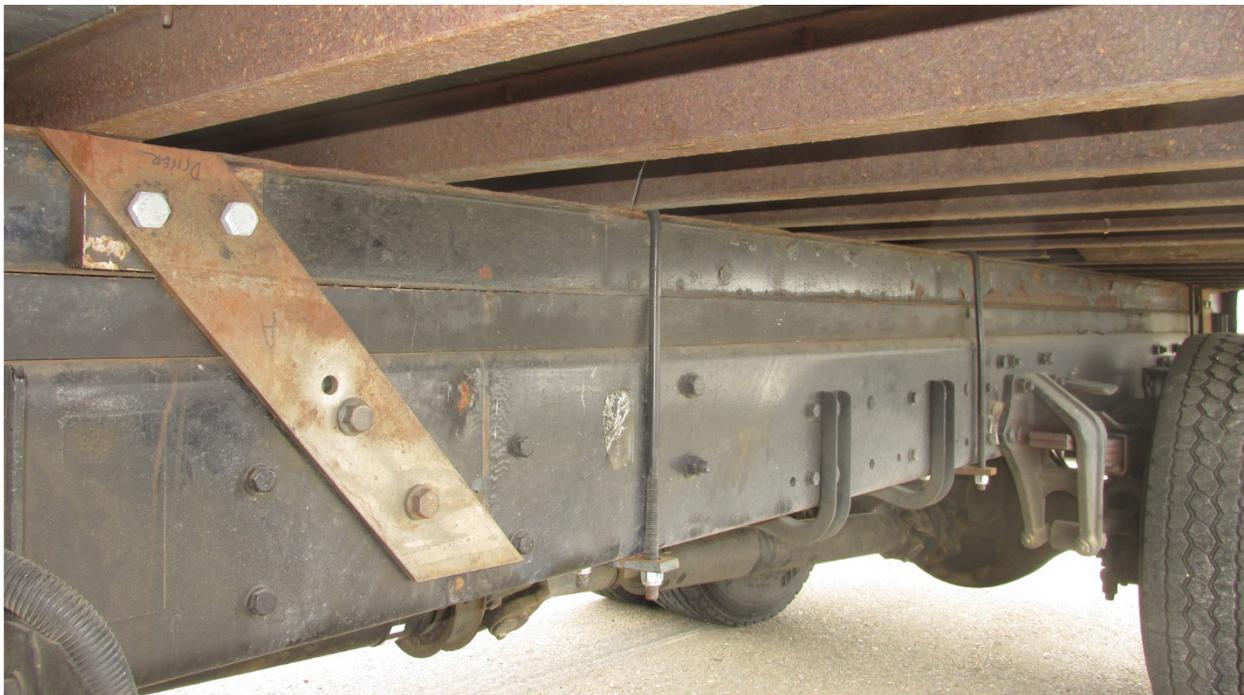
Figure 7-21 Test 4-12 Front Left Shear Plate After Impact

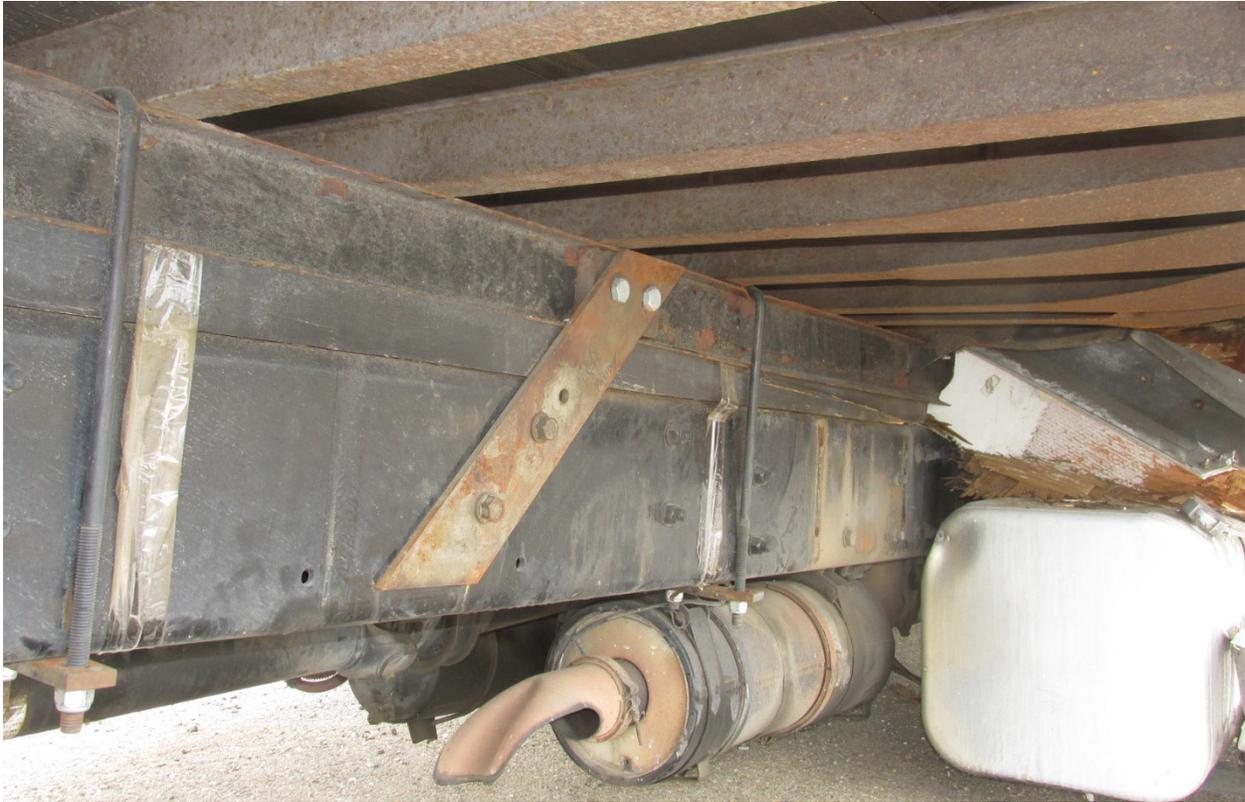
**Figure 7-22 Test 4-12 Front Right Shear Plate After Impact**

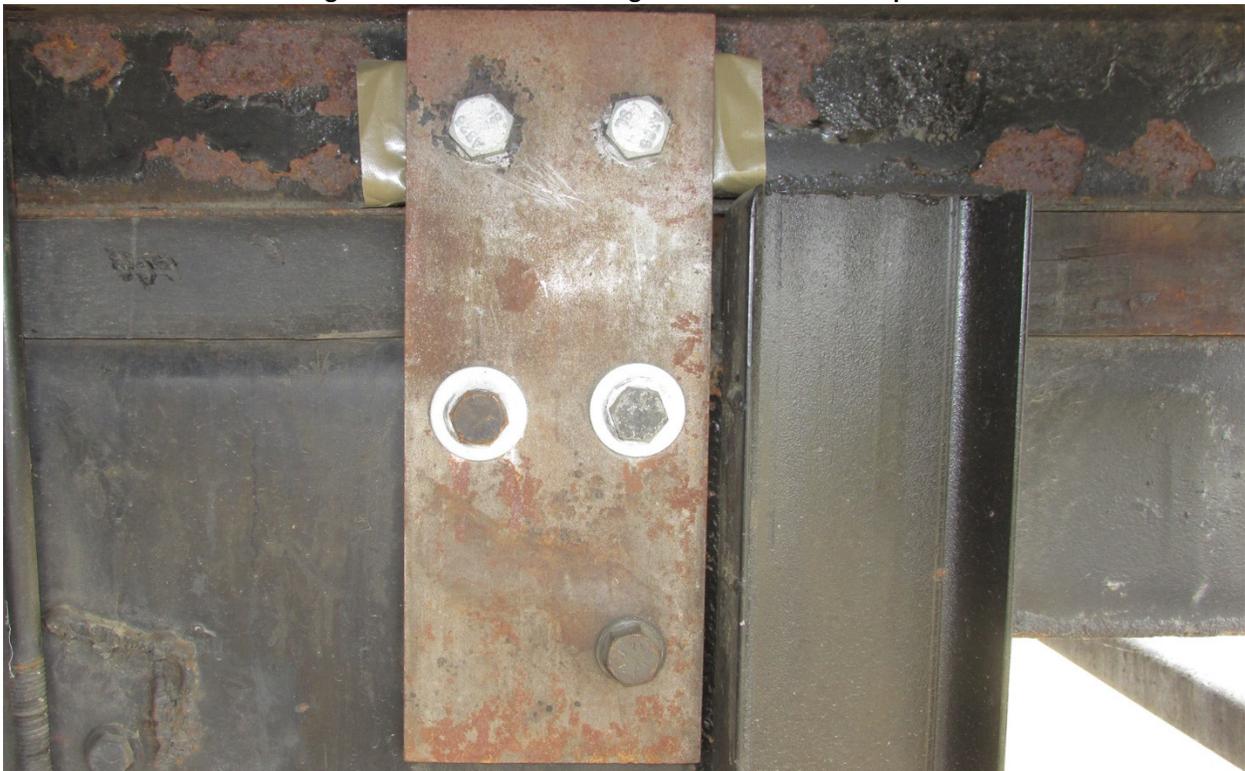
**Figure 7-23 Test 4-12 Rear Left Shear Plate After Impact**

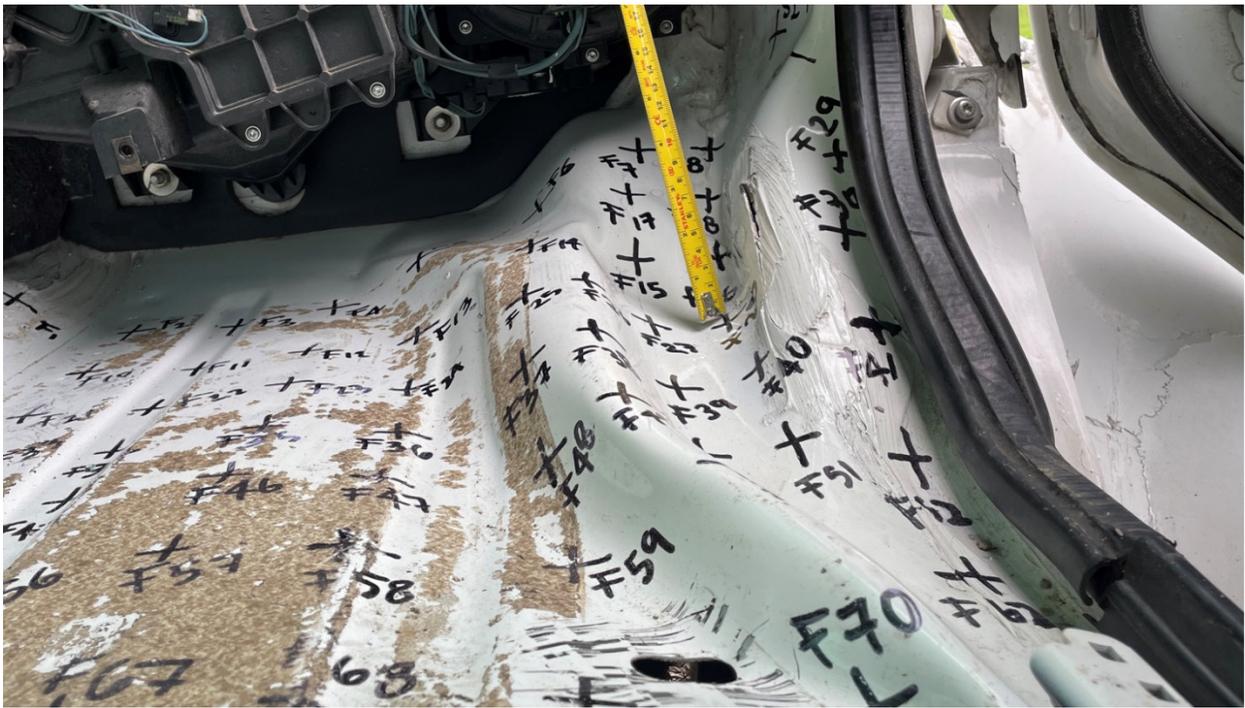
Figure 7-26 Test 4-12 Test Vehicle Passenger-Side Floorboard Deformation
